# JEKYLL ISLAND AIRPORT

## PAVEMENT EVALUATION REPORT

JULY 2002

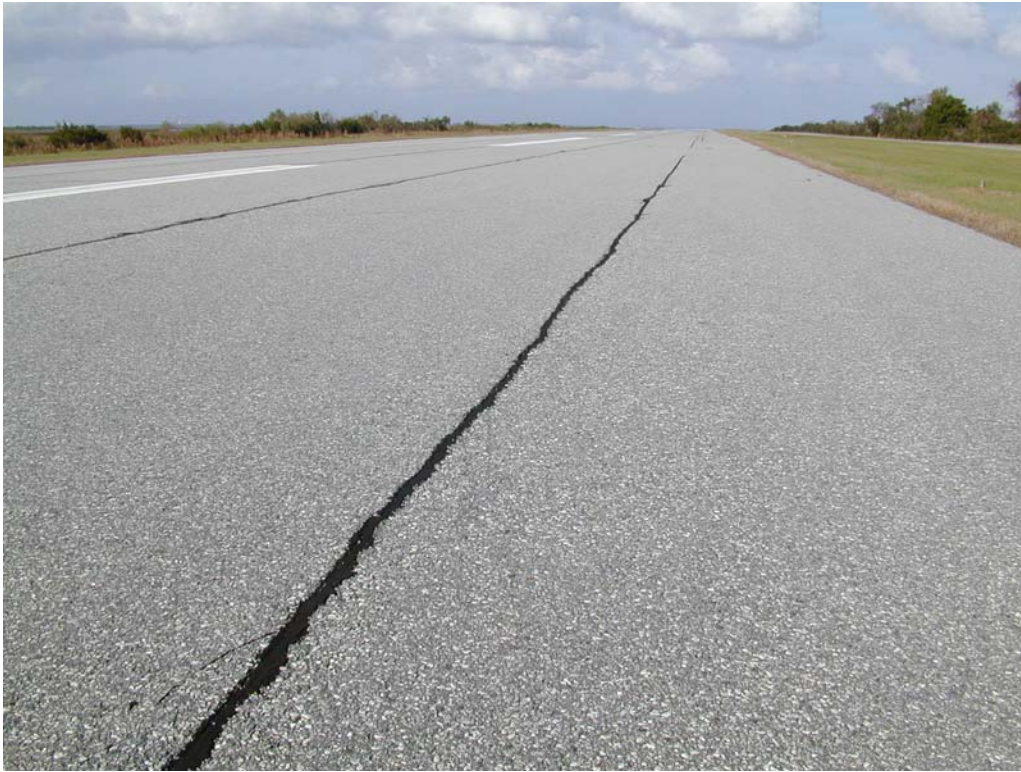
Runway 18-36 is in good condition with significant amounts of low-severity longitudinal and transverse (L&T) cracking observed throughout the pavement. The majority of this cracking was sealed with sealant in good condition. Low-severity raveling and weathering was found on more the half of the pavements surface.

Overview of section R1836JK-10.

Branch <sup>1</sup>	Section	Year	Type of Repair <sup>2</sup>	Estimated Cost <sup>3</sup>
R1836JK	10	2004	Major M&R	\$192,260
TAJK	10	2006	Preventive	\$21,005
A01JK	10	2006	Preventive	\$5,236

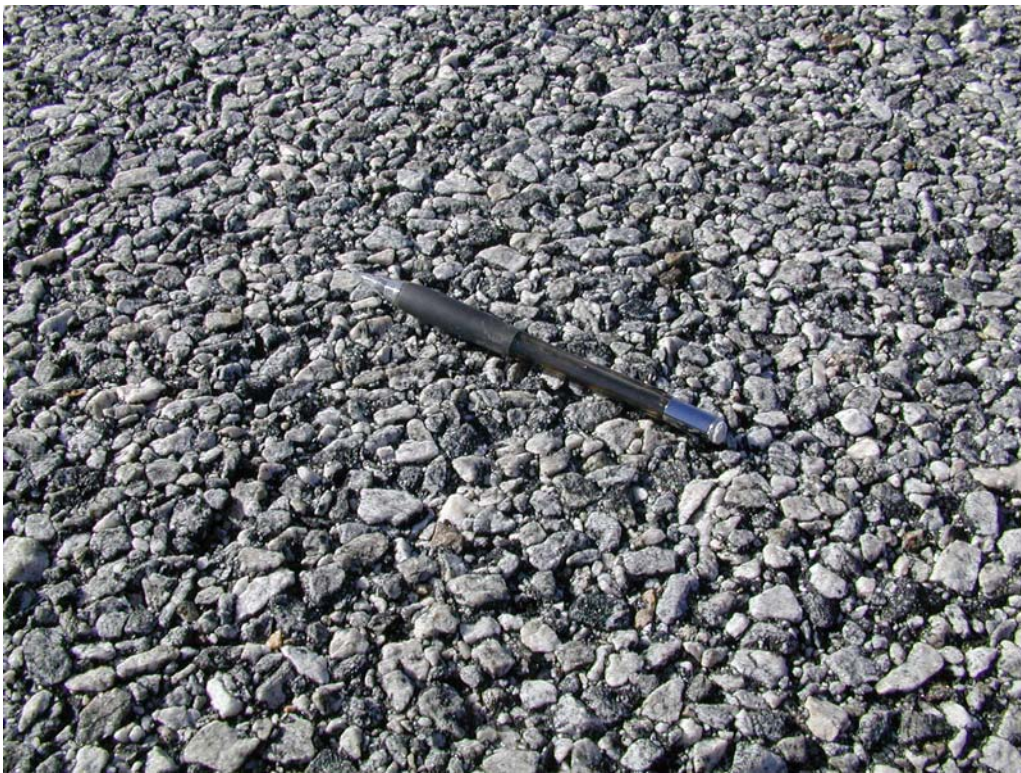
Raveling and weathering on section R1836JK-10.

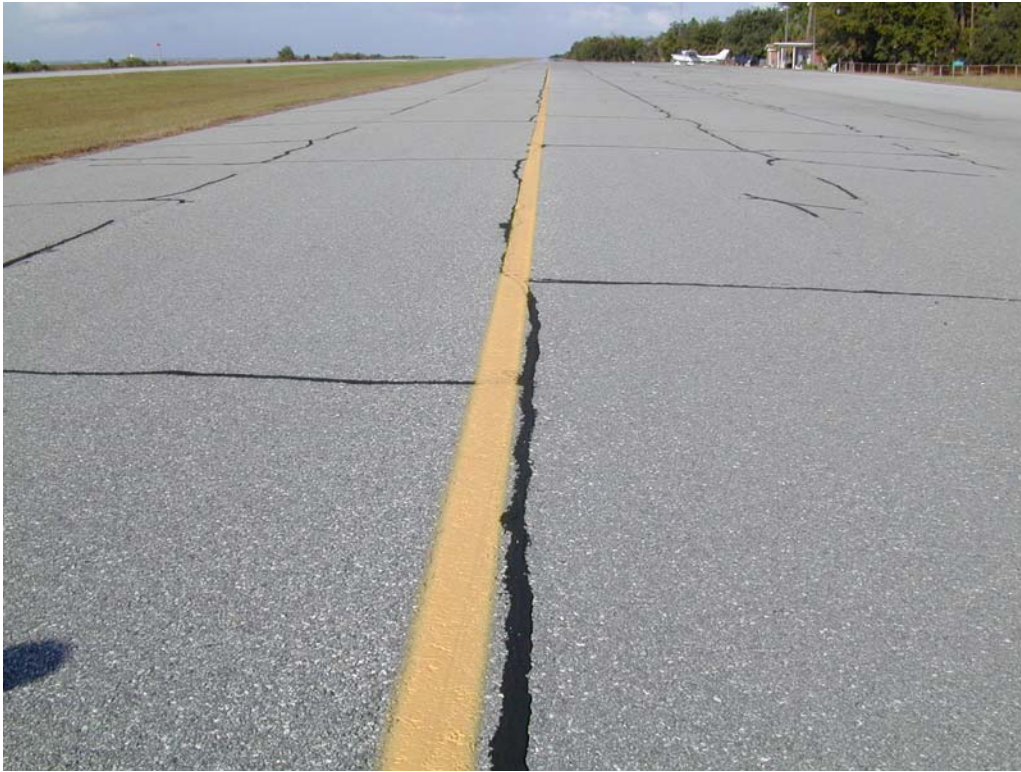
The taxiway and apron were both in good condition with similar distresses present. Substantial amounts of low-severity L&T cracking along with swelling were recorded in both areas.

Isolated areas of bleeding were found in the taxiway while significant amounts of raveling and weathering were observed in the apron.

Overview of section TAJK-10.

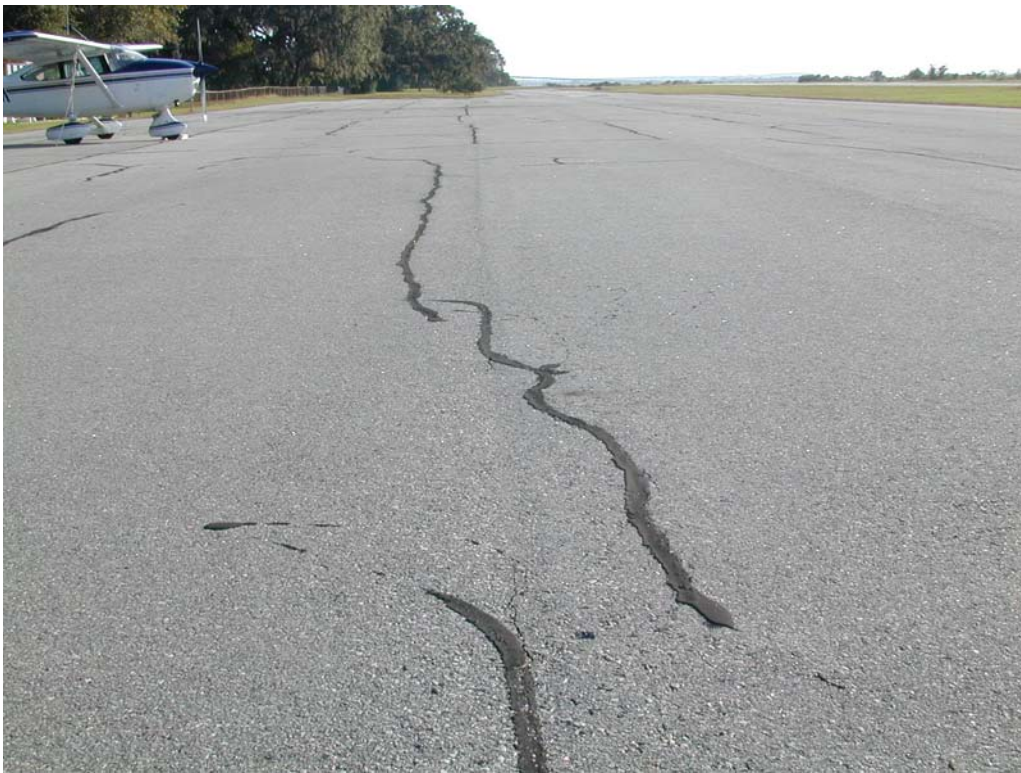
Overview of section A01JK-10.
