# COCHRAN MUNICIPAL AIRPORT

# PAVEMENT EVALUATION REPORT

JULY 2002

Applied Pavement Technology, Inc. 3001 Research Road, Suite C Champaign, Illinois 61822 217-398-3977 www.pavementsolutions.com

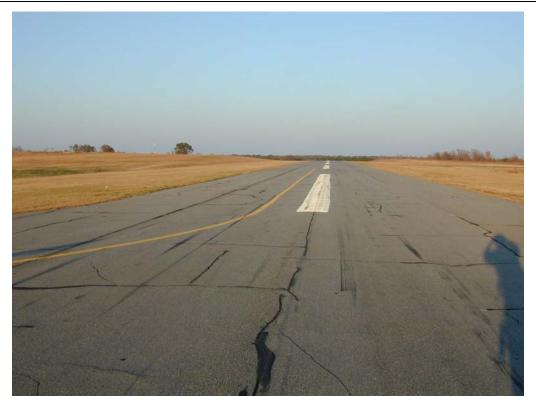
Runway 5-23 and Taxiway A are each defined by one section and in good condition. Low-severity, sealed, longitudinal and transverse (L&T) cracking, as well as isolated amounts of unsealed cracking, were found throughout each facility.

Overview of section R523CH-10.

Branch <sup>1</sup>	Section	Year	Type of Repair <sup>2</sup>	Estimated Cost <sup>3</sup>
R523CH	10	2006	Preventive	\$28,131

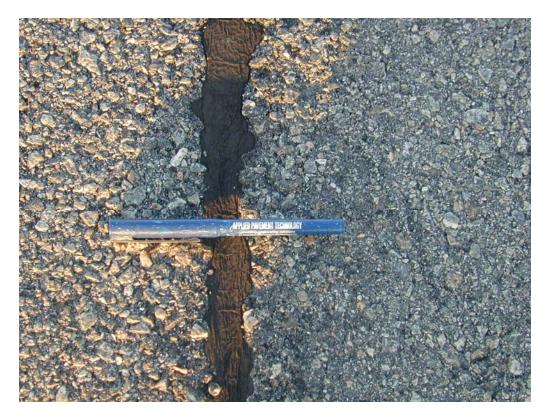
L&T cracking in section R523CH-10.

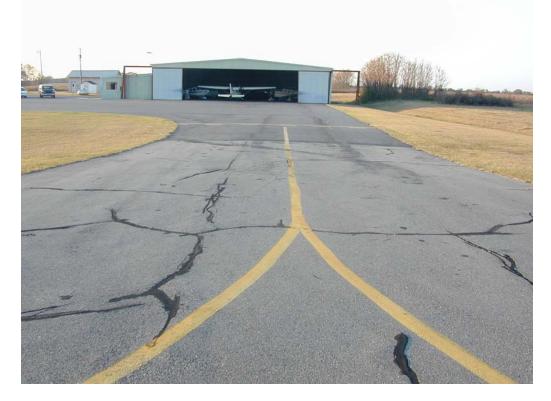
Overview of section TACH-10.

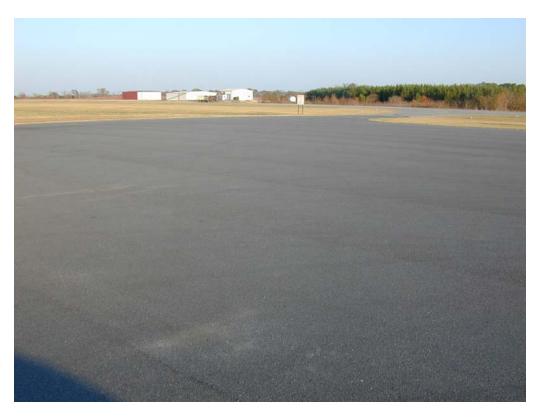
The apron was recently rehabilitated and is in excellent condition with isolated amounts of unsealed L&T cracking found.

Overview of section A01CH-10.
