BRANTLEY COUNTY AIRPORT

PAVEMENT EVALUATION REPORT

JULY 2002

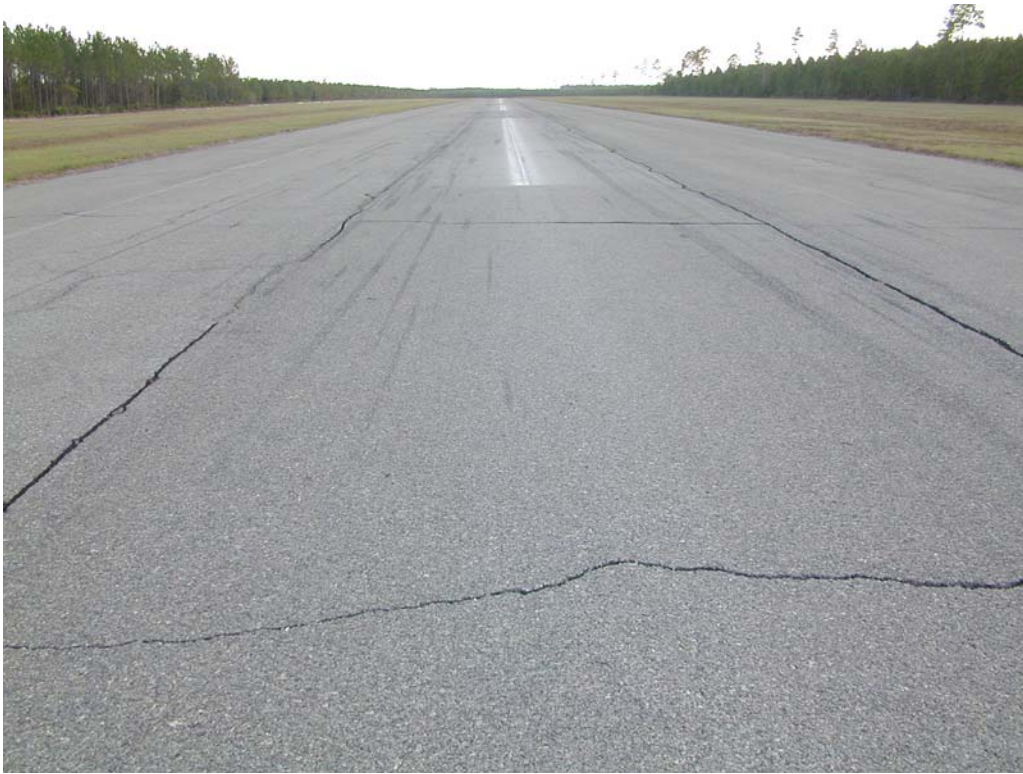
Runway 1-19 is in fair condition with significant amounts of low and medium-severity longitudinal and transverse (L&T) cracking found throughout. Isolated amounts of high-severity L&T cracking were also found. Occasional areas of block cracking and raveling and weathering were observed. Small circular swells, approximately one square foot in size, were found scattered throughout the runway. Finally, isolated quantities of rutting were found throughout the runway that appear to be caused by non-aircraft vehicle traffic.

Overview of section R119NH-10.

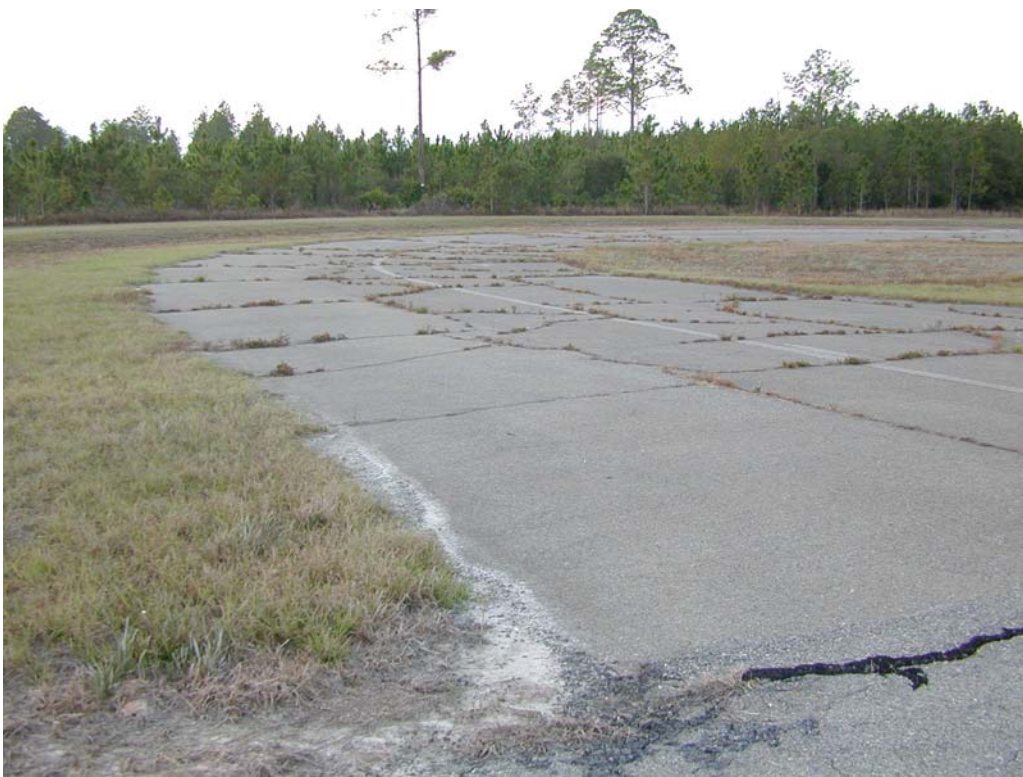
Overview of abandoned pavement in section R119NH-10.

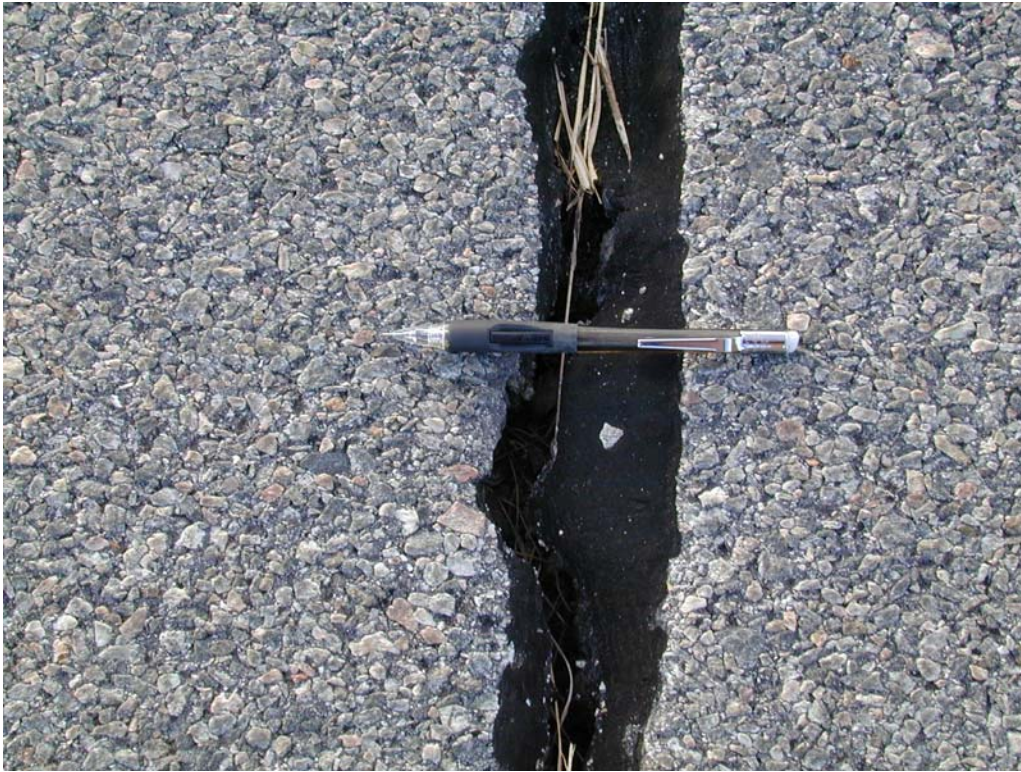
L&T cracking in section R119NH-10.

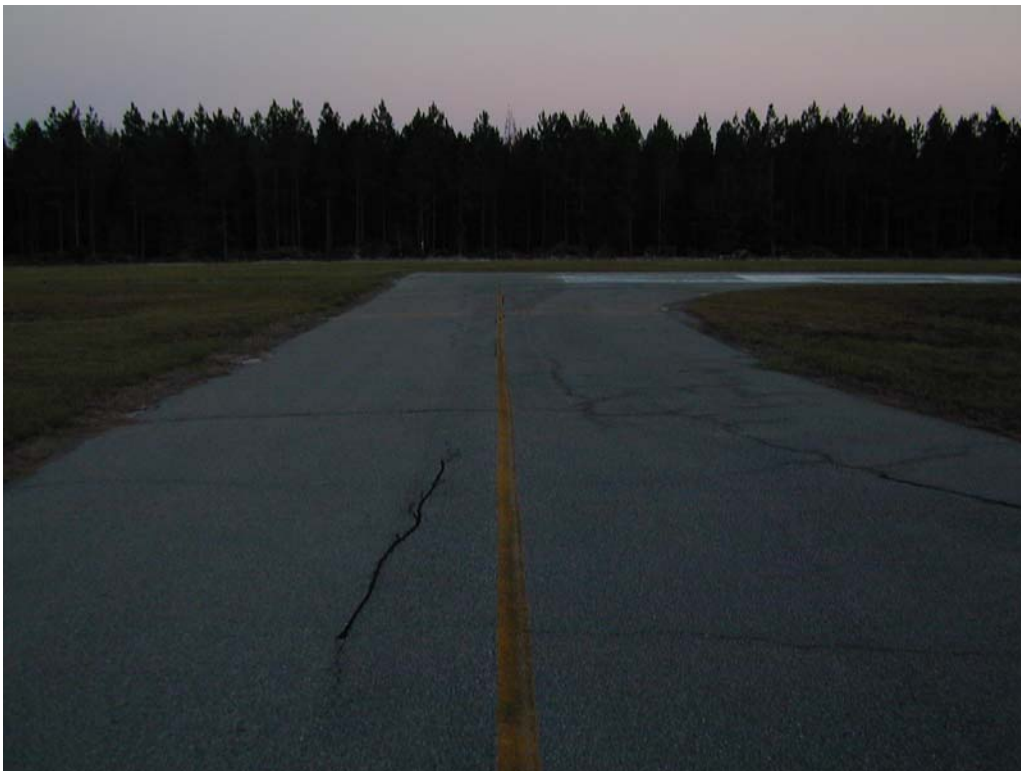
The taxiway and apron were in similar condition to the runway. L&T and block cracking, raveling and weathering, and swelling were all found in substantial amounts.

Overview of section TANH-10.

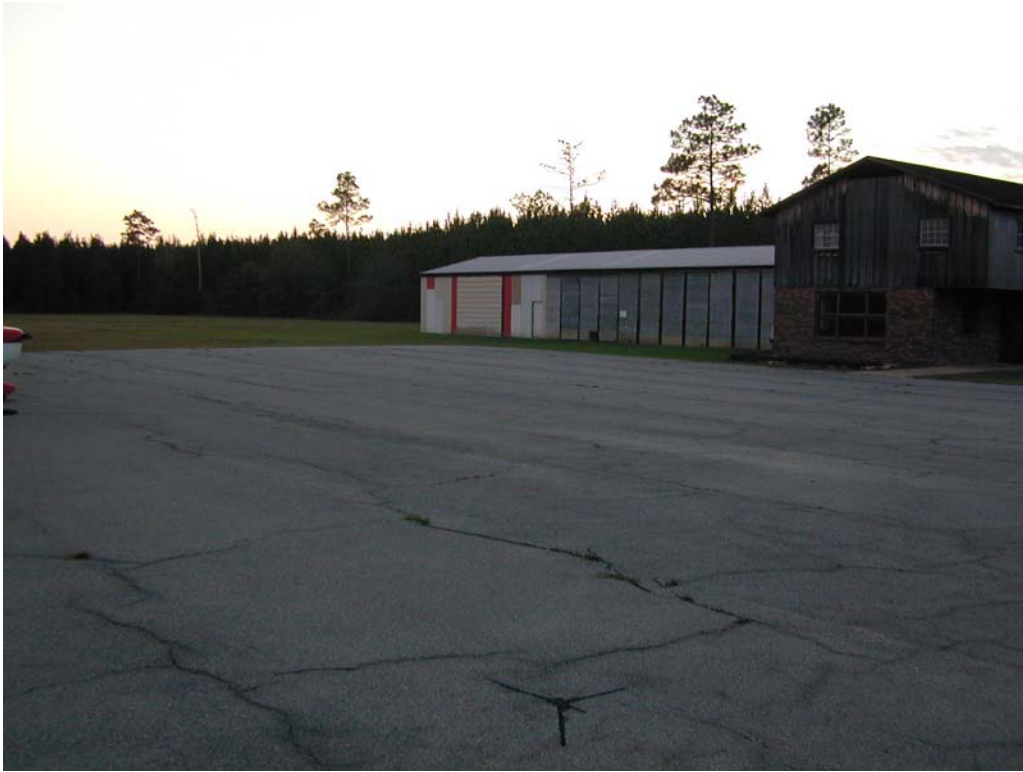
Overview of section A01NH-10.
