BUTLER MUNICIPAL AIRPORT

PAVEMENT EVALUATION REPORT

JULY 2002

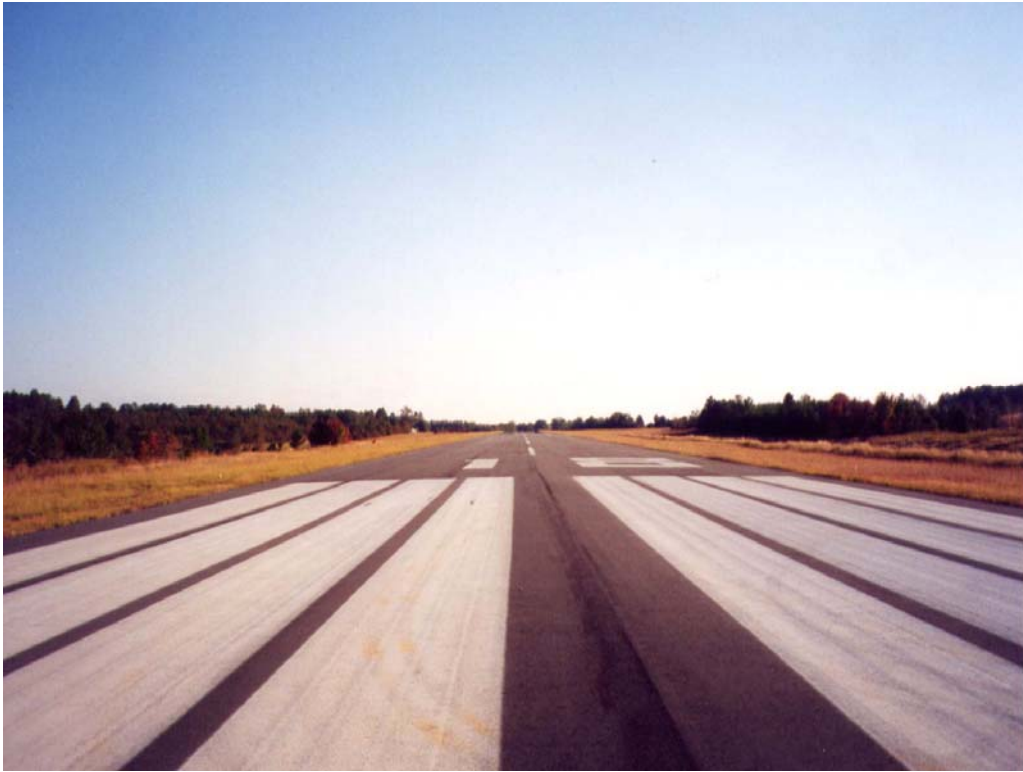
Runway 18-36 is in excellent condition with no observed distresses. It appeared the runway has been extended to 4000-ft and overlaid.

Overview of section R1836BT-10.

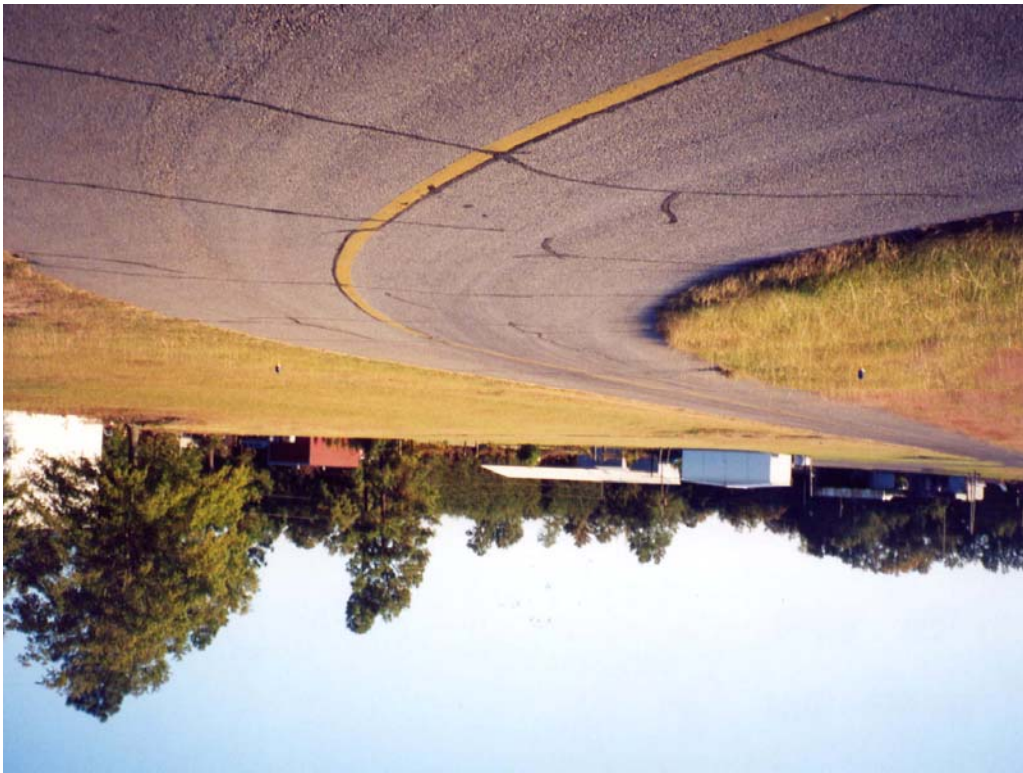
The taxiway, TABT-10, is in poor condition. The pavement has sealed and unsealed, low-severity longitudinal and transverse (L&T) cracking, low-severity weathering, and low-severity patching.

Overview of section TABT-10.

Branch ¹	Section	Year	Type of Repair ²	Estimated Cost ³
A01BT	10	2002	Major M&R	\$14,650
TABT	10	2006	Preventive	\$3,474

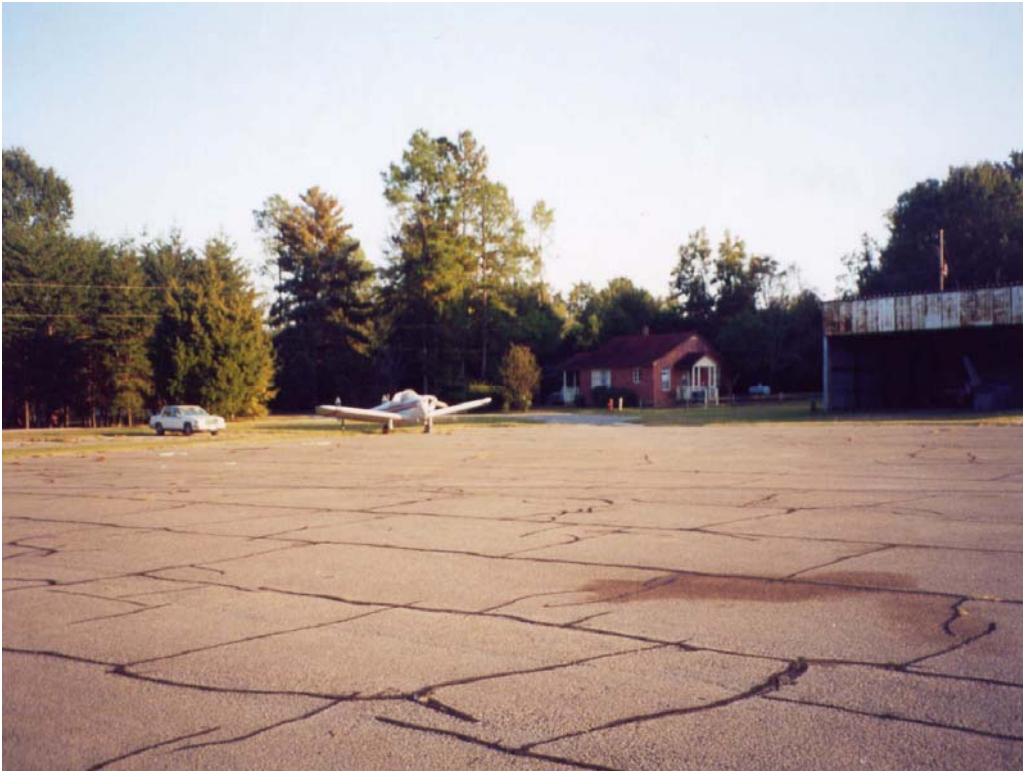
The apron, section A01BT-10, has sealed, low-severity block cracking over 100 percent of its area. Additionally, the pavement has low-severity weathering over 25 percent of its area.

Overview of section A01BT-10.
