WILLIAM A. ZORN AIRPORT

PAVEMENT EVALUATION REPORT

JULY 2002

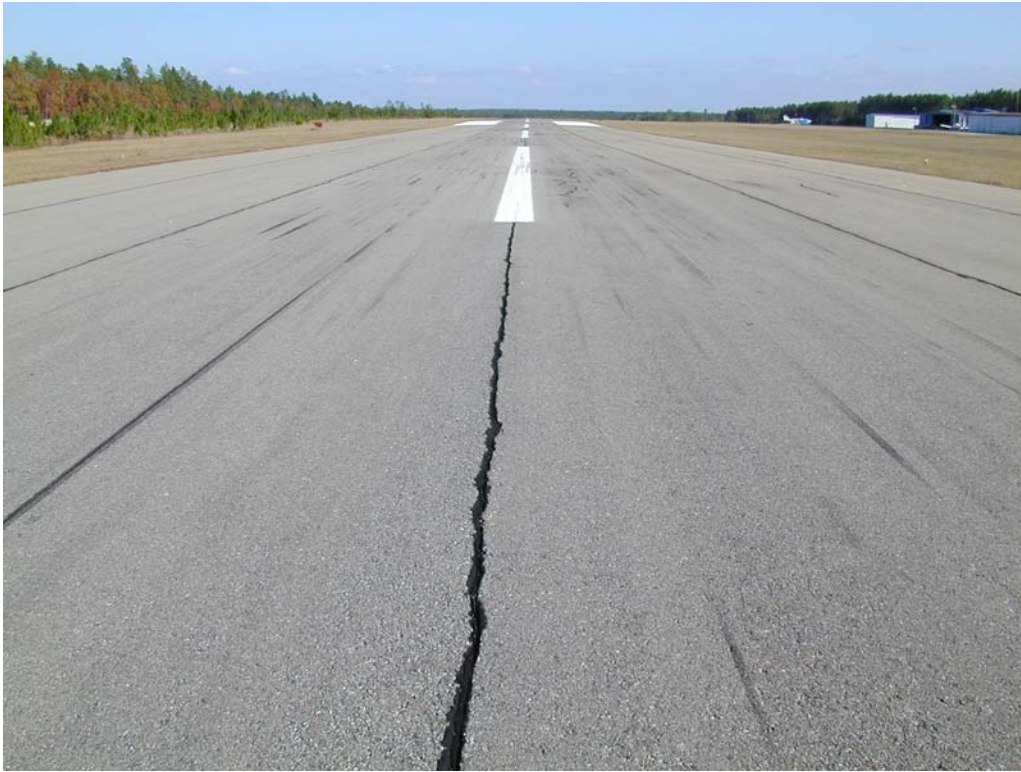
One section was defined in Runway 10-28 which included the new extension on the east end of the runway as well as both the turnarounds on either end. The new pavement is included in this section for management purposes and was found to be free of distress. The condition of the runway as discussed here, pertains to the older pavement found in the section. R1028JS-10 is in good condition with moderate to significant amounts of low-severity, sealed and unsealed, longitudinal and transverse cracking (L&T) being found throughout the section. Isolated areas of swelling and raveling and weathering were also observed throughout the section. In many

instances, the pavement was showing signs of further weathering; however, the conditions were not severe enough to record under the ASTM standard criteria.

Overview of section R1028JS-10.

Plan Year	Network	Branch	Section	Distress Description	Severity	Work Description	Work Qty.	Work Unit	Unit Cost	Work Cost
2002	JESUP	A01JS	10	L & T CR	M	Crack Sealing	791	LF	\$1.28	\$1,012
2002	JESUP	R1028JS	10	L & T CR	M	Crack Sealing	5,588	LF	\$1.28	\$7,152

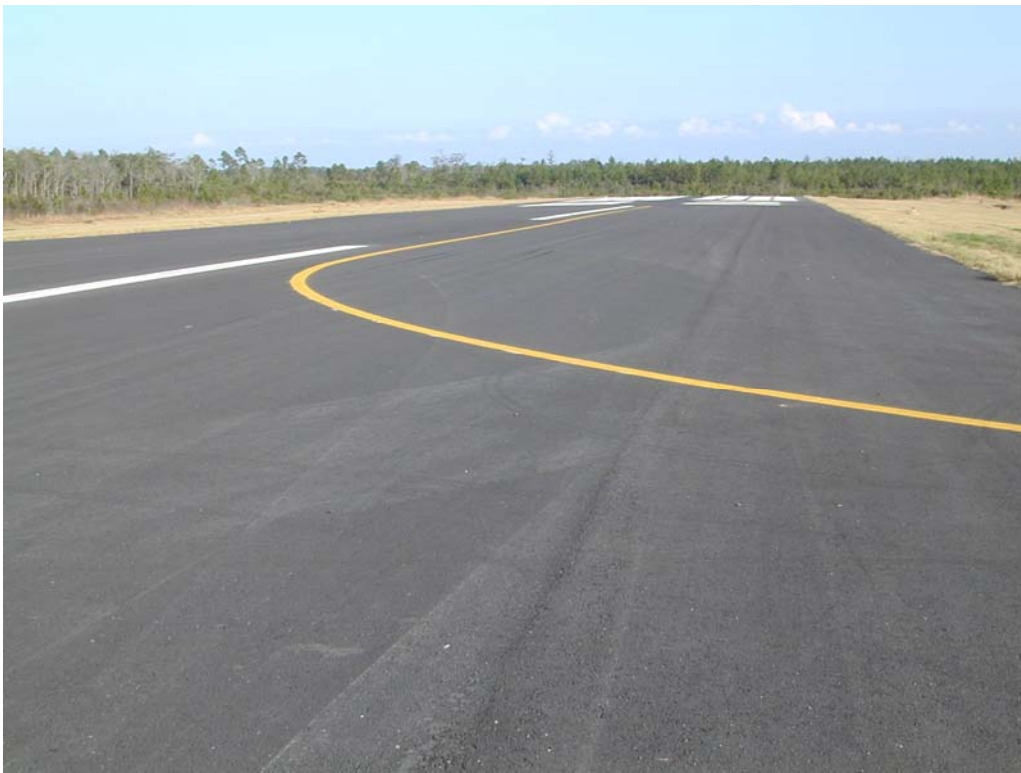
Overview of new extension on section R1028JS-10.

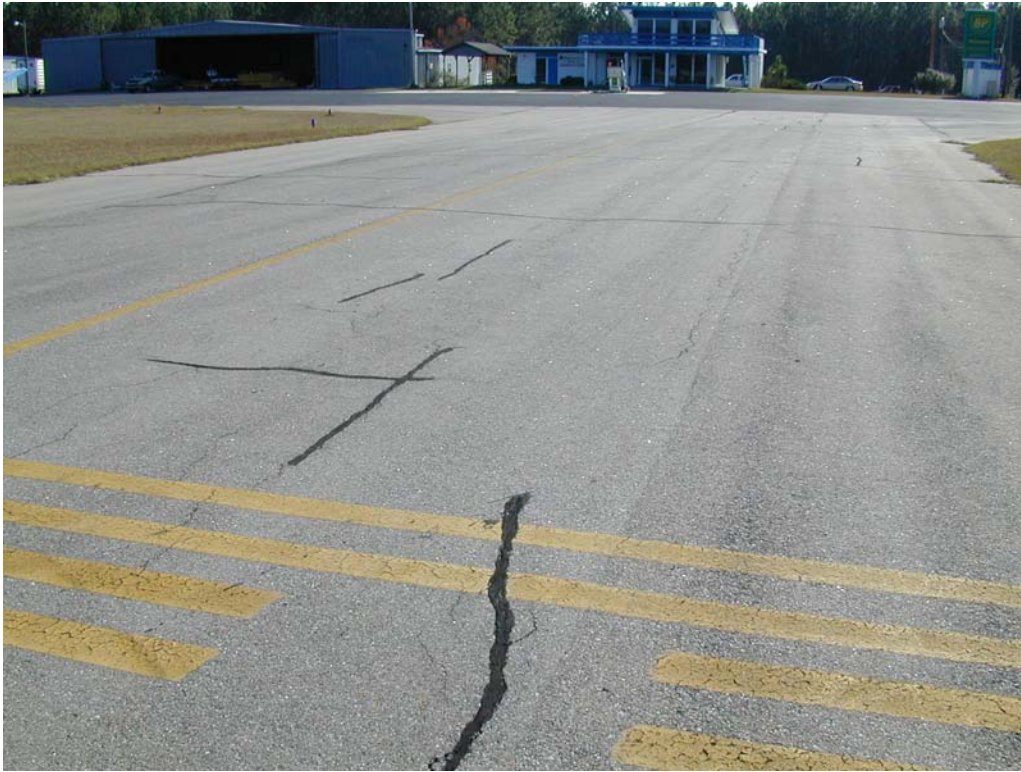
Taxiway A is in fair condition with large amounts of low-severity, sealed and unsealed, L&T cracking being observed. Moderate amounts of medium-severity L&T cracking were also found in the section. Finally, isolated amounts of low and medium-severity raveling and weathering were found.

Overview of section TAJIS-10.

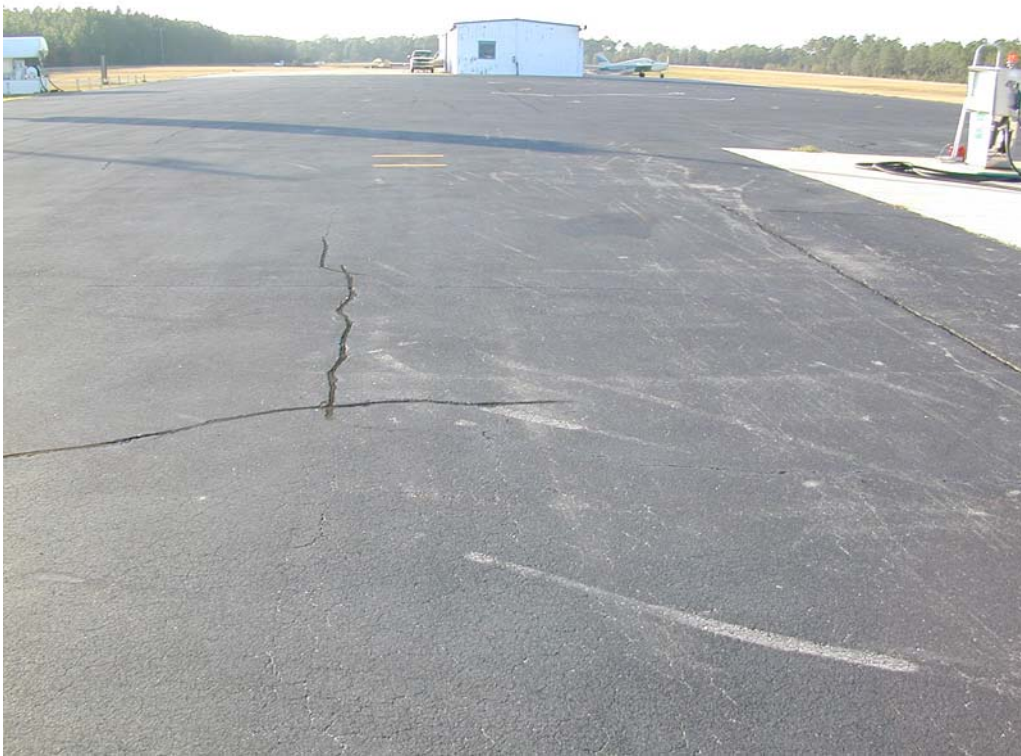
Section A01JS-10 is the only section defined in the apron. The section is in good condition with significant amounts of low-severity, sealed and unsealed, L&T cracking being found. Isolated amounts of medium-severity L&T cracking were also observed throughout the section. Approximately 80% of the section has had a surface treatment applied to it in the past.

Overview of section A01JS-10.

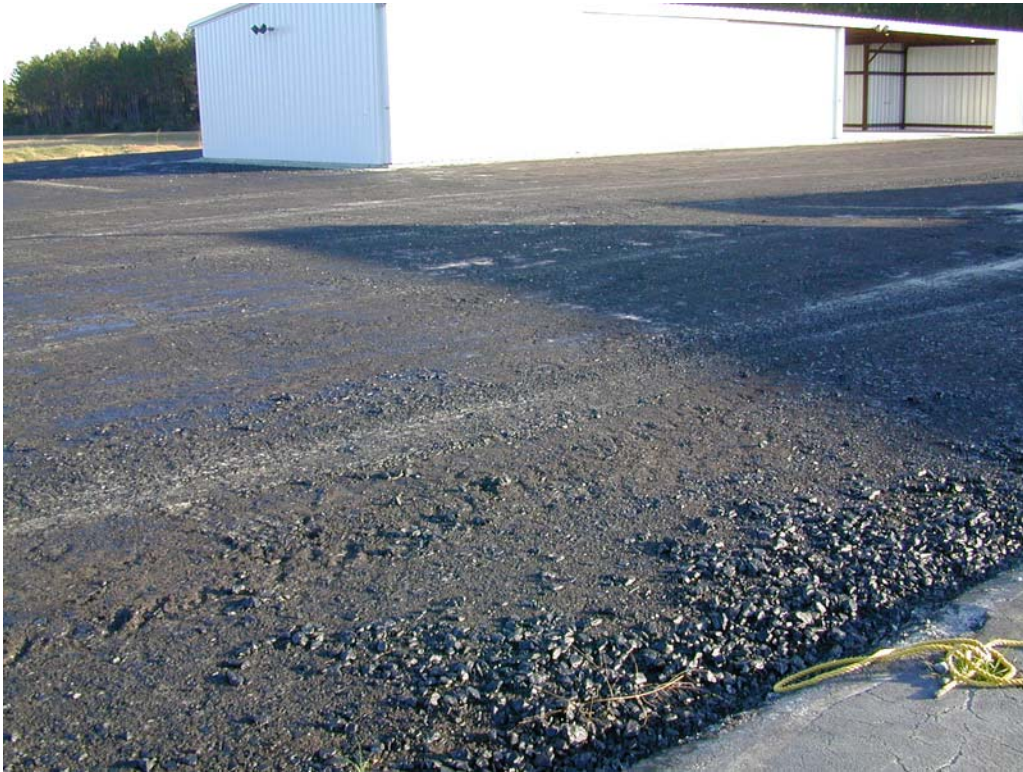
A new t-hangar area on the eastern side of the apron was being constructed at the time of inspection. It is assumed that once constructed, the pavement will be free of distress.

Overview of section THANGJS-10 (new construction).
