2012 Butler Municipal Airport Pavement Management Plan

BUTLER MUNICIPAL AIRPORT

PAVEMENT MANAGEMENT REPORT

DECEMBER 2012

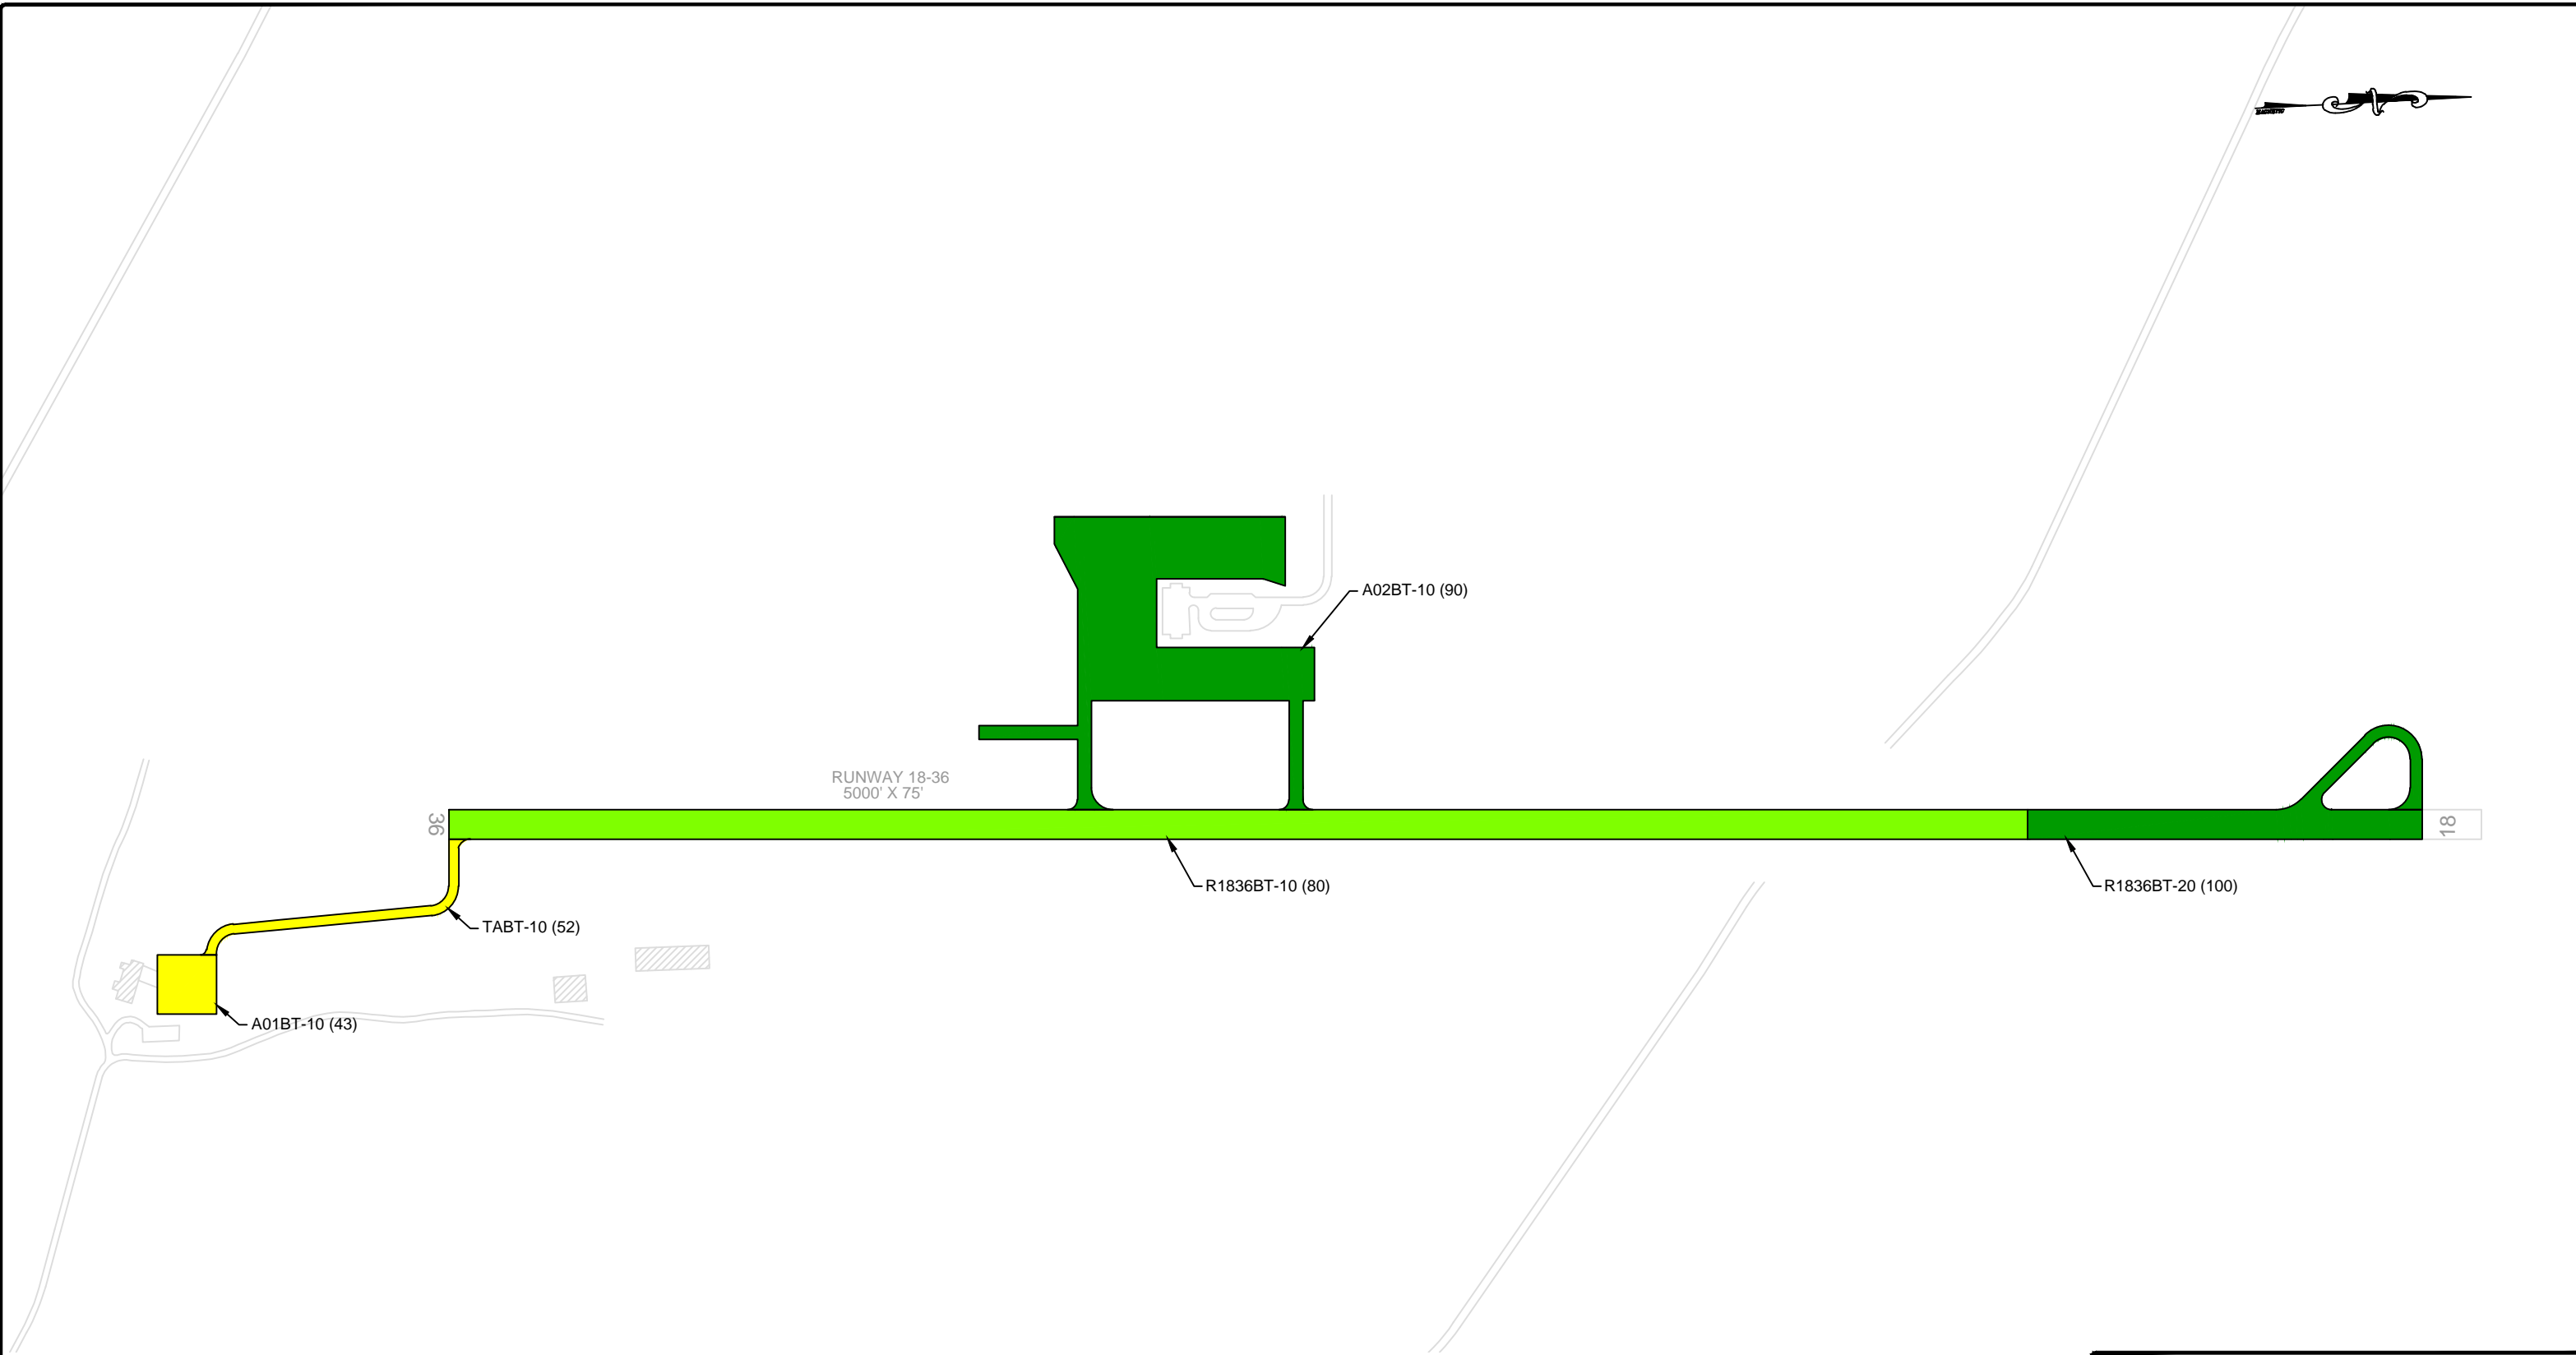
PAGE TITLE: PAVEMENT CONDITION INDEX MAP

The 2012 area-weighted condition of Butler Municipal Airport is 84, with conditions ranging from 43 to 100 [on a scale of 0 (failed) to 100 (excellent)]. This compares to a 2007 PCI of 92.

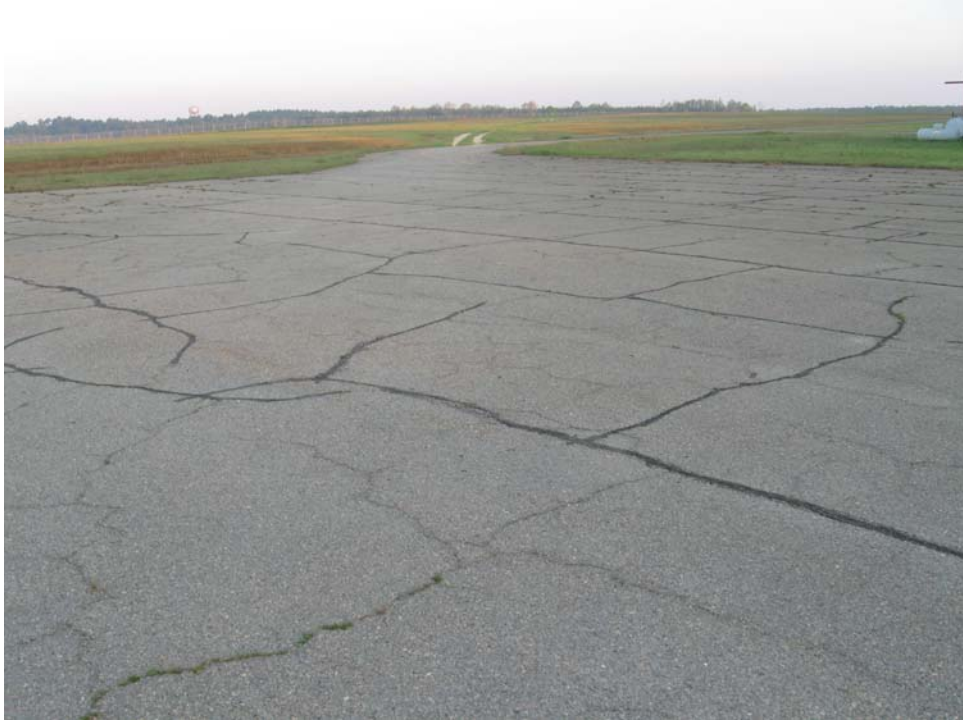
Apron 01 (A01BT) was defined by one section with a PCI value of 43. Extensive quantities of low- and medium-severity block cracking and medium-severity weathering were recorded. The medium-severity cracking was identified where the crack sealant was no longer performing satisfactorily.

A01BT-10. Overview.

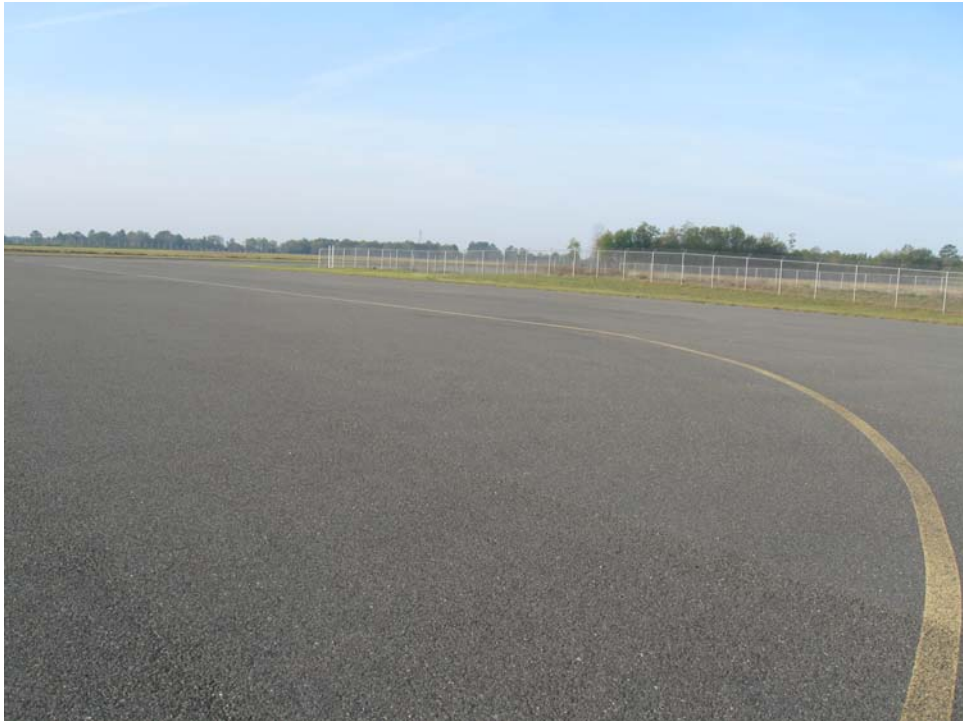
Apron 02 (A02BT) consisted of one section with a PCI value of 90. Small amounts of low-severity L&T cracking, weathering, and raveling were observed.

A02BT-10. Overview.

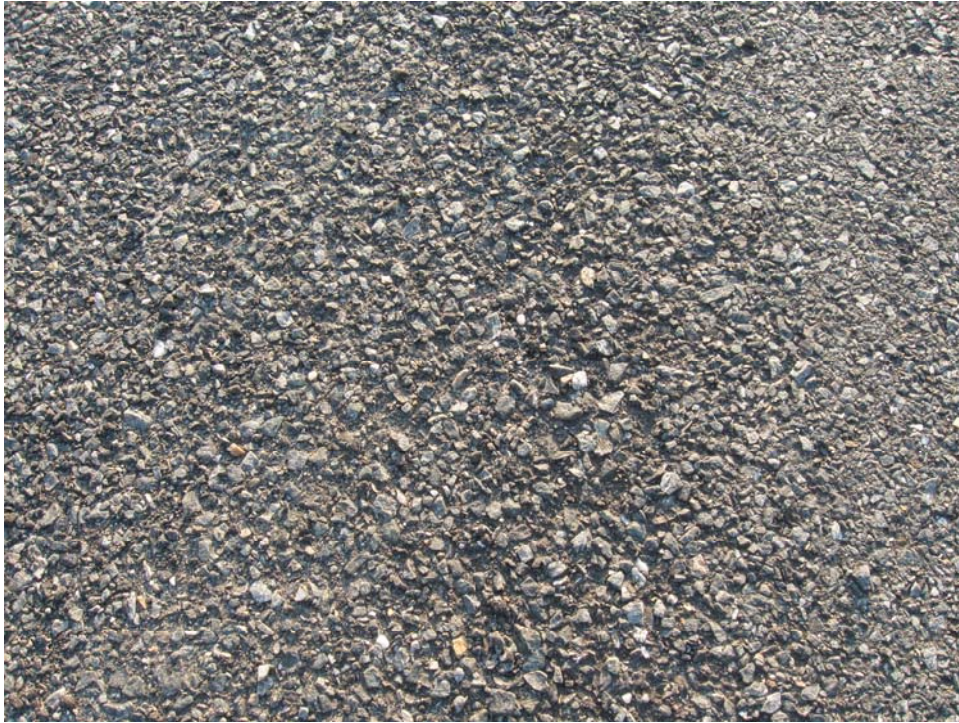
A02BT-10. Raveling (Sample Unit #04).

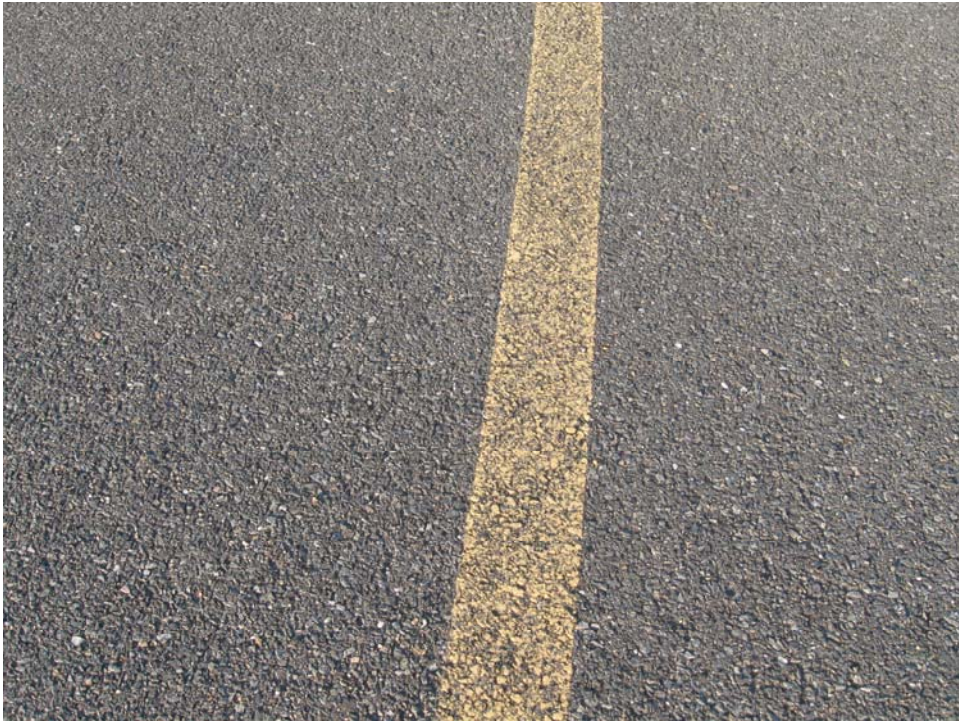
A02BT-10. Unsatisfactory Paint.

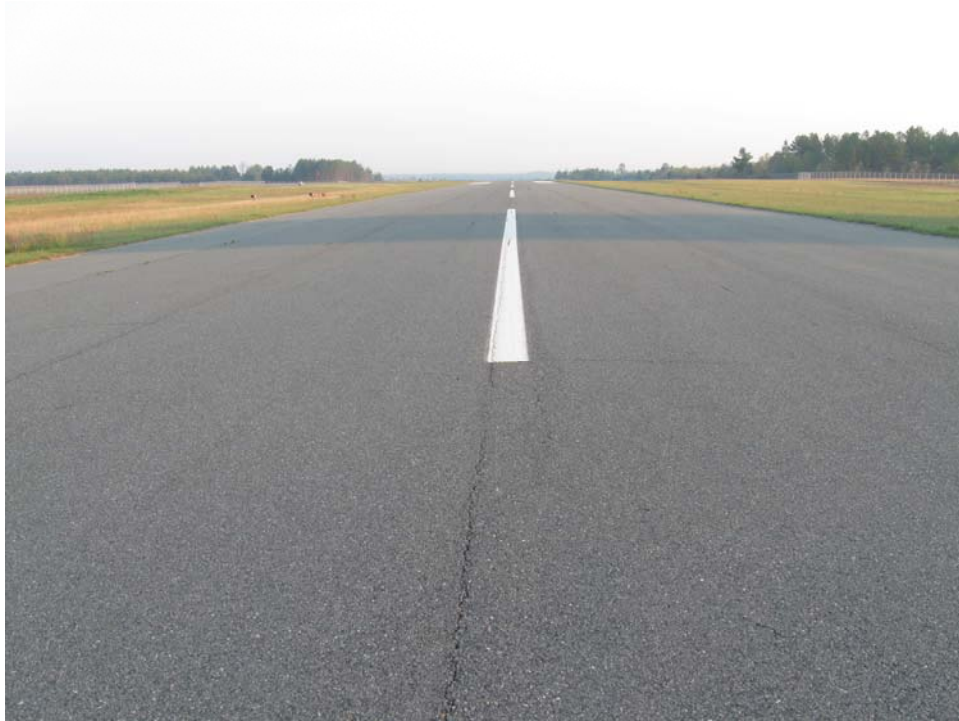
Runway 18-36 was comprised of two sections. Section 10 had a PCI value of 80. Small amounts of low- and medium-severity longitudinal and transverse (L&T) cracking and isolated areas of low-severity swelling were recorded. The majority of the low-severity cracking was unsealed; medium-severity cracking was due to either unsealed crack widths that exceeded $\frac{1}{4}$ in or crack sealant that was no longer performing satisfactorily. Section 20 was recently constructed and was in excellent condition with a PCI value of 100. No distresses were observed at the time of inspection.

R1836BT-10. Overview.

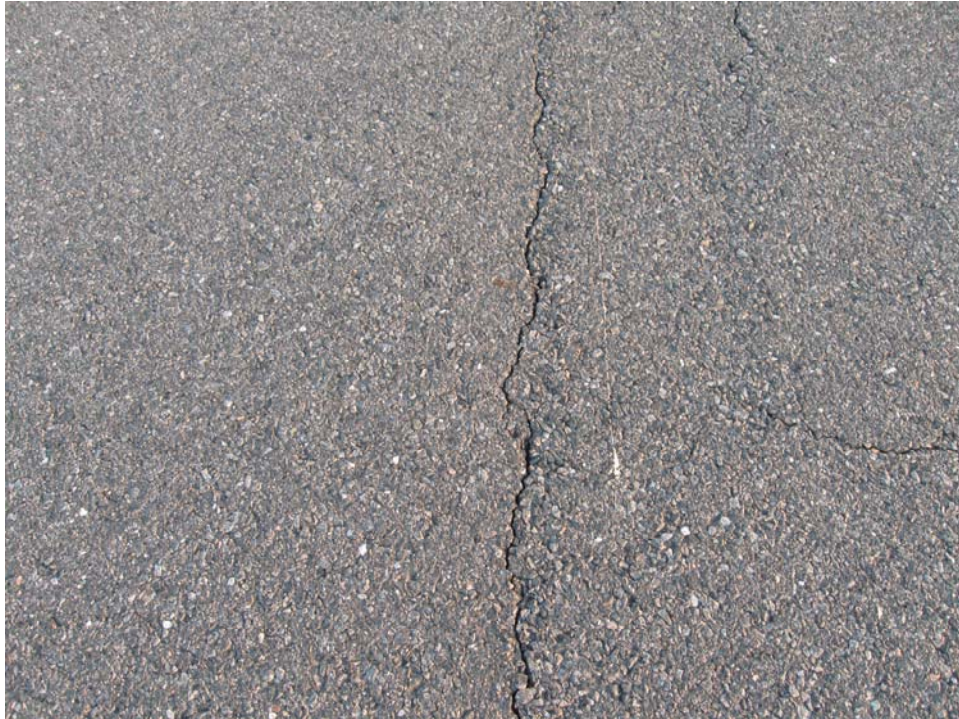
R1836BT-10. Longitudinal and Transverse Cracking (Sample Unit #03).

Sample Number: 03 Type: R Area: 6,750.00SqFt PCI = 86
Sample Comments:
48 LONGITUDINAL/TRANSVERSE CRACKING L 304.00 Ft Comments:u

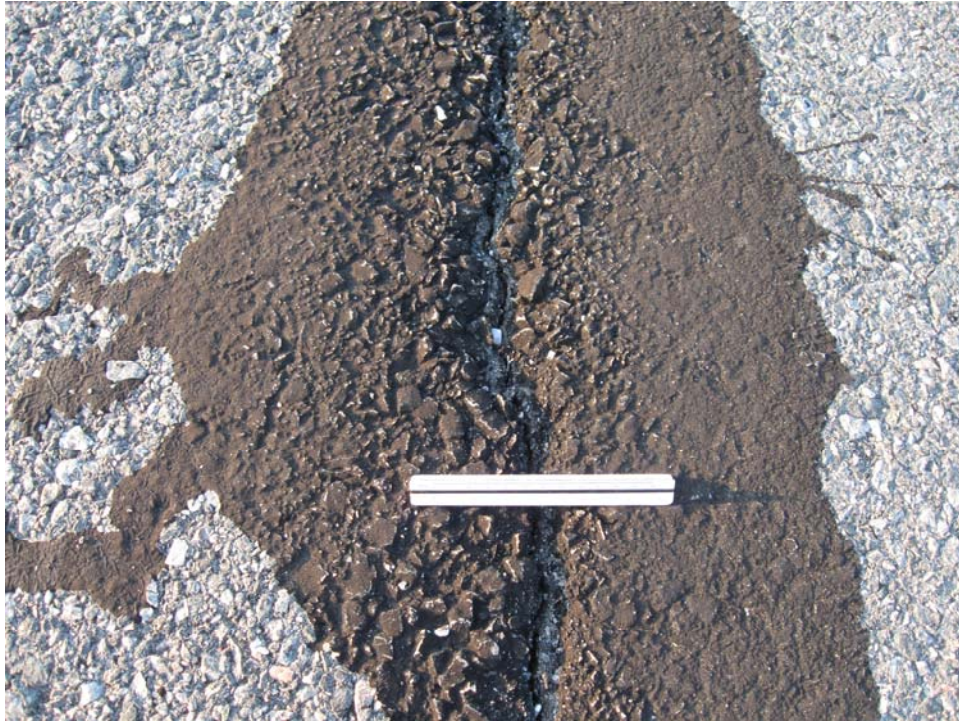
R1836BT-10. Longitudinal and Transverse Cracking (Sample Unit #28).

Sample Number: 28 Type: R Area: 6,750.00SqFt PCI = 75
Sample Comments:
48 LONGITUDINAL/TRANSVERSE CRACKING L 318.00 Ft Comments:u
48 LONGITUDINAL/TRANSVERSE CRACKING M 219.00 Ft Comments:fs
48 LONGITUDINAL/TRANSVERSE CRACKING L 3.00 Ft Comments:s

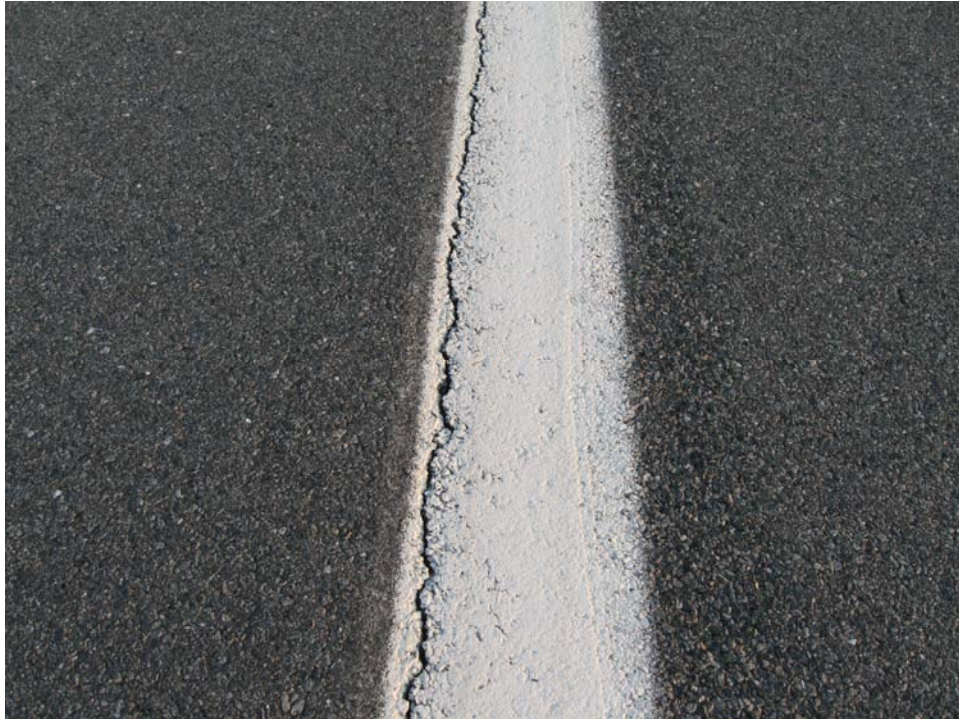
R1836BT-10. Satisfactory Paint.

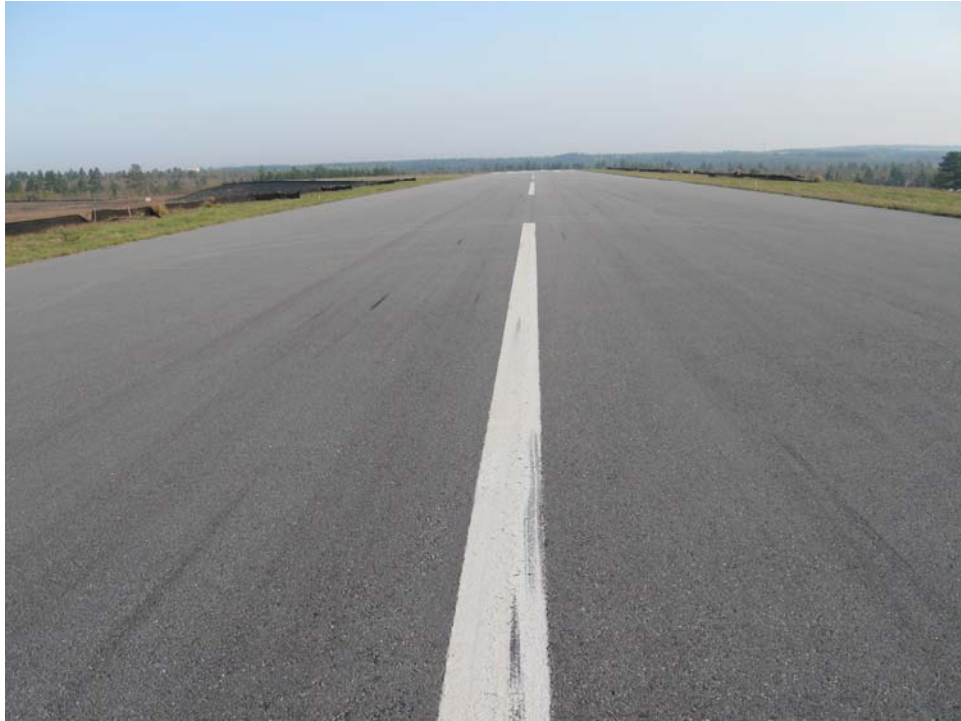
R1836BT-20. Overview.

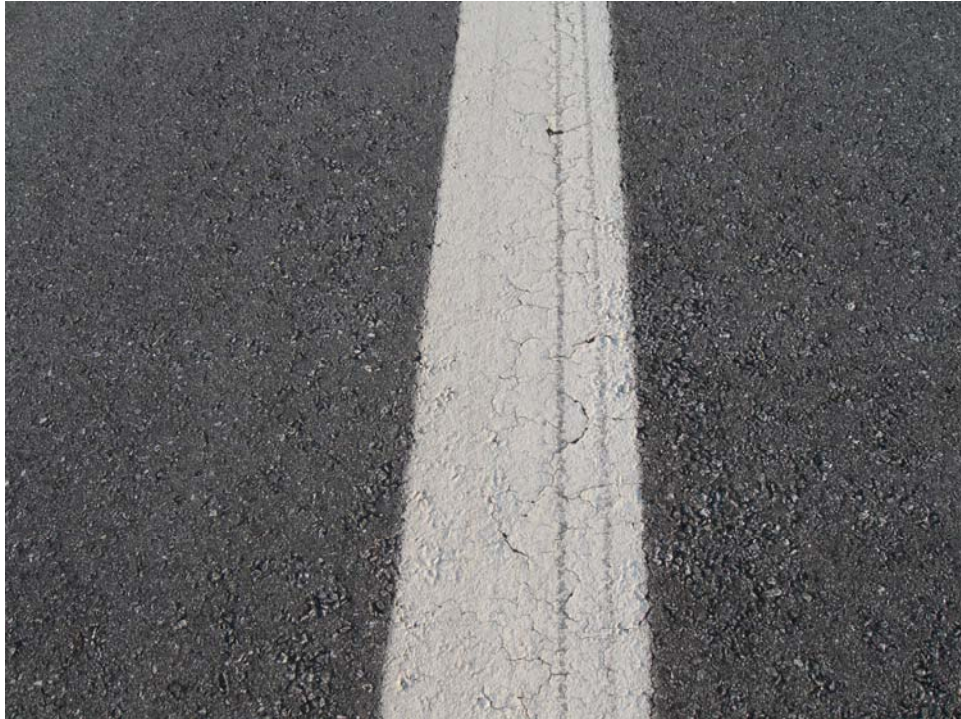
R1836BT-20. Unsatisfactory Paint.

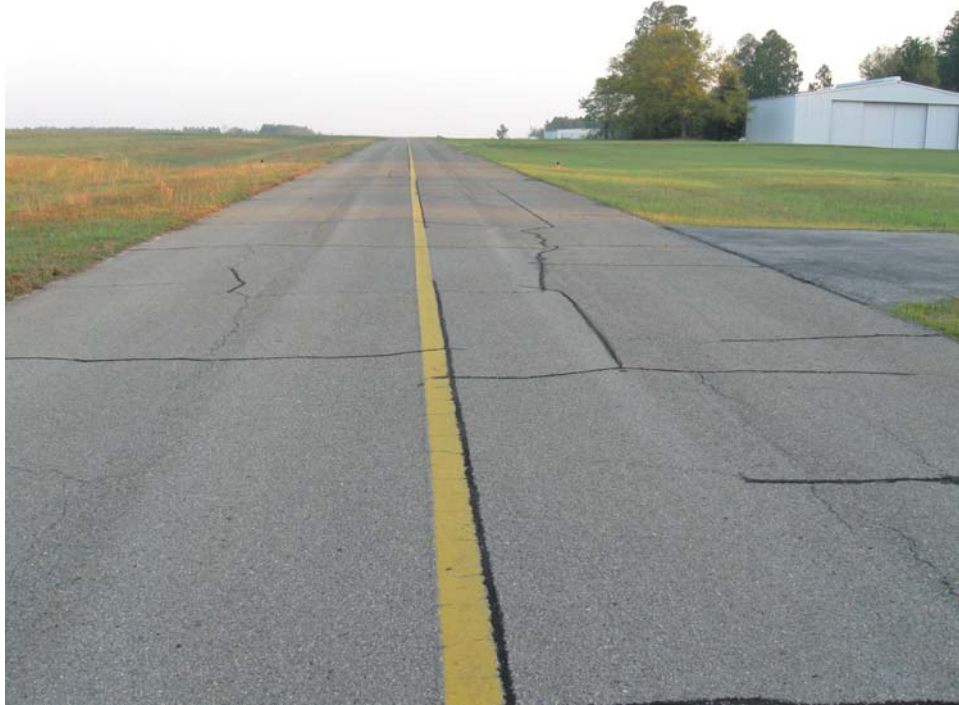
Taxiway A consisted of one section. Section 10 had a PCI value of 52. Extensive quantities of low- and medium-severity block cracking and low-severity weathering were recorded. A small amount of medium-severity patching was also identified. The low-severity cracking was both sealed and unsealed, and the medium-severity cracking was due to crack sealant that was no longer performing satisfactorily.

TABT-10. Overview.

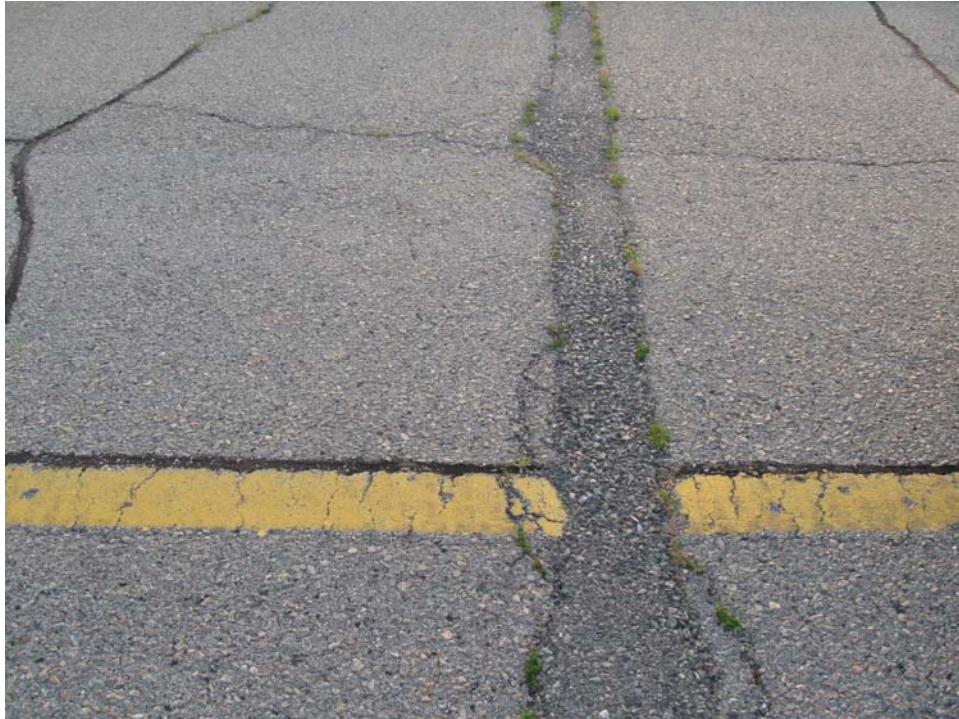
TABT-10. Longitudinal and Transverse Cracking (Sample Unit #04).

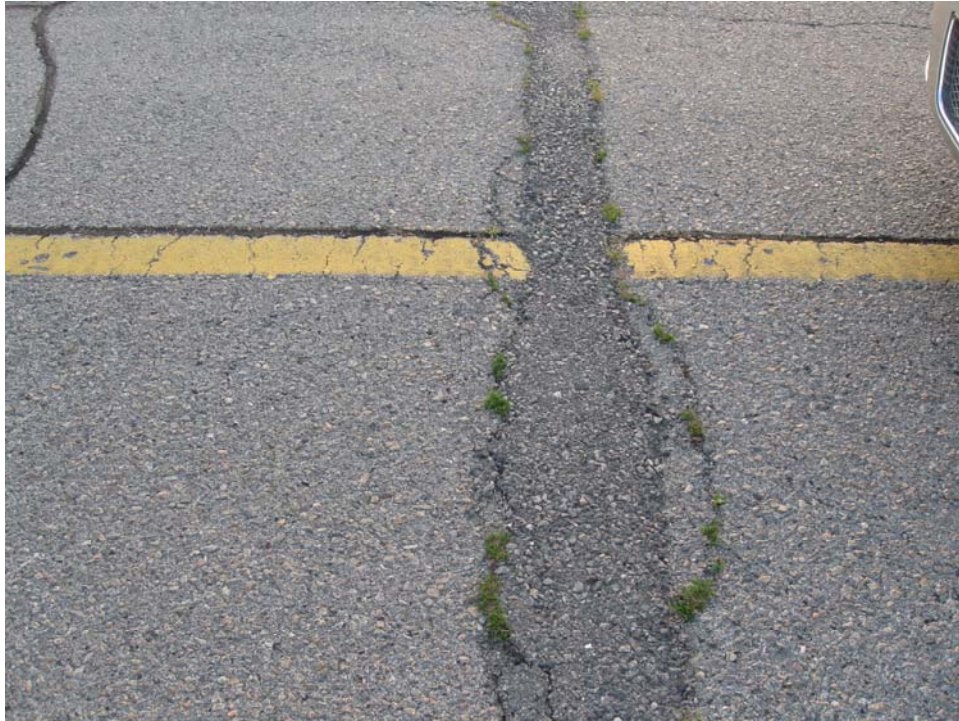
TABT-10. Patching (Sample Unit #04).

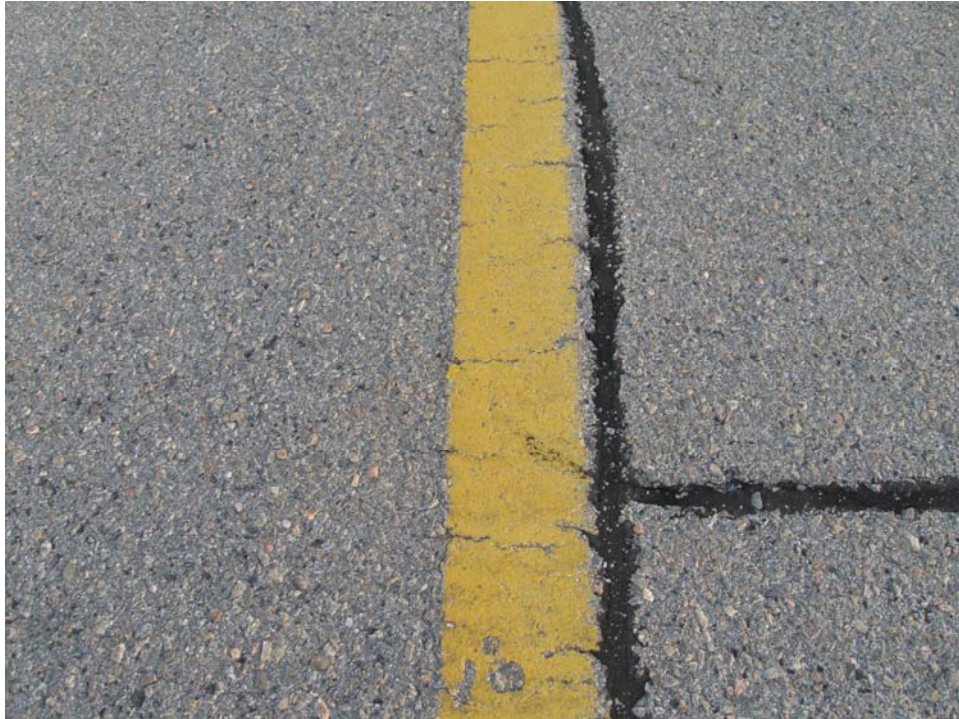
TABT-10. Unsatisfactory Paint.
