# 2012 Cochran Airport Pavement Management Plan

# COCHRAN AIRPORT

## PAVEMENT MANAGEMENT REPORT

**DECEMBER 2012**

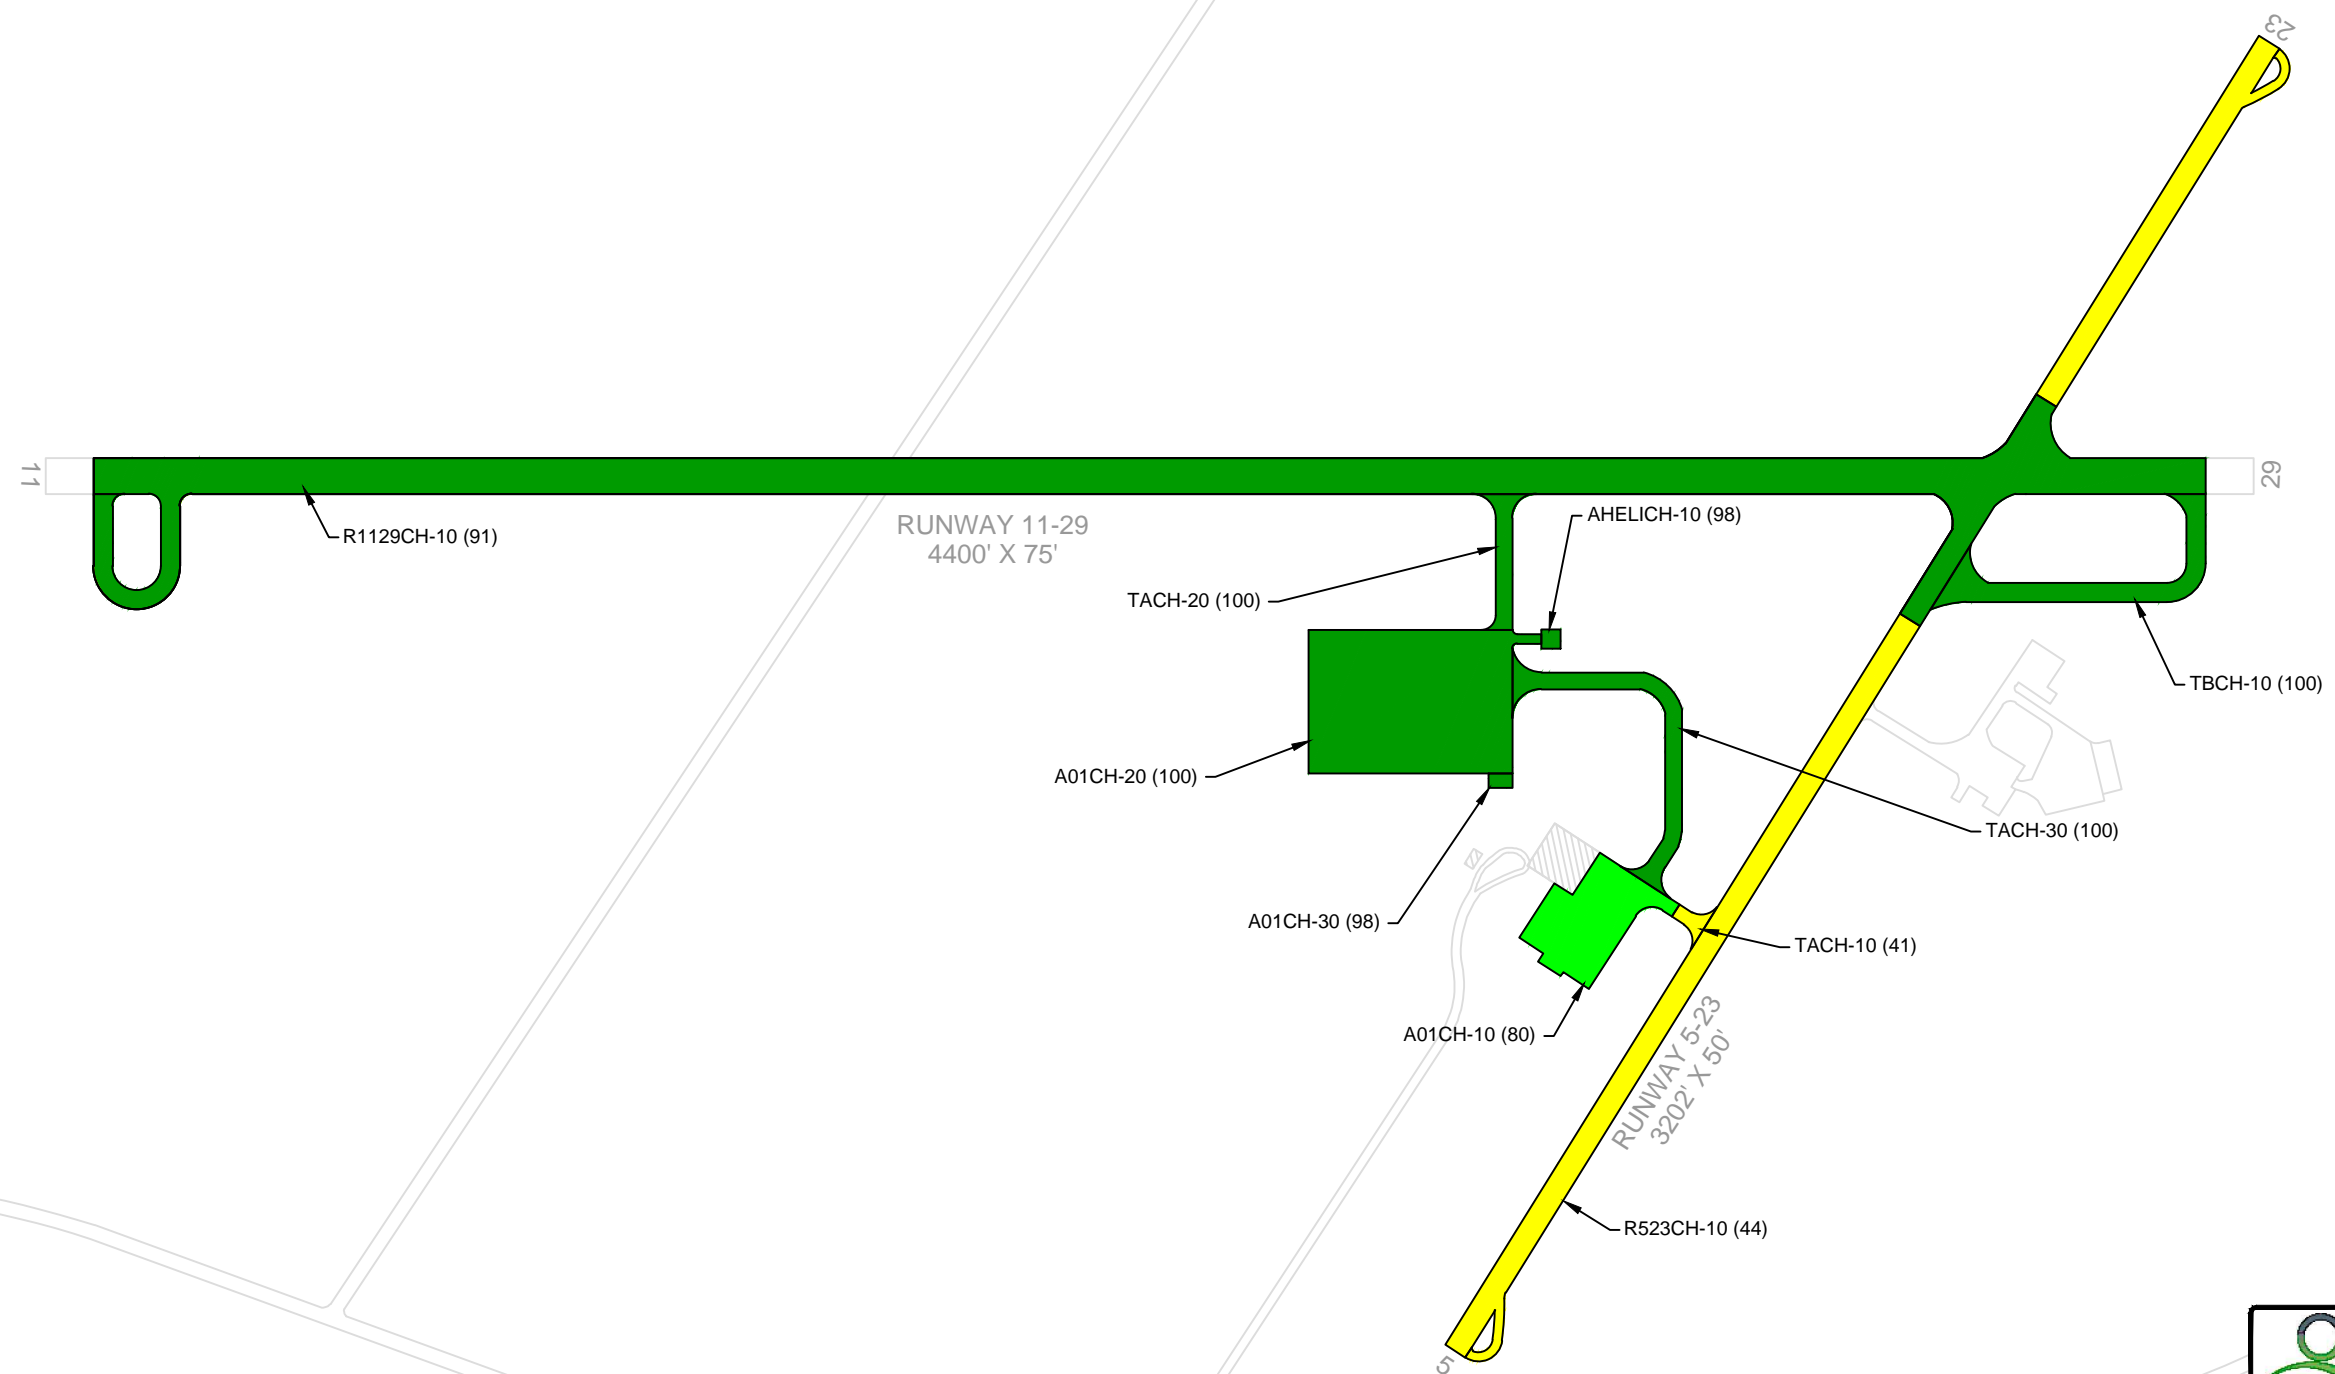
PAGE TITLE: PAVEMENT CONDITION INDEX MAP

The 2012 area-weighted condition of Cochran Airport is 84, with conditions ranging from 41 to 100 [on a scale of 0 (failed) to 100 (excellent)]. This compares to a 2007 PCI of 87.

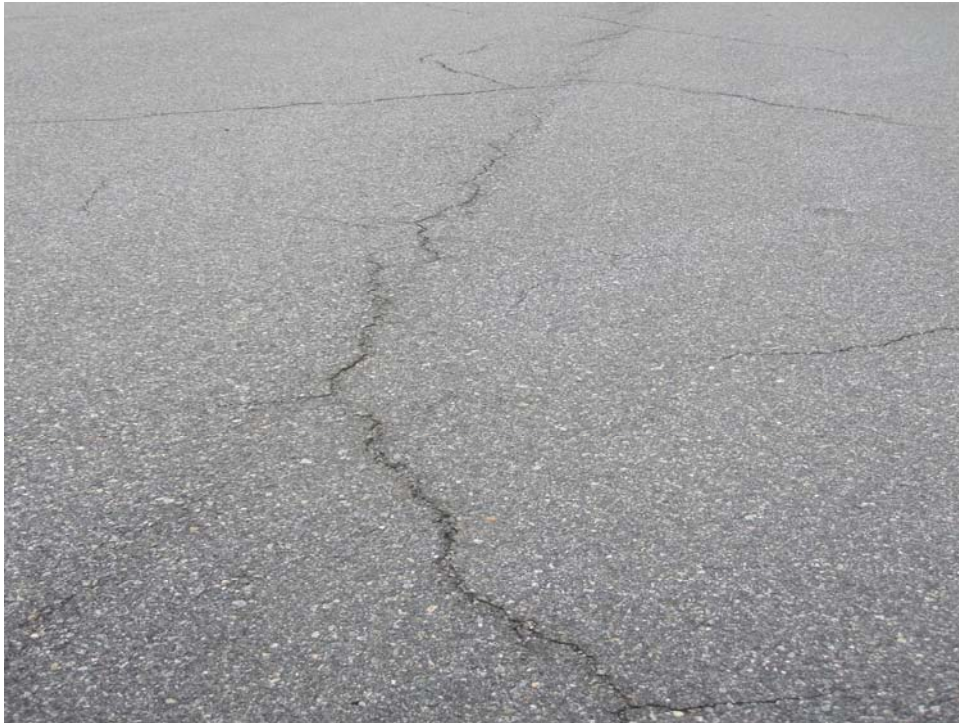
The apron area consisted of three sections. Section 10 had a PCI value of 80. The primary distress identified in this section was low-severity L&T cracking. In addition, small quantities of medium-severity L&T cracking were observed. Section 20 was constructed in 2009 and was in excellent condition with a PCI value of 100. No distresses were observed. Section 30, a PCC pavement constructed in 2009, was in excellent condition with a PCI value of 98. Only low-severity joint seal damage was recorded in this section.

A01CH-10. Longitudinal and Transverse Cracking (Sample Unit #03).

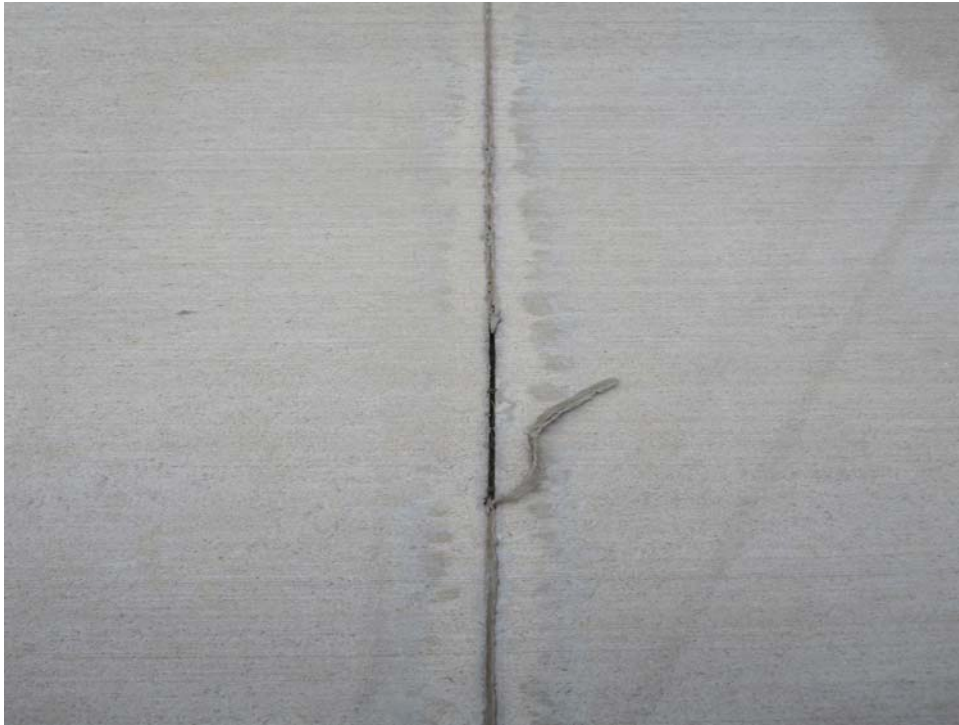
A01CH-30. Joint Seal Damage (Sample Unit #01).

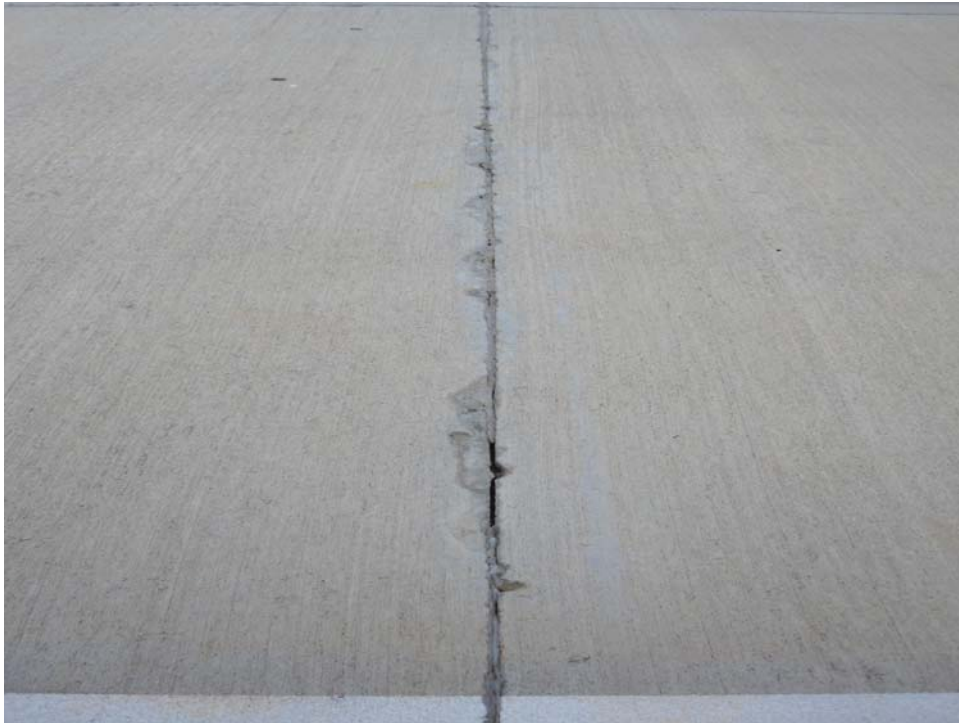
The helipad area was defined by one section. Section 10, a PCC pavement constructed in 2009, was in excellent condition with a PCI value of 98. Only low-severity joint seal damage was identified in this section at the time of inspection.

AHELICH-10. Joint Seal Damage (Sample Unit #01).

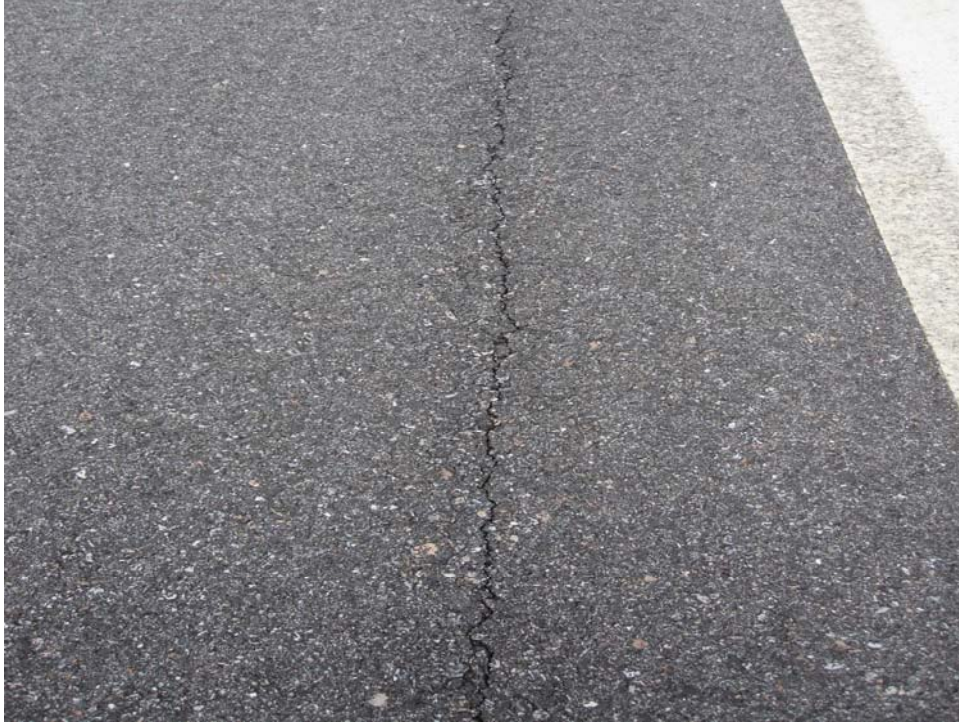
Runway 11-29 was comprised of one section with a PCI value of 91. This runway was constructed in 2007 shortly after the previous inspection. The primary distress identified in this section was low-severity longitudinal and transverse (L&T) cracking.

R1129CH-10. Longitudinal and Transverse Cracking (Sample Unit #03).

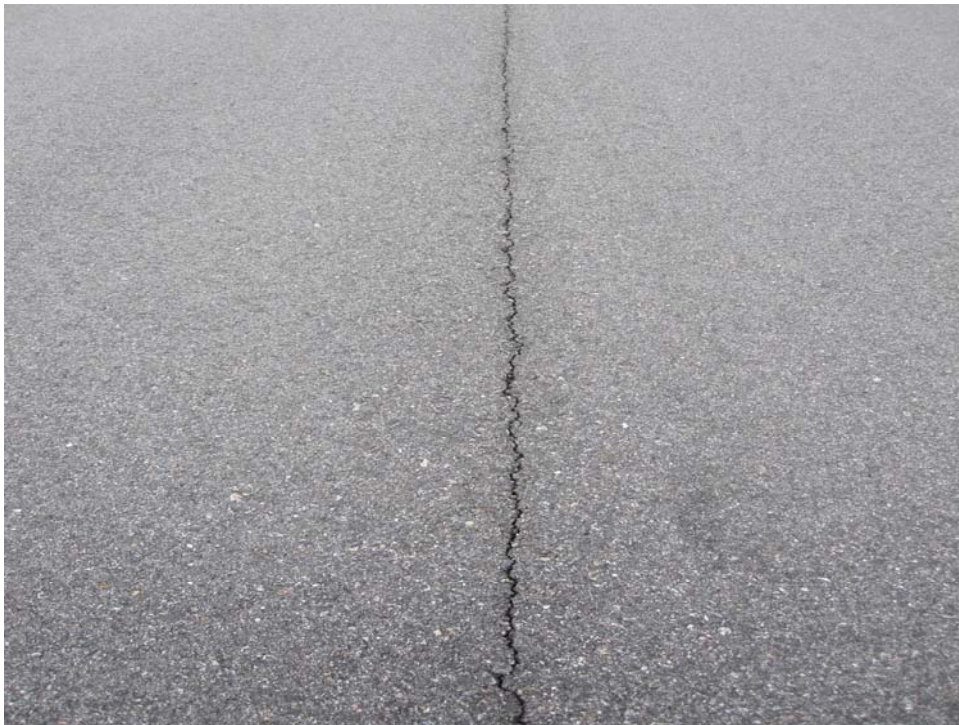
R1129CH-10. Longitudinal and Transverse Cracking (Sample Unit #11).

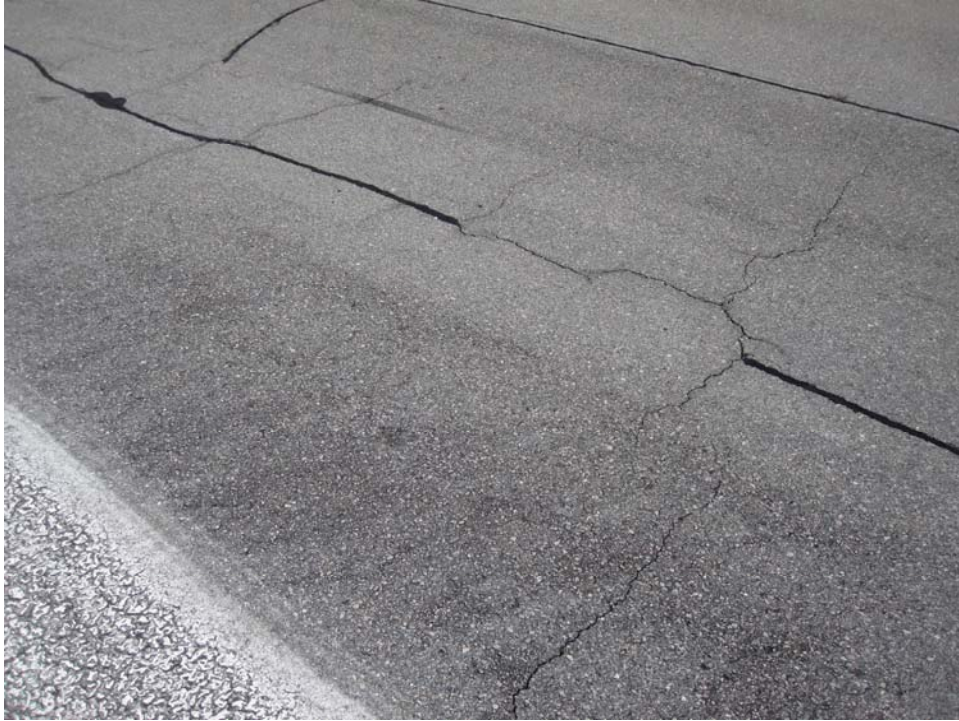
Runway 5-23 consisted of one section with a PCI value of 44. Extensive amounts of medium-severity block cracking were recorded throughout Section 10. Moderate amounts of low-severity swelling were also observed.

R523CH-10. Block Cracking (Sample Unit #07).

Sample Number: 07 Type: R Area: 5,000.00SqFt PCI = 44  
Sample Comments:  
43 BLOCK CRACKING M 5,000.00 SqFt Comments:  
56 SWELLING L 55.00 SqFt Comments:

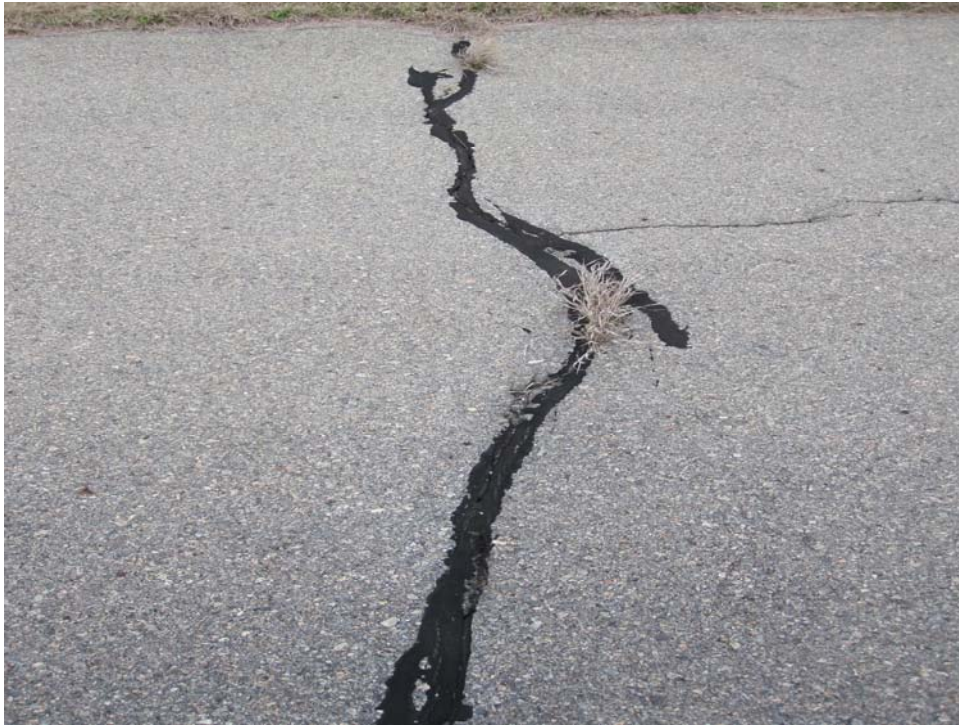
R523CH-10. Longitudinal and Transverse Cracking (Sample Unit #07).

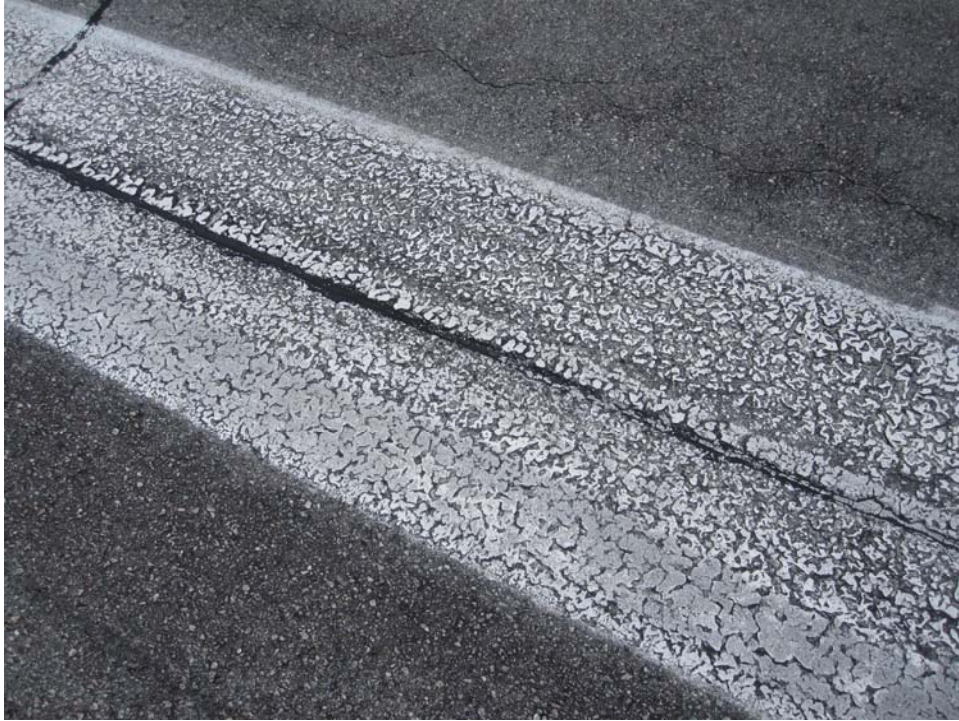
R523CH-10. Unsatisfactory Paint.

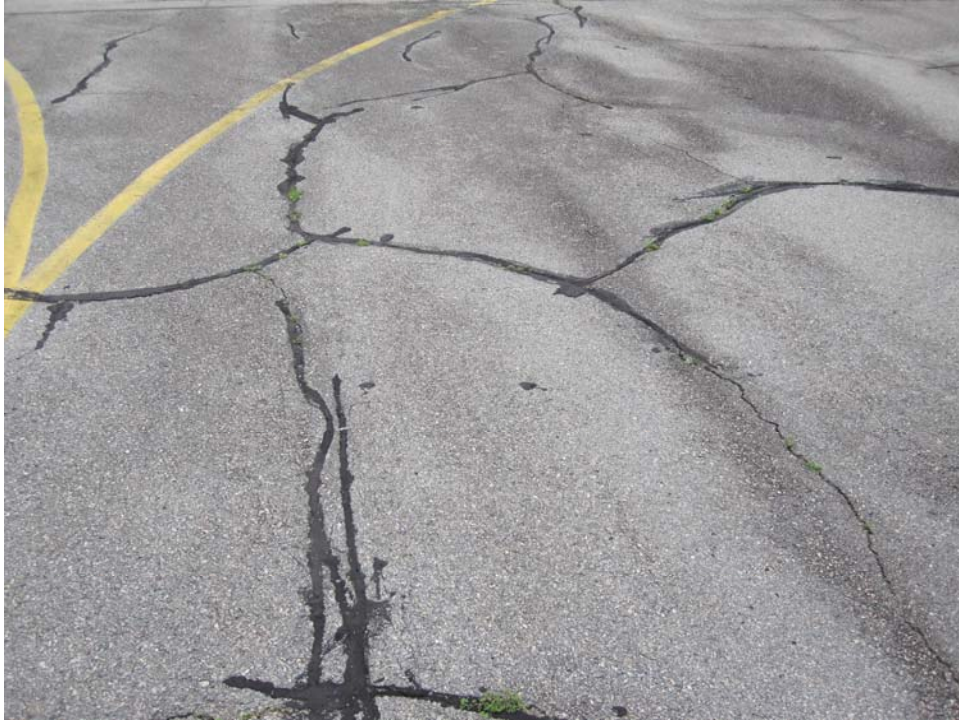
Taxiway A was defined by three sections. Section 10 had a PCI value of 41. Extensive amounts of medium-severity block cracking were identified throughout the section. Small quantities of medium-severity patching were also recorded. Sections 20 and 30 were constructed in 2009 and were both in excellent condition with PCI values of 100. No distresses were identified in these sections.

TACH-10. Block Cracking (Sample Unit #01).

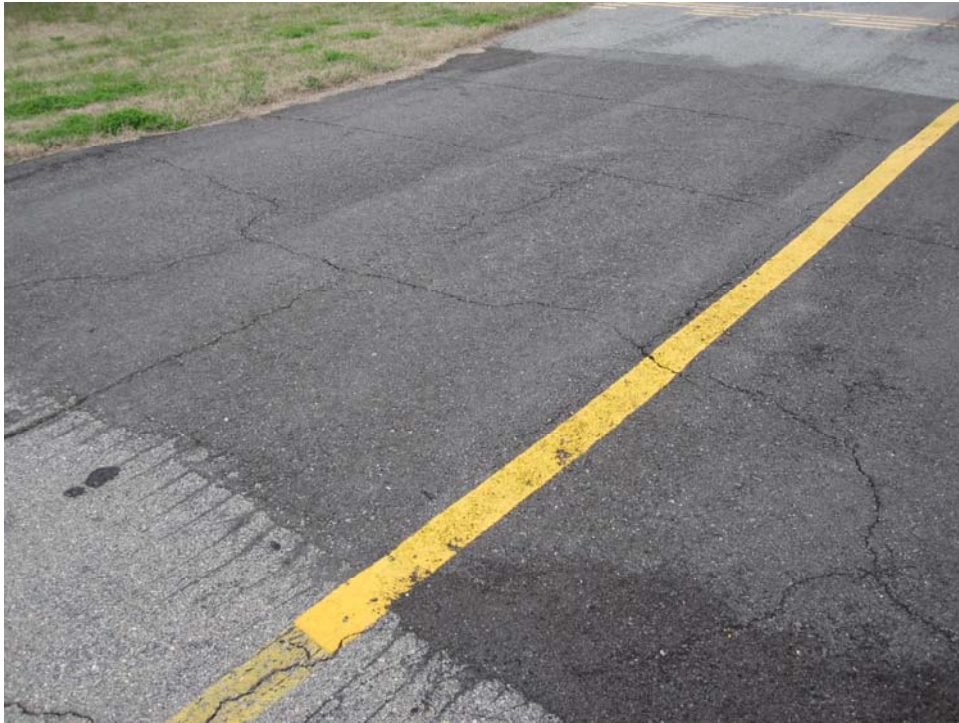
TACH-10. Patching (Sample Unit #01).

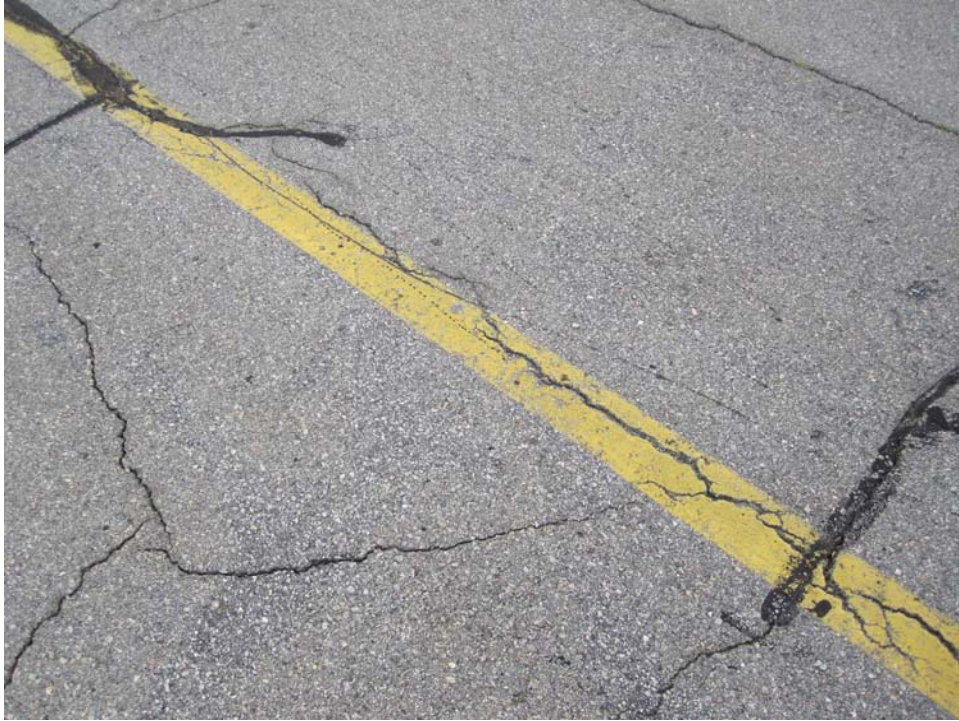
TACH-10. Unsatisfactory Paint.
