# 2012 Griffin-Spalding County Airport Pavement Management Plan

# GRIFFIN-SPALDING COUNTY AIRPORT

## PAVEMENT MANAGEMENT REPORT

**DECEMBER 2012**

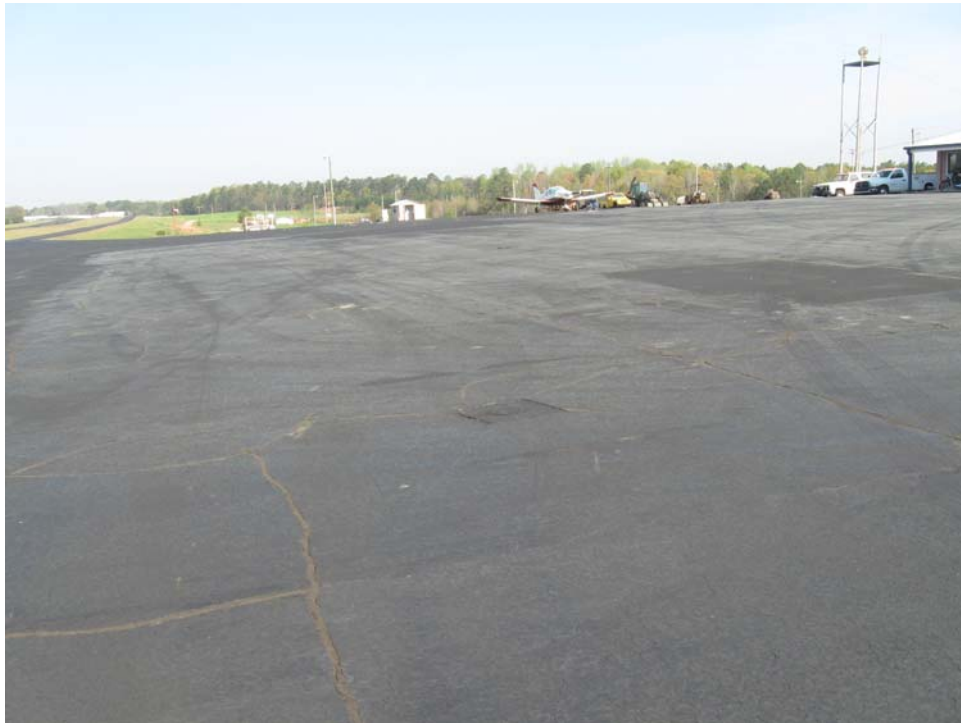
Apron 01 (A01GF) consisted of two sections. Sections 10 and 20 had PCI values of 68 and 67, respectively, with extensive quantities of low-severity L&T cracking identified. In addition, small areas of low-severity patching, swelling, depression, and block cracking on Section 10 and isolated quantities of medium-severity alligator cracking, high-severity raveling, and oil/fuel damage on Section 20 were observed.

A01GF-10. Overview.

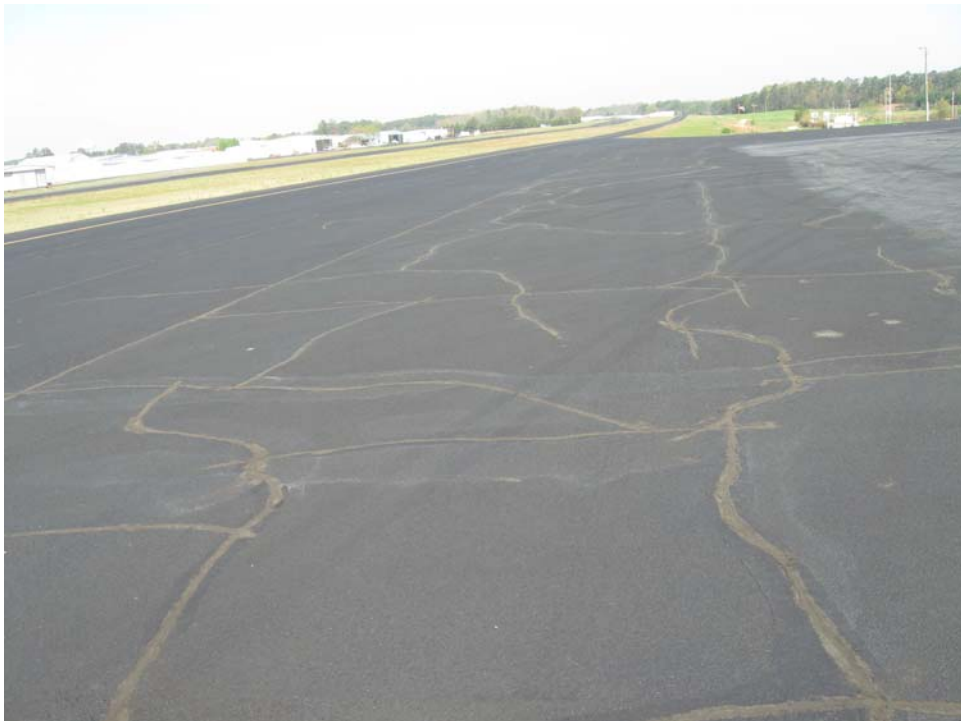
A01GF-10. Block Cracking (Sample Unit #03).

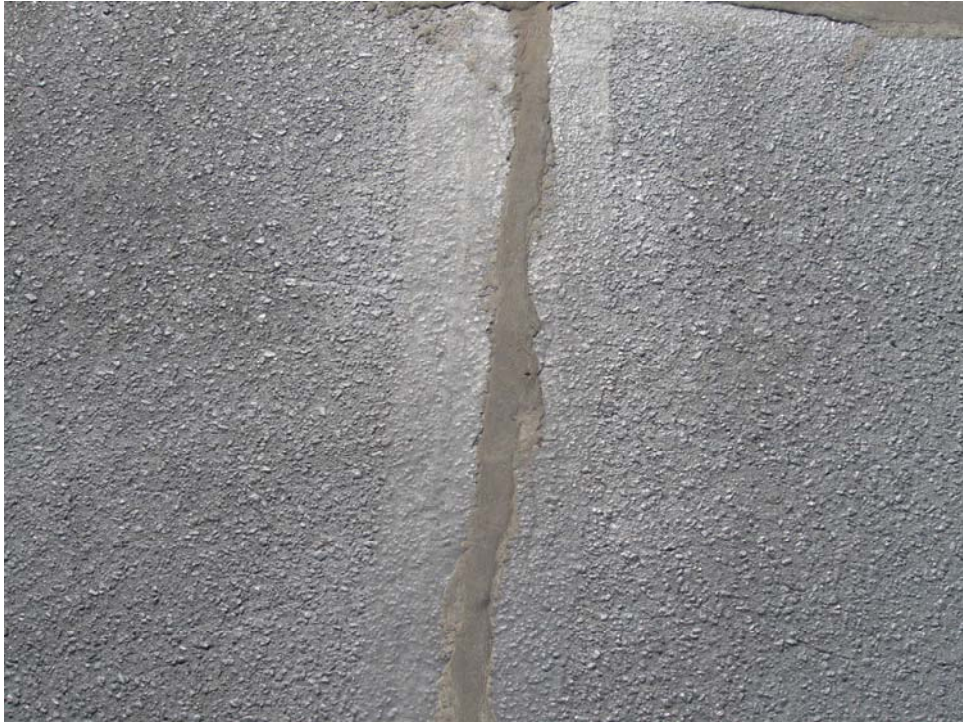
A01GF-10. Longitudinal and Transverse Cracking (Sample Unit #03).

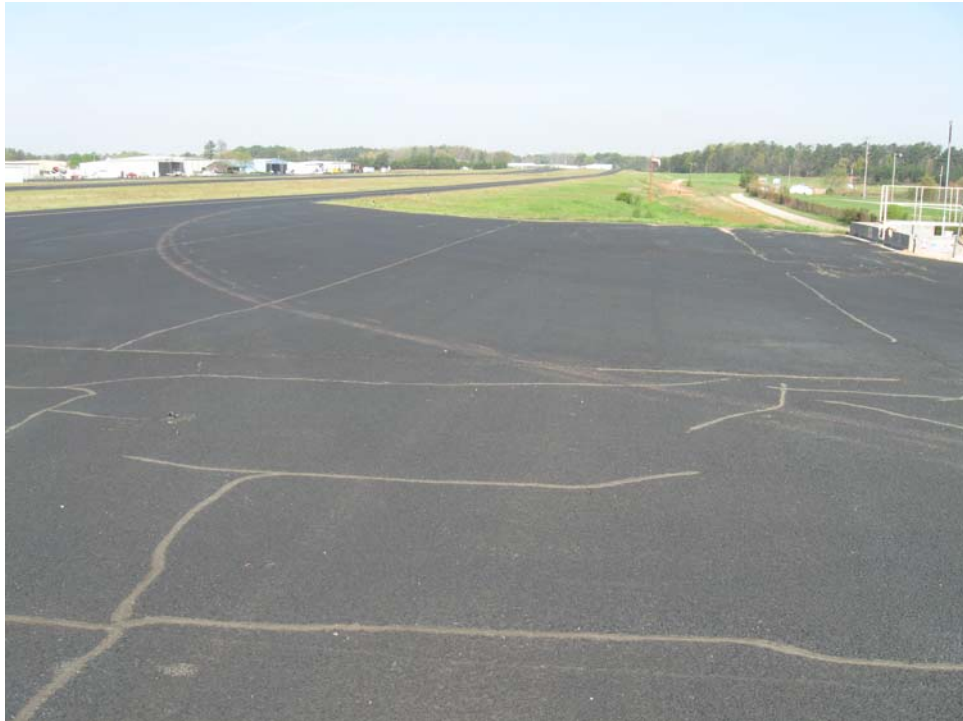
A01GF-20. Overview.

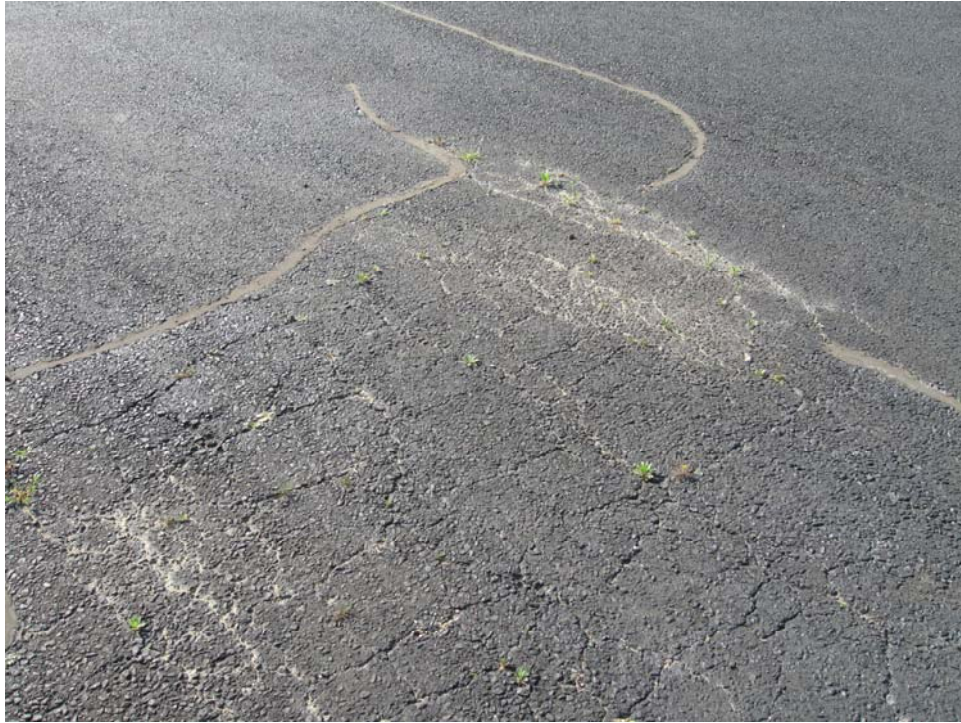
A01GF-20. Alligator Cracking (Sample Unit #02).

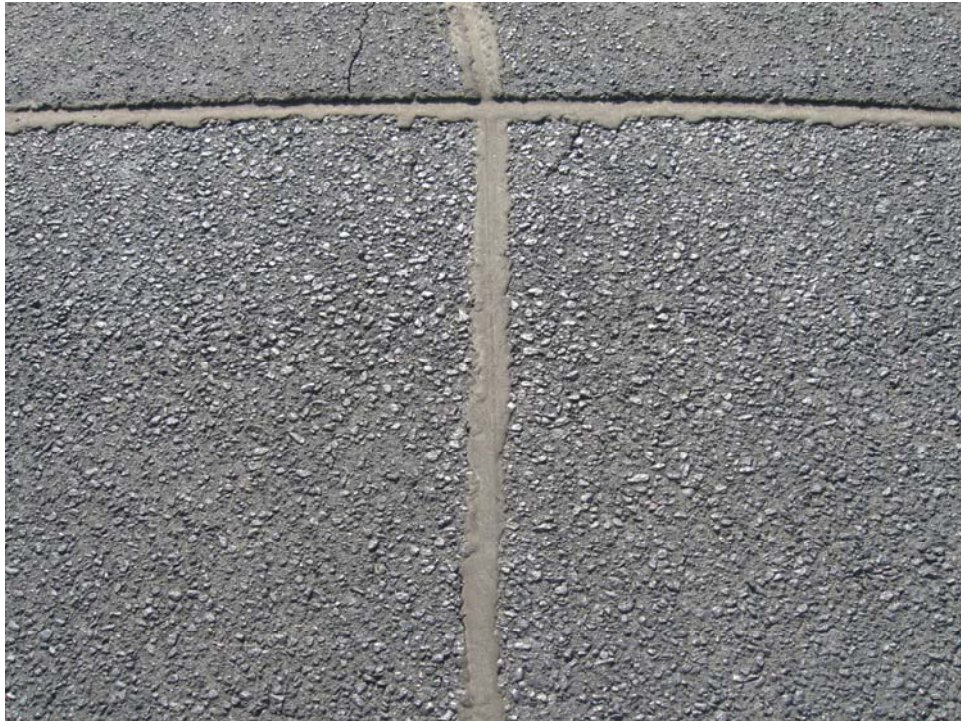
A01GF-20. Longitudinal and Transverse Cracking (Sample Unit #03).

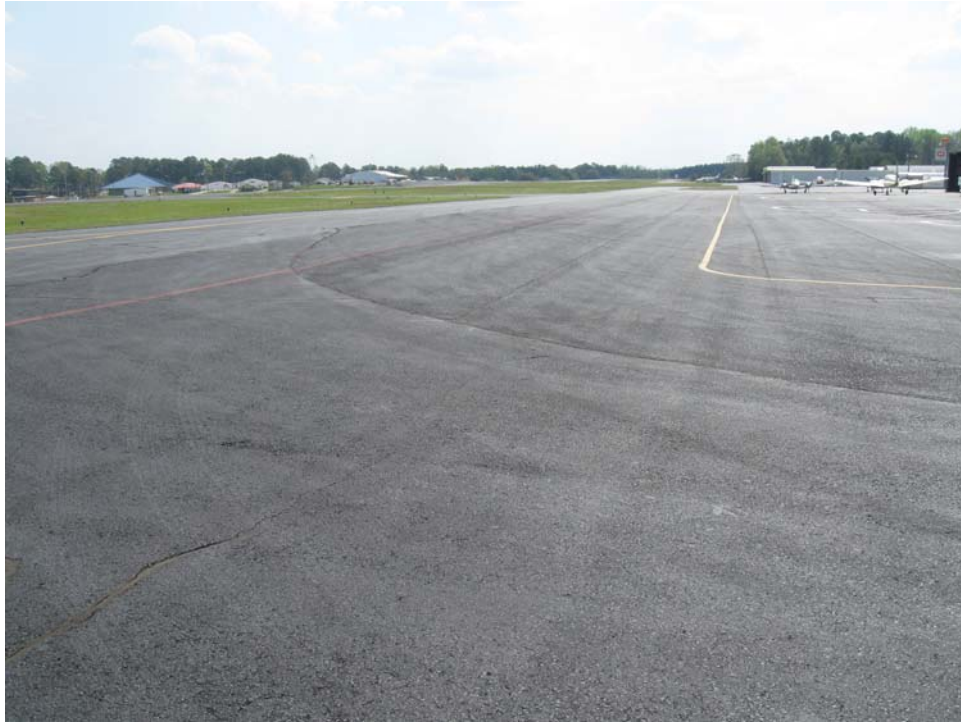
A02GF-10. Overview.

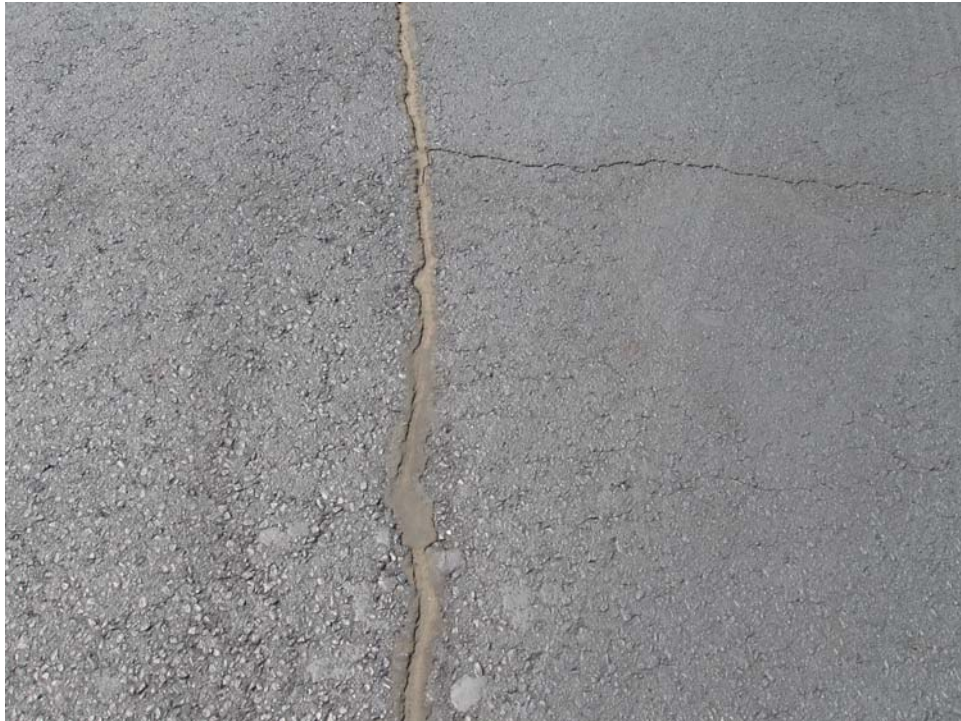
A02GF-10. Longitudinal and Transverse Cracking (Sample Unit #12).

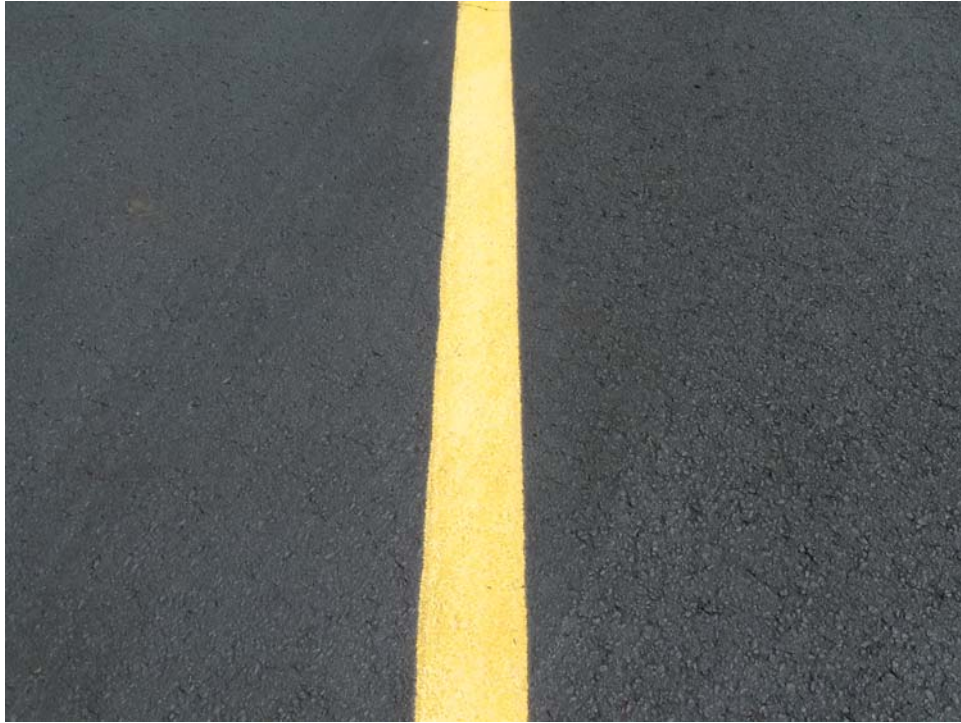
A02GF-10. Satisfactory Paint.

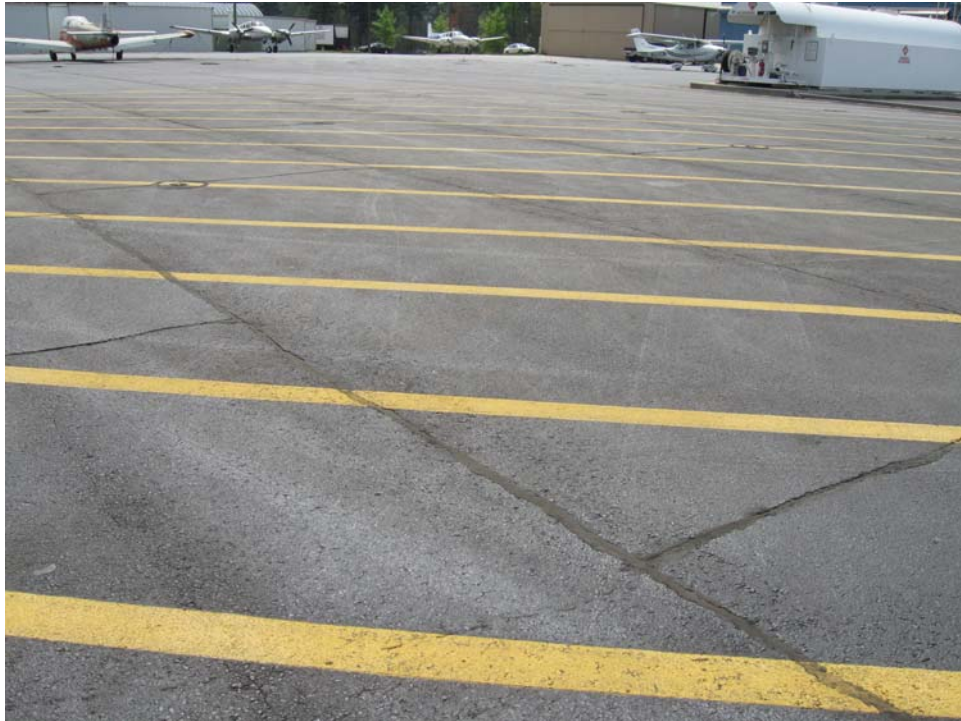
A02GF-20. Overview.

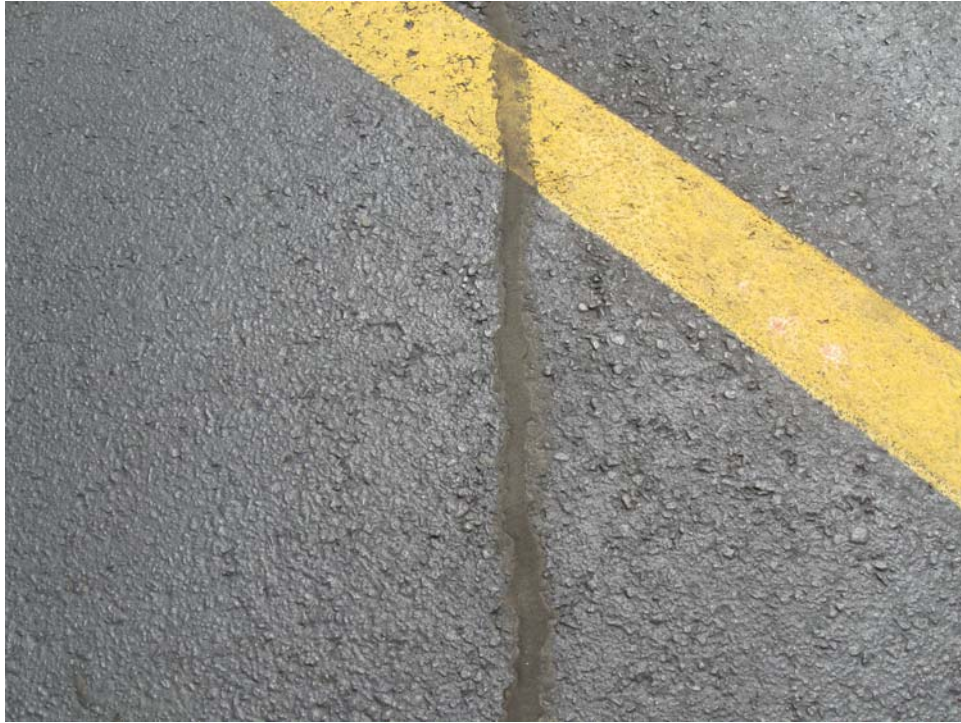
A02GF-20. Longitudinal and Transverse Cracking (Sample Unit #12).

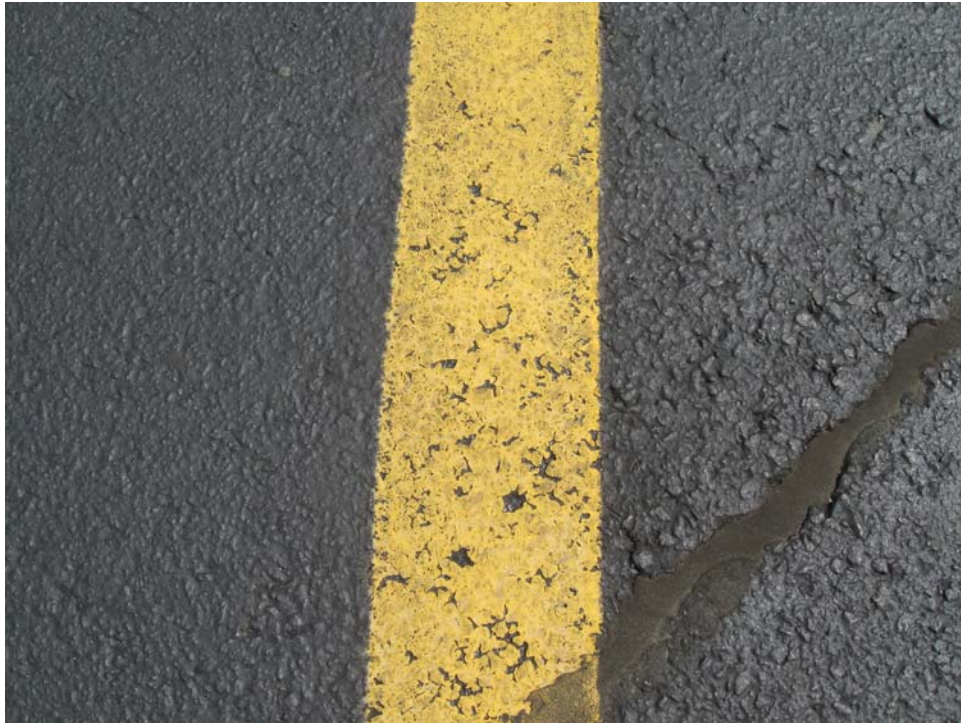
A02GF-20. Unsatisfactory Paint.

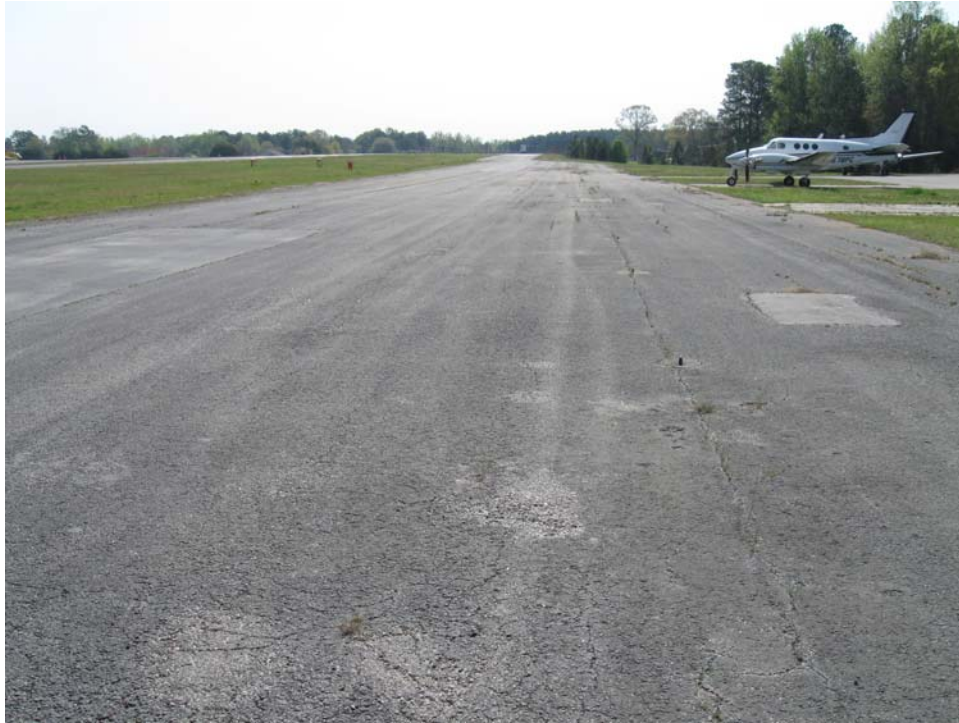
A02GF-30. Overview.

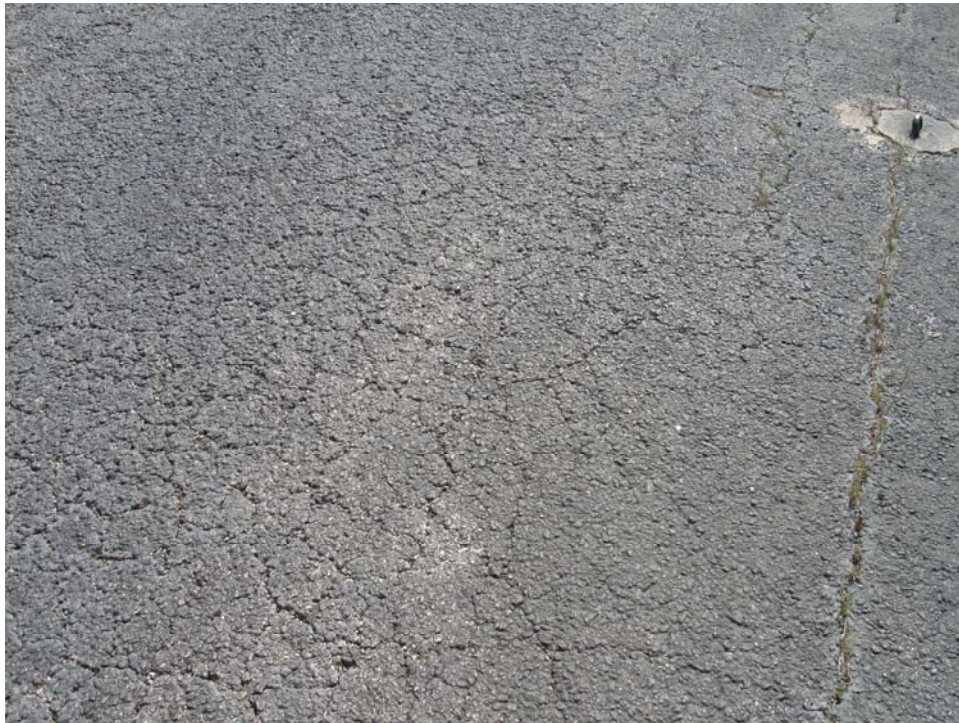
A02GF-30. Alligator Cracking (Sample Unit #01).

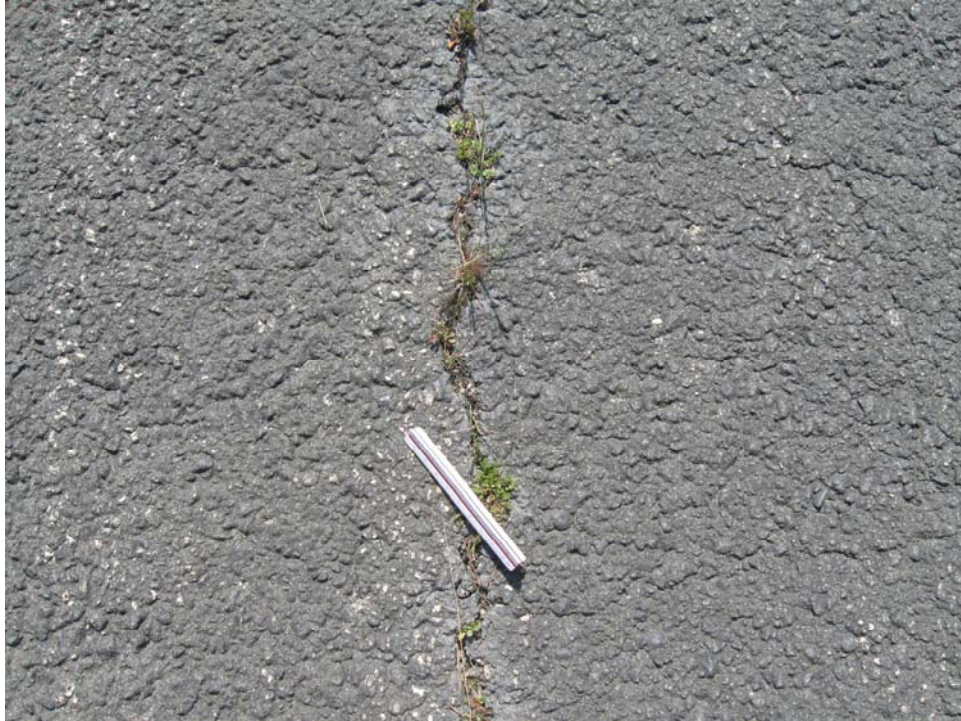
A02GF-30. Longitudinal and Transverse Cracking (Sample Unit #01).

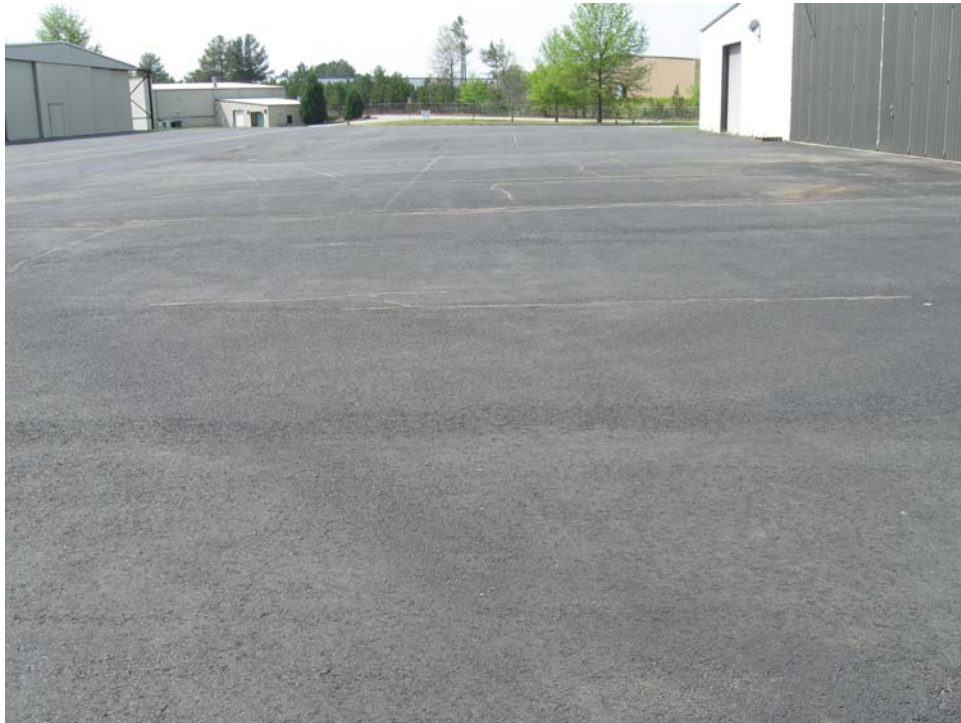
A02GF-40. Overview.

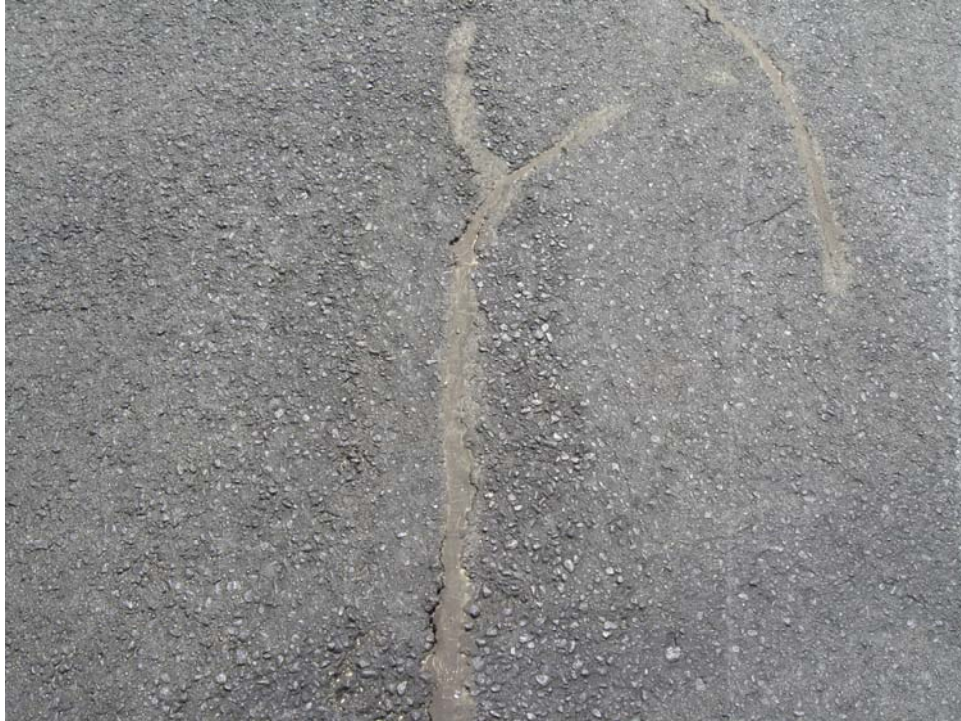
A02GF-40. Longitudinal and Transverse Cracking (Sample Unit #01).

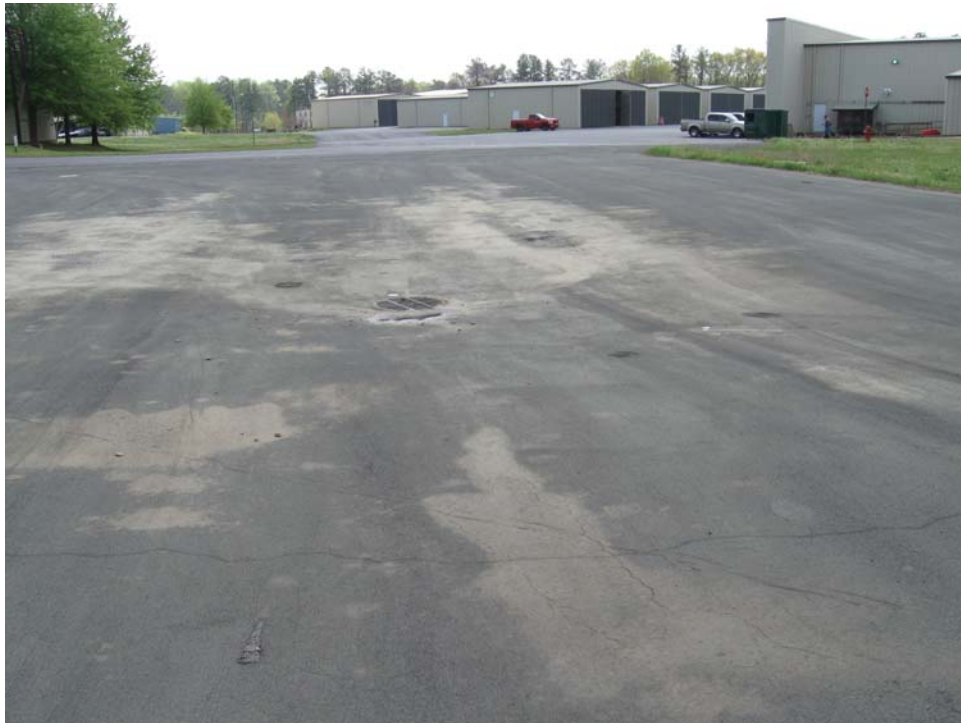
A02GF-50. Overview.

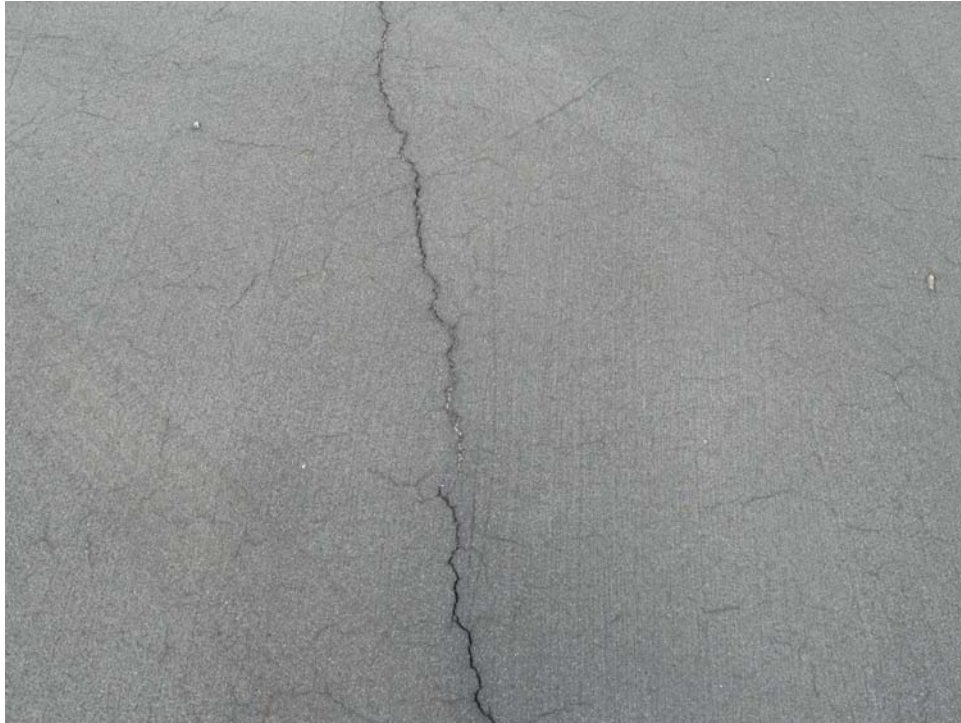
A02GF-50. Longitudinal and Transverse Cracking (Sample Unit #01).

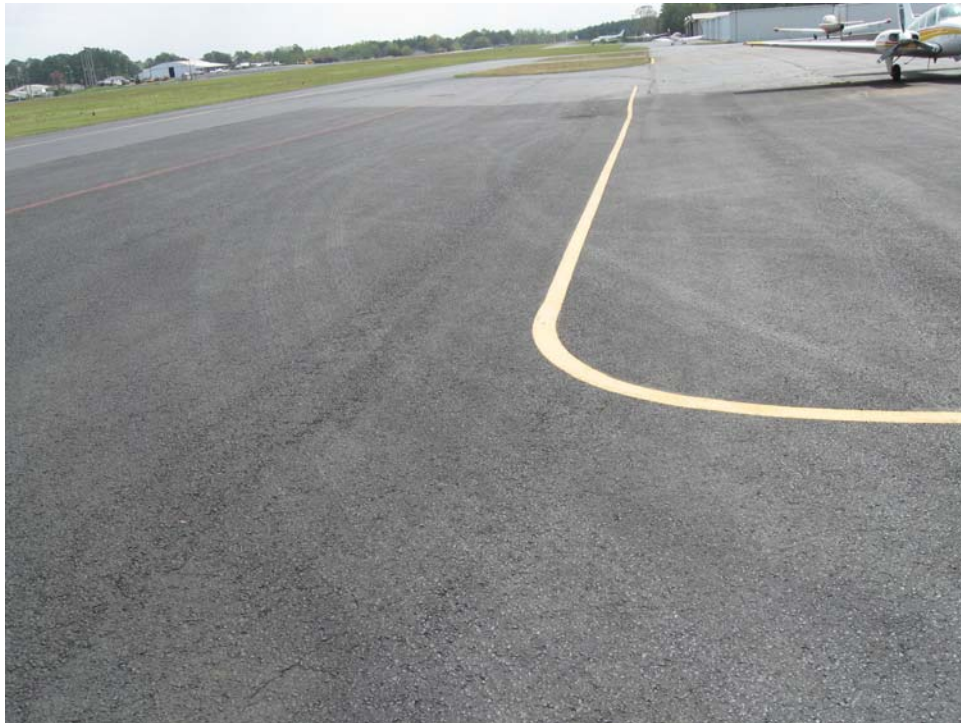
A02GF-60. Overview.

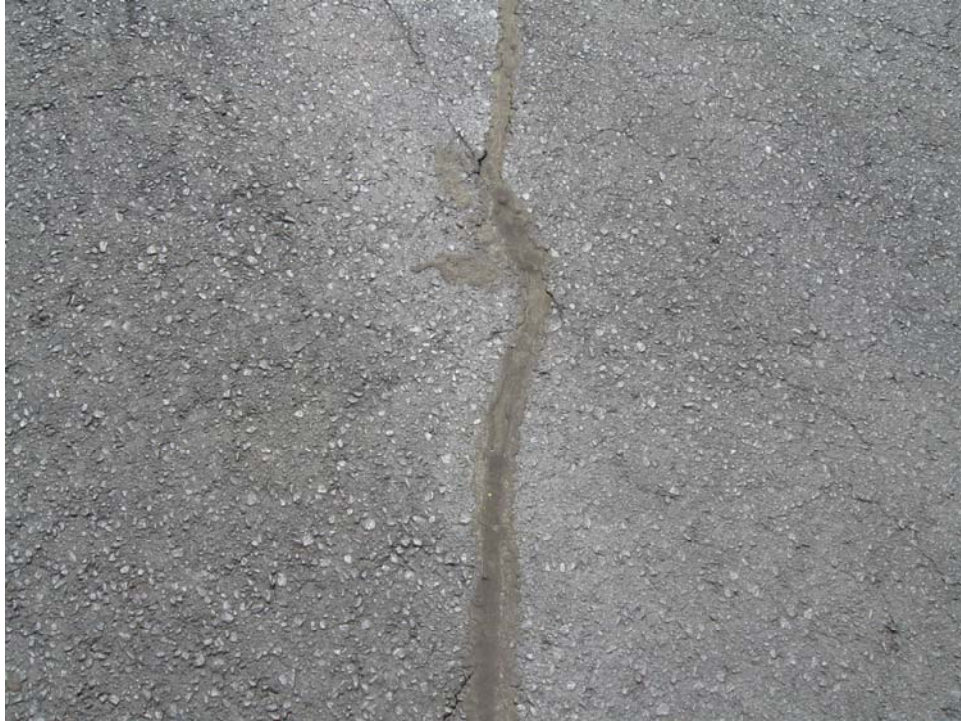
A02GF-60. Longitudinal and Transverse Cracking (Sample Unit #01).

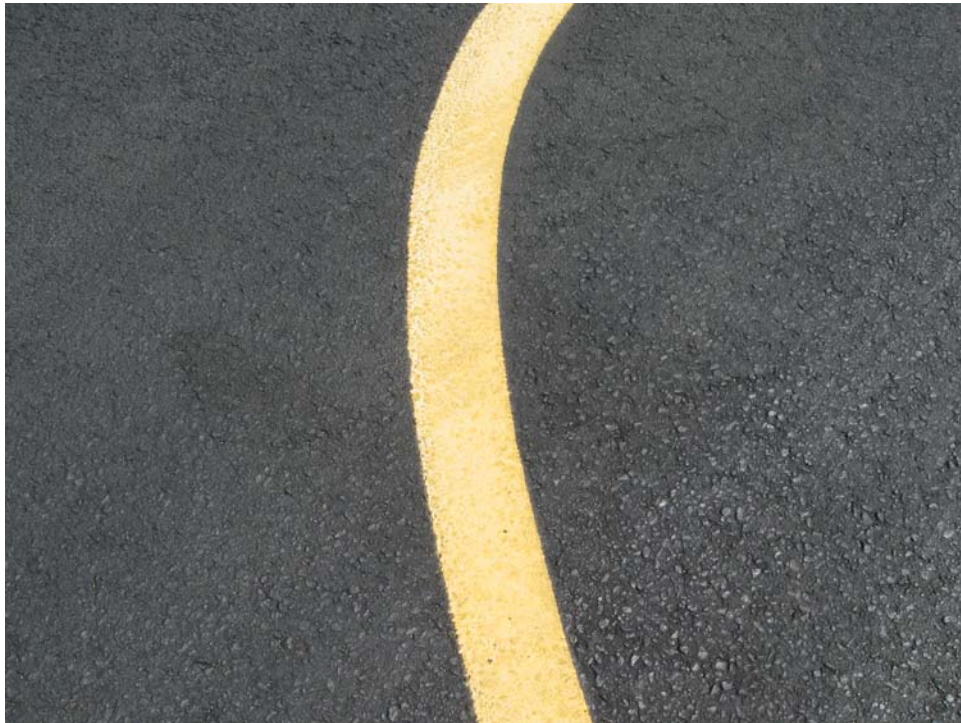
A02GF-60. Satisfactory Paint.

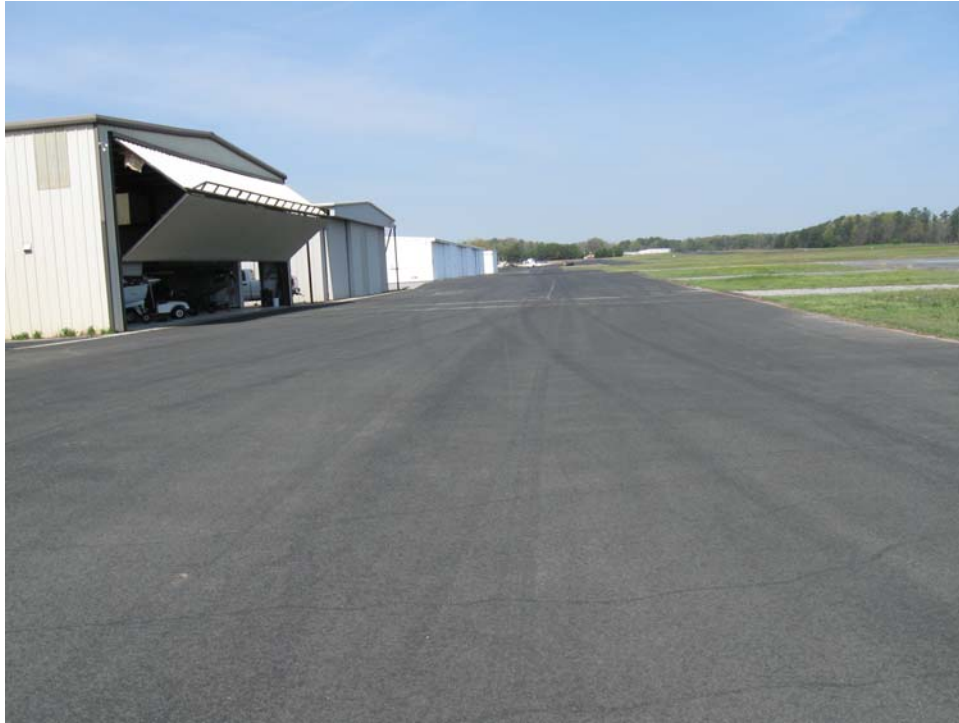
A02GF-70. Overview.

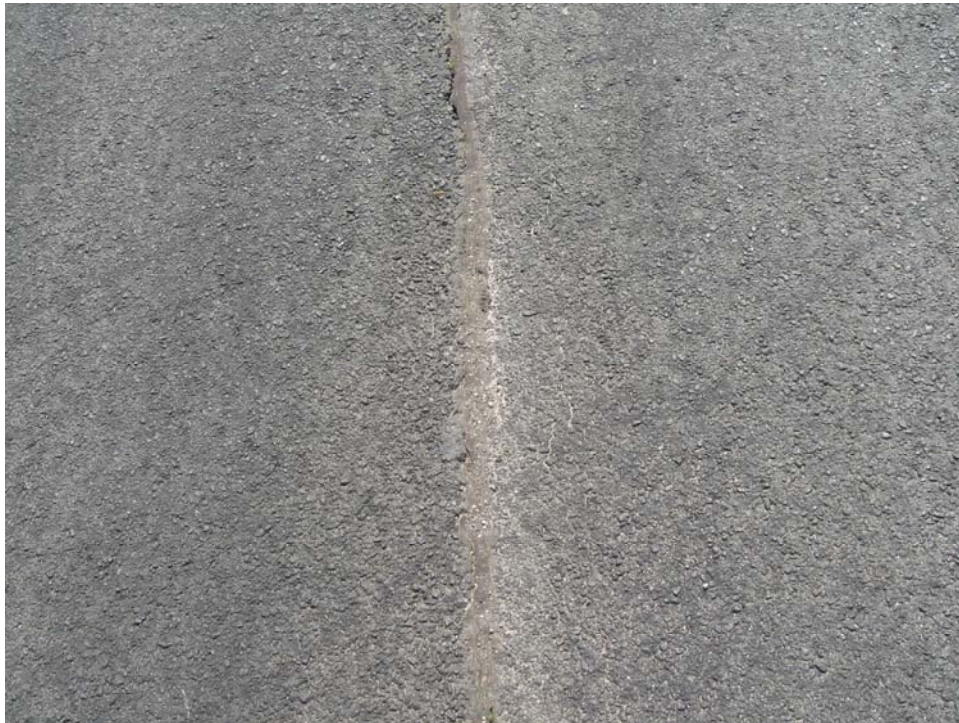
A02GF-70. Longitudinal and Transverse Cracking (Sample Unit #10).

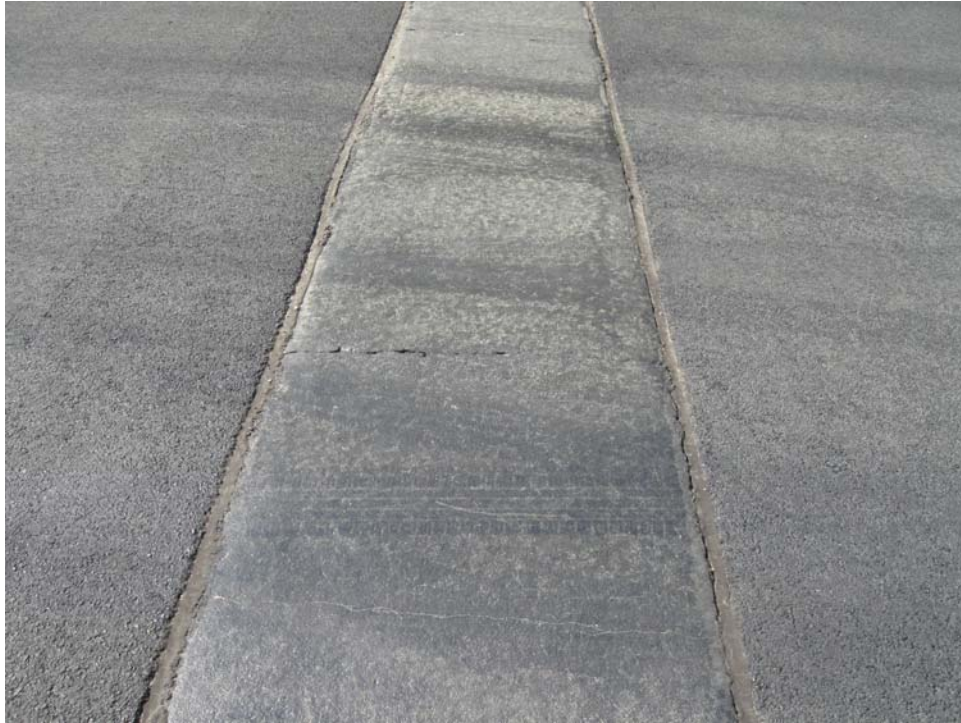
A02GF-70. Patching (Sample Unit #10).

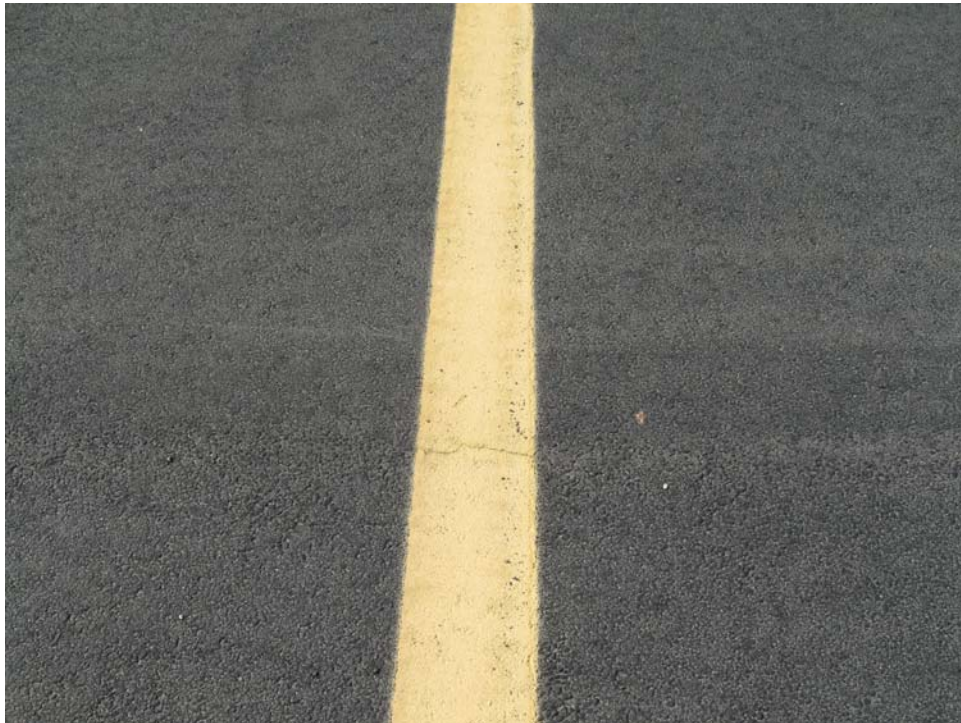
A02GF-70. Satisfactory Paint.

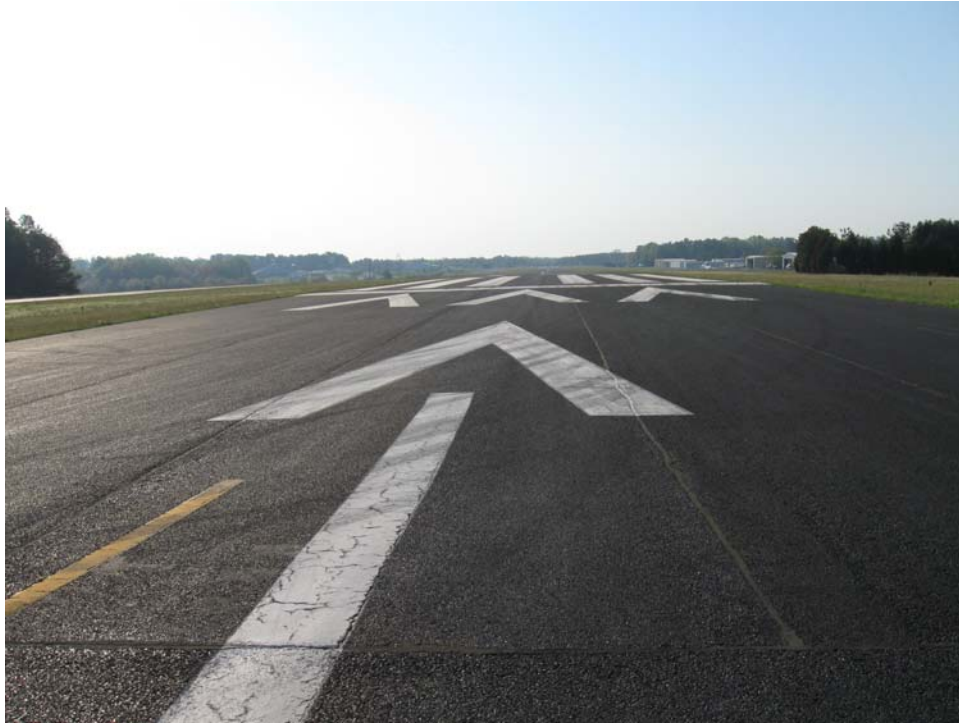
Runway 14-32 consisted of one section with a PCI value of 76. Moderate amounts of low-severity longitudinal and transverse (L&T) cracking were observed.

R1432GF-10. Overview.

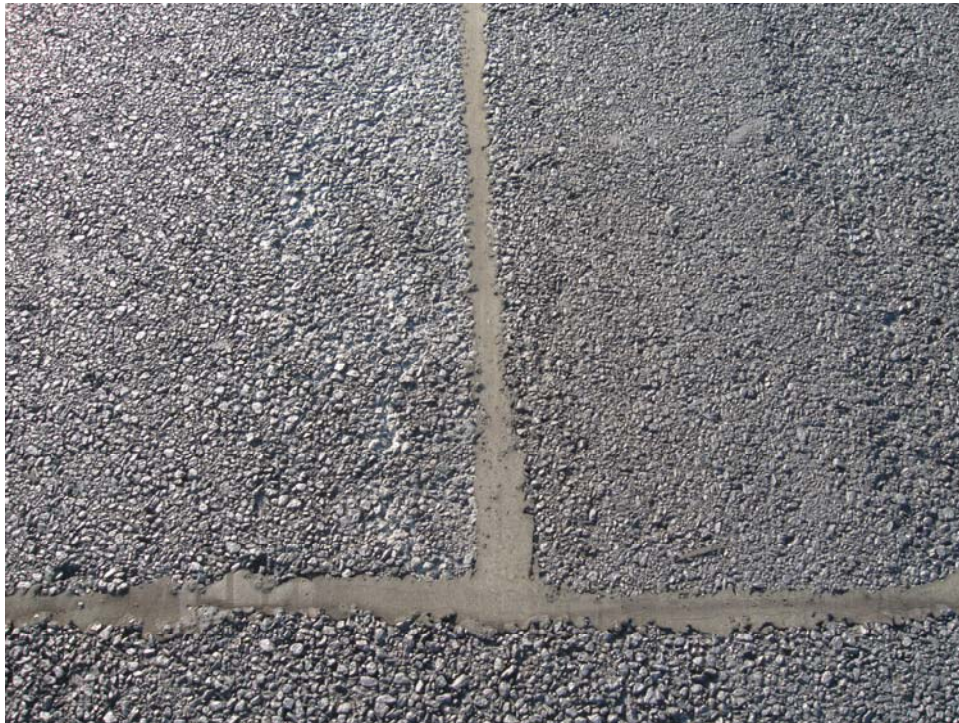
R1432GF-10. Longitudinal and Transverse Cracking (Sample Unit #02).

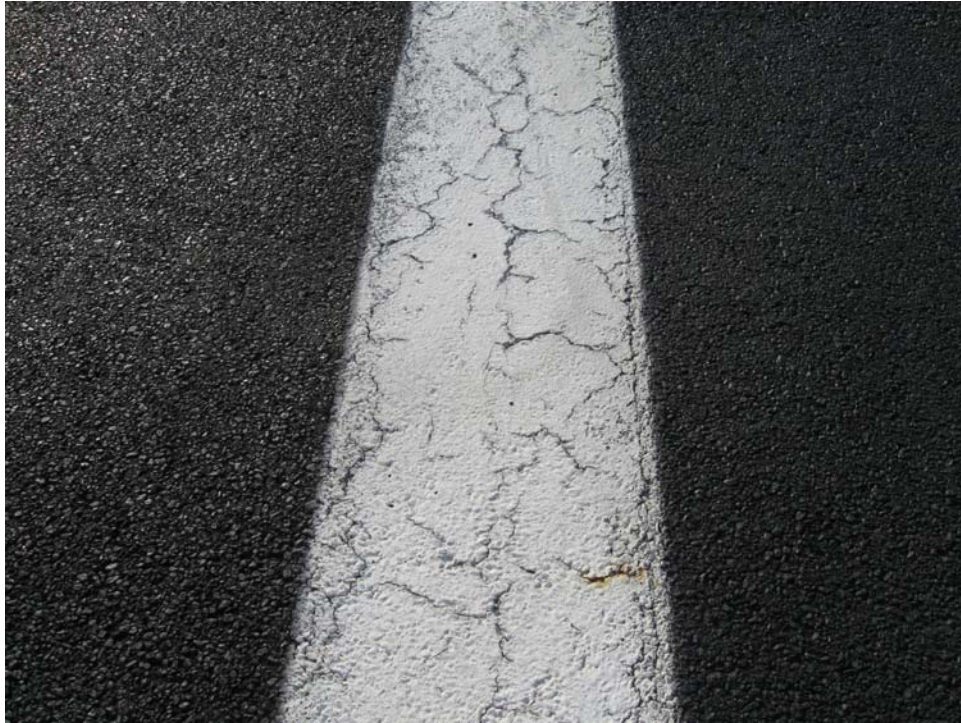
R1432GF-10. Unsatisfactory Paint.

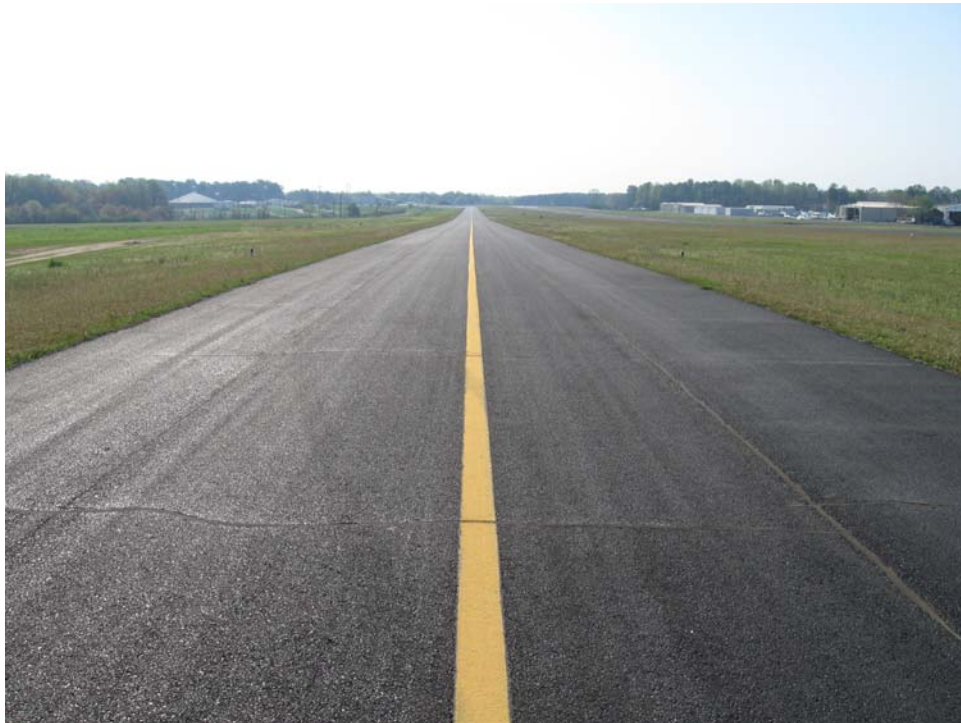
Taxiway A was comprised of one section with a PCI value of 79. Moderate quantities of low-severity L&T cracking were identified.

TAGF-10. Overview.

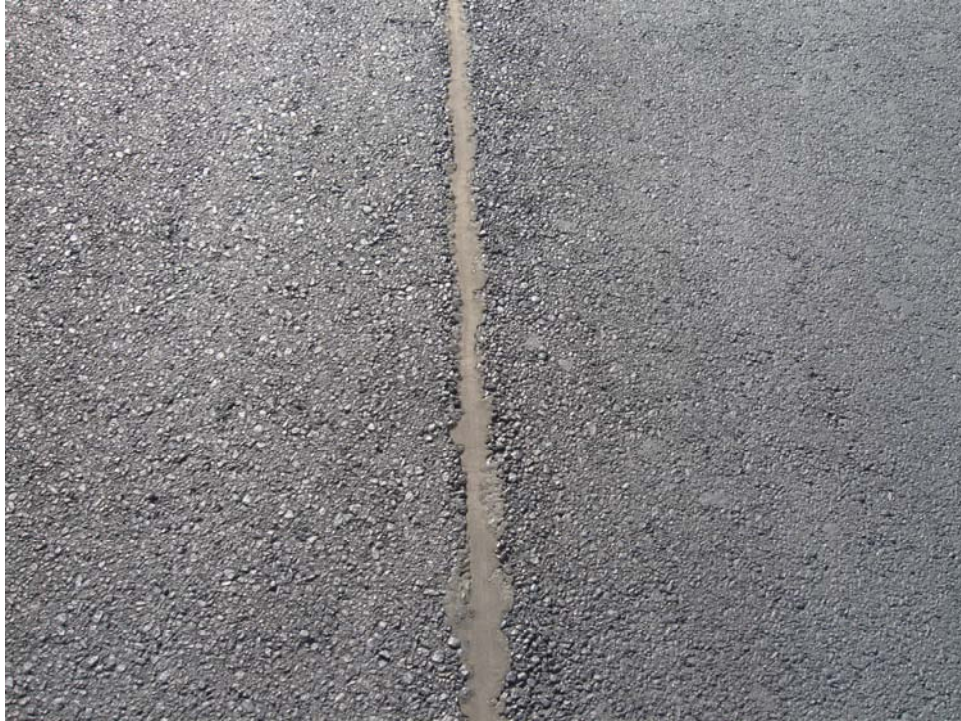
TAGF-10. Longitudinal and Transverse Cracking (Sample Unit #04).

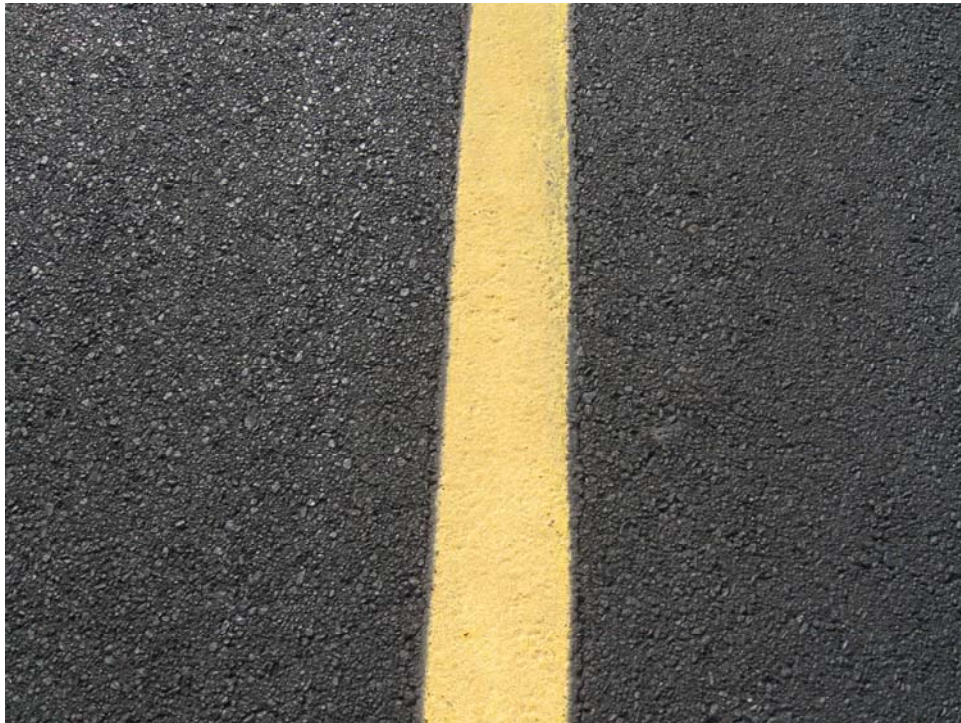
TAGF-10. Satisfactory Paint.
