# 2012 Griffin-Spalding County Airport Pavement Management Plan

# GRIFFIN-SPALDING COUNTY AIRPORT

## PAVEMENT MANAGEMENT REPORT

**DECEMBER 2012**

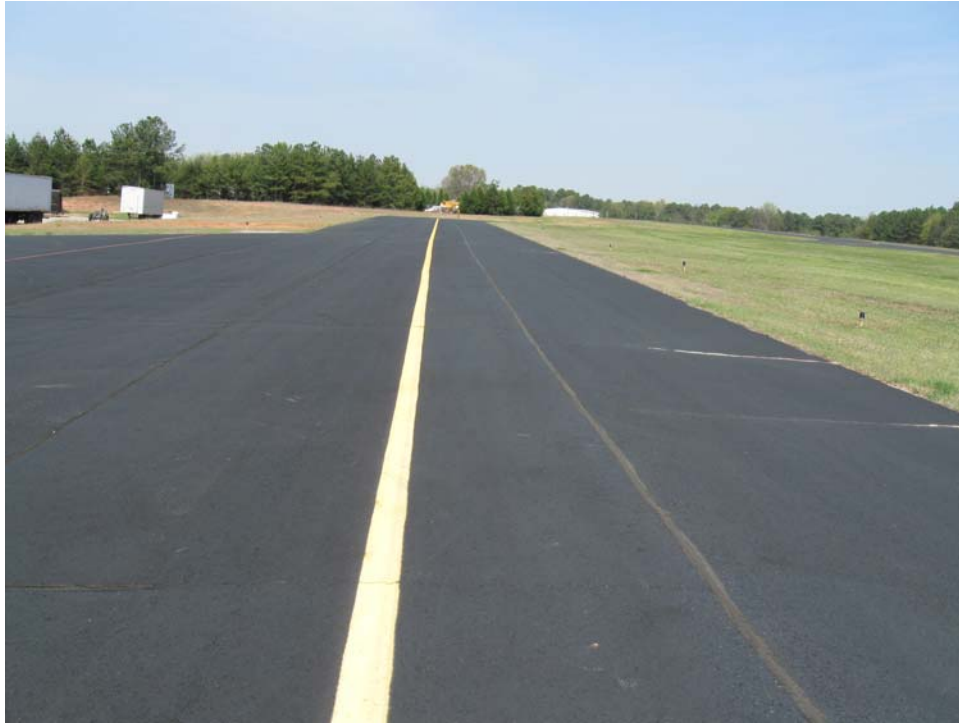
TBGF-10. Overview.

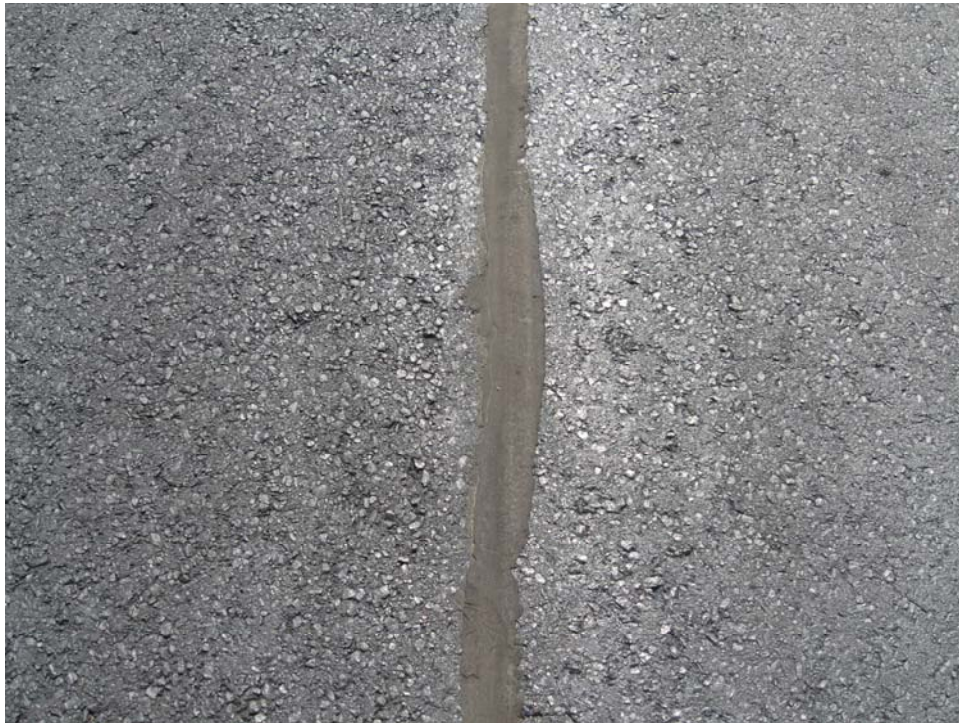
TBGF-10. Longitudinal and Transverse Cracking (Sample Unit #04).

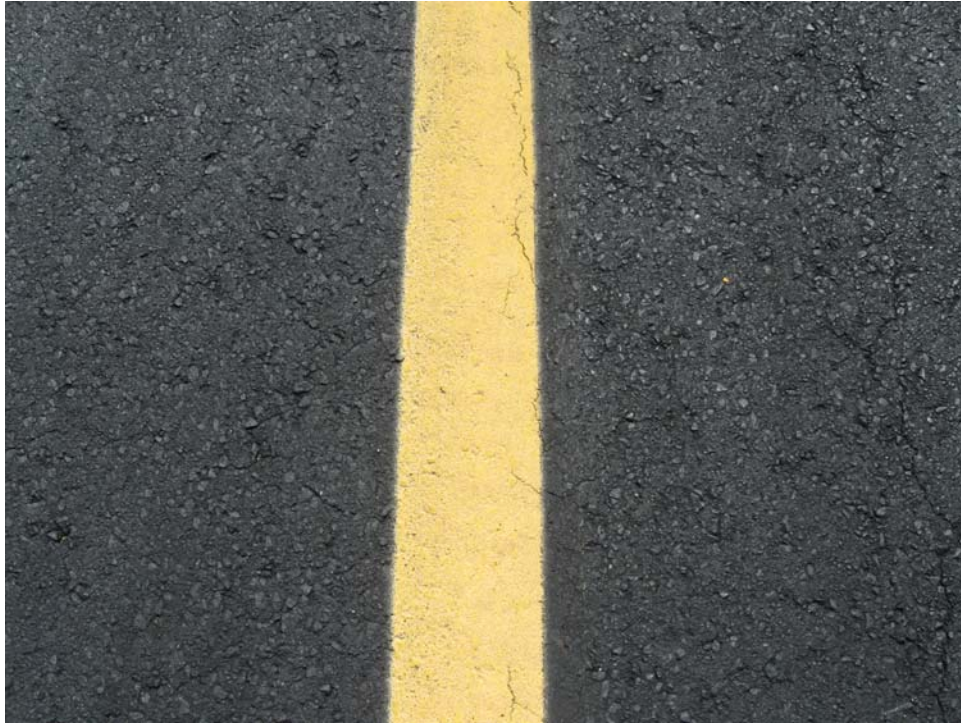
TBGF-10. Satisfactory Paint.

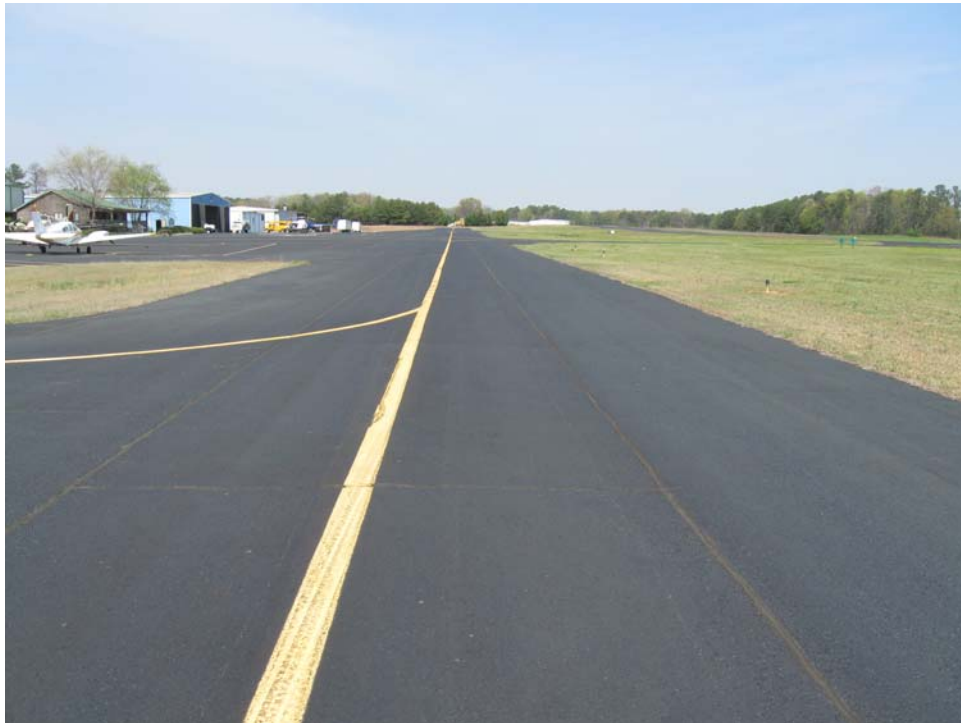
TBGF-20. Overview.

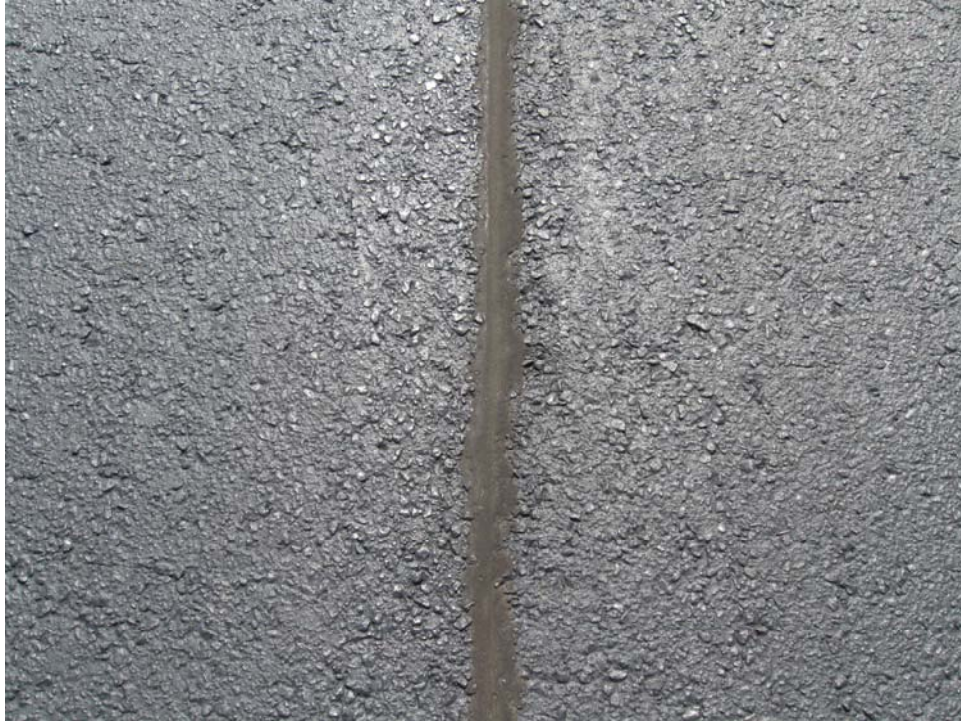
TBGF-20. Longitudinal and Transverse Cracking (Sample Unit #05).

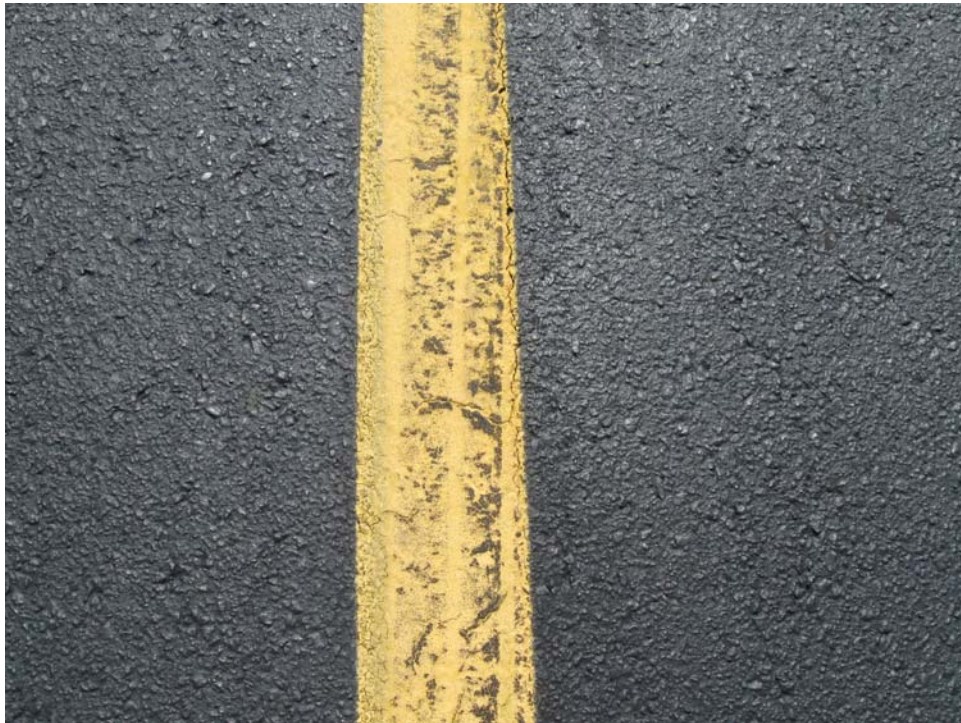
TBGF-20. Unsatisfactory Paint.

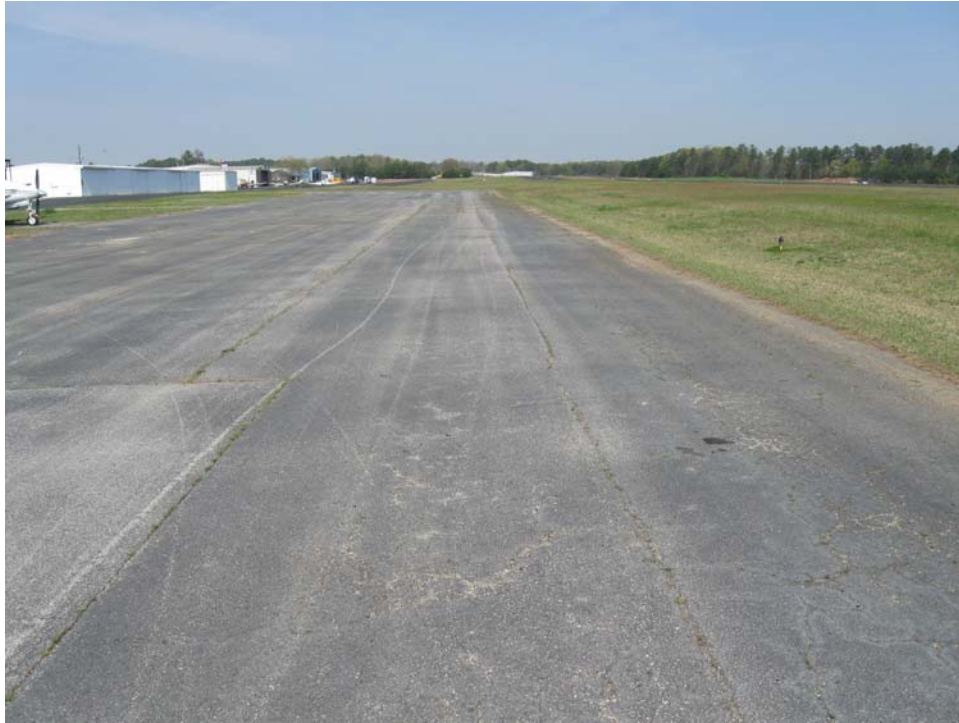
TBGF-30. Overview.

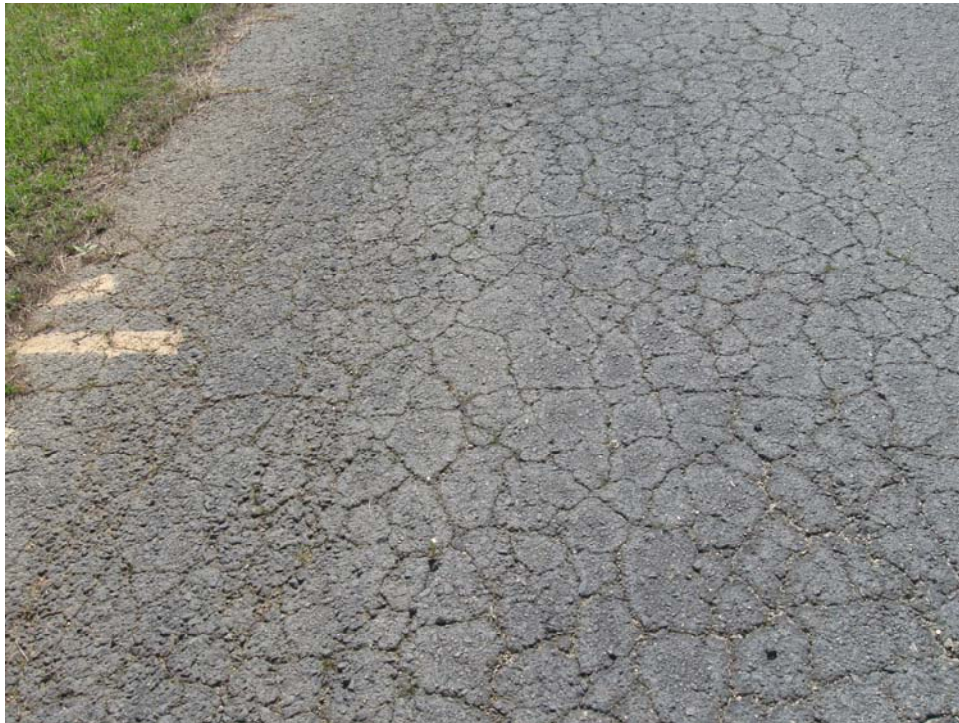
TBGF-30. Alligator Cracking (Sample Unit #03).

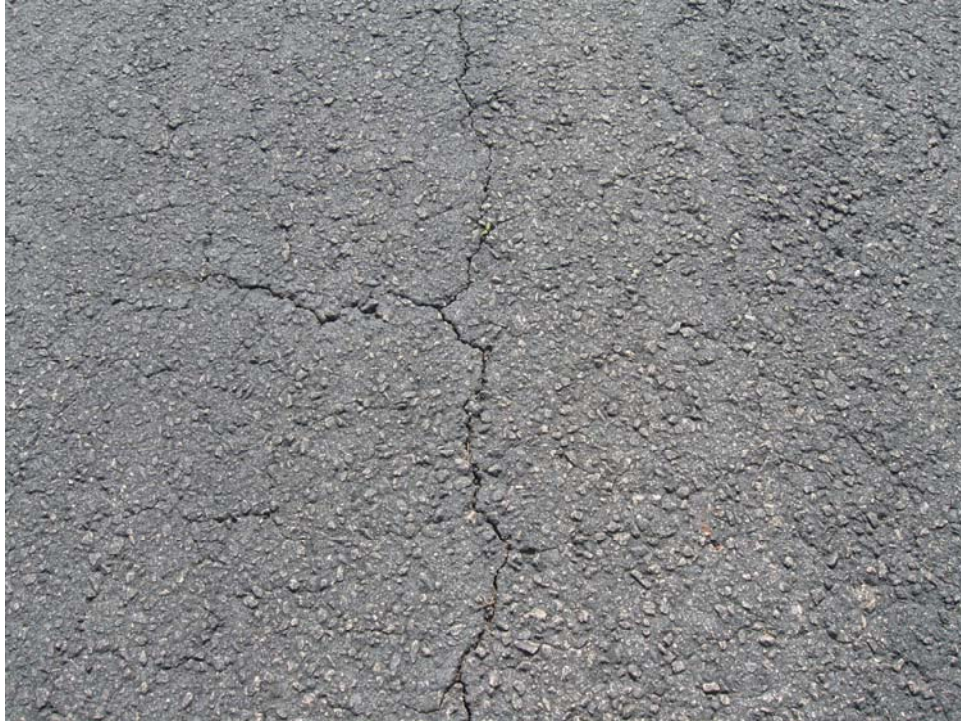
TBGF-30. Longitudinal and Transverse Cracking (Sample Unit #03).

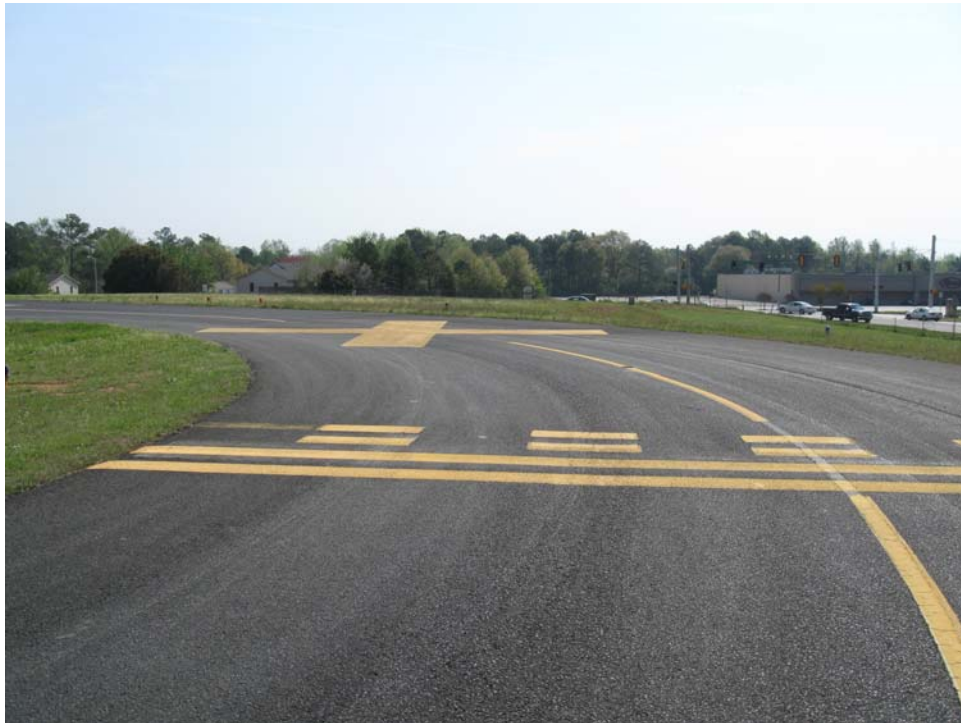
TBGF-40. Overview.

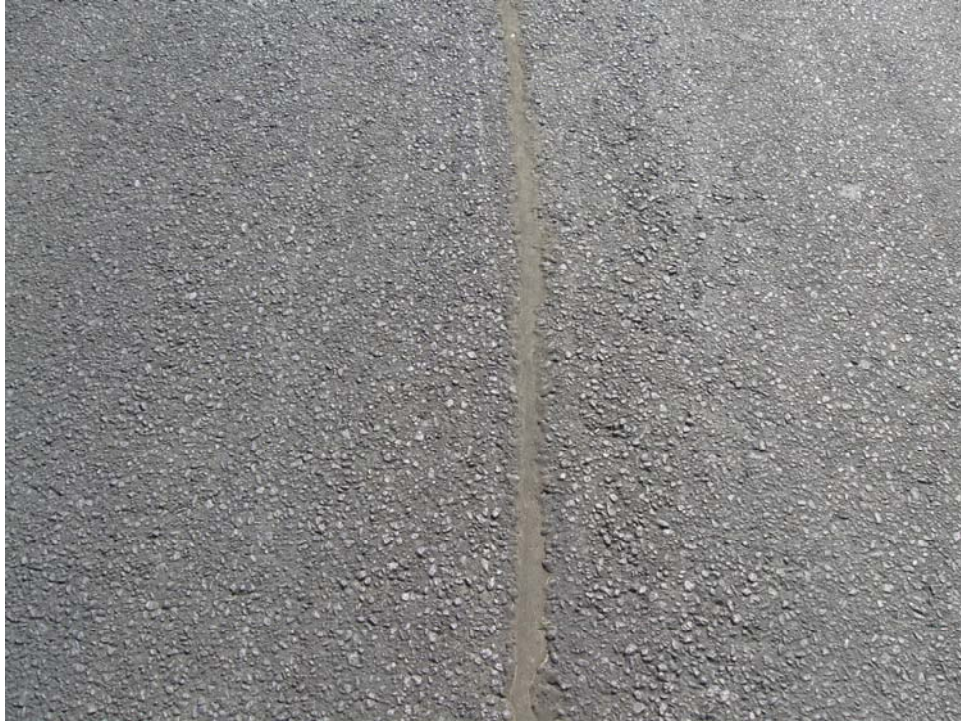
TBGF-40. Longitudinal and Transverse Cracking (Sample Unit #02).

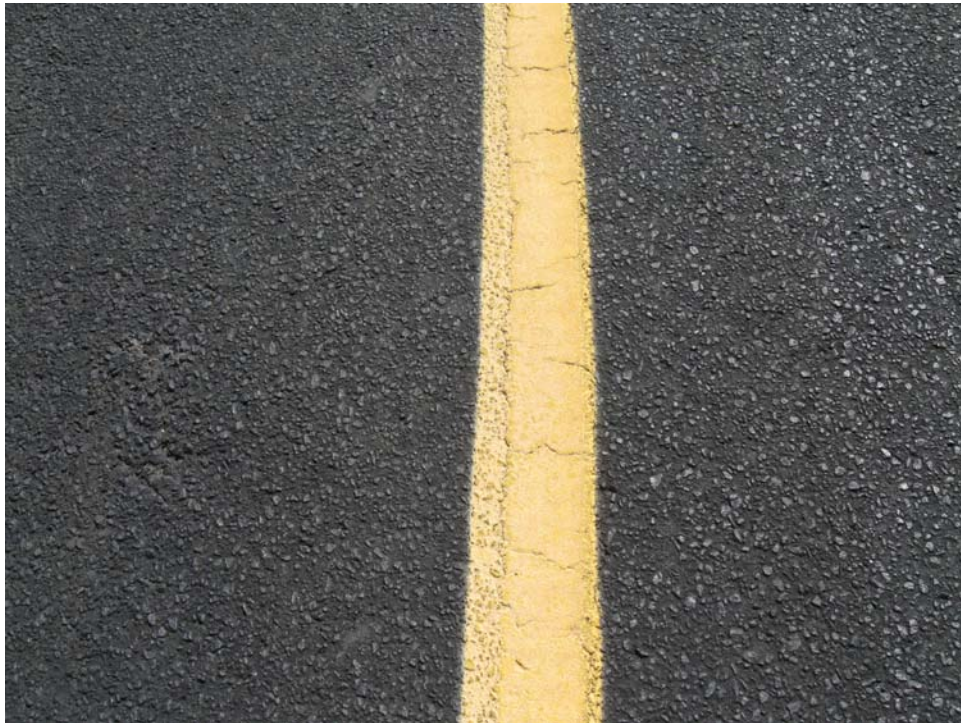
TBGF-40. Satisfactory Paint.

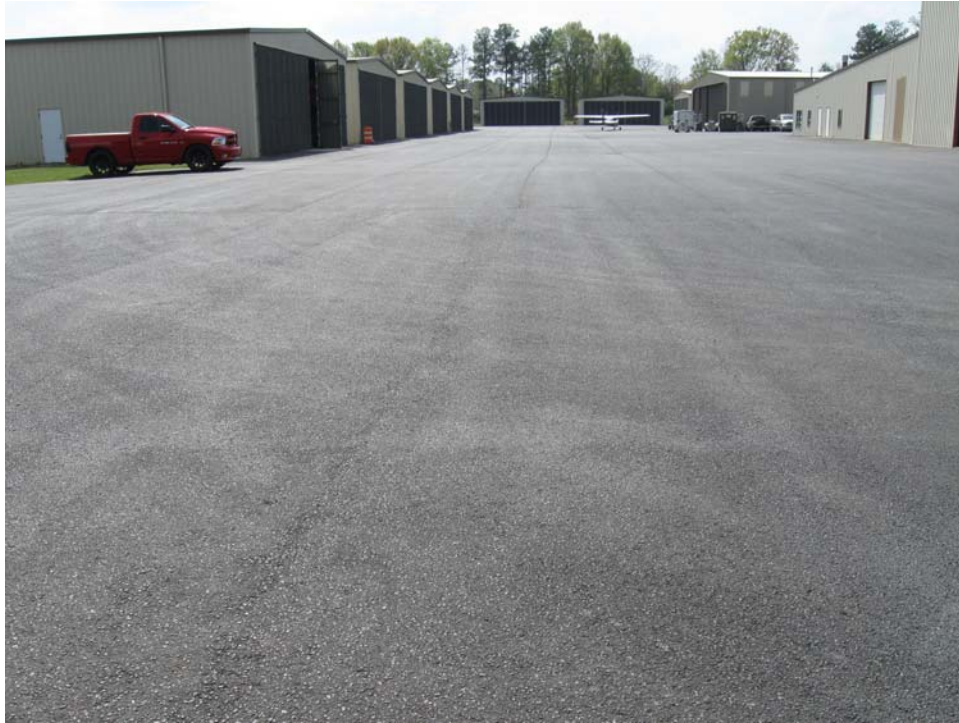
The T-Hangar area was defined by one section with a PCI value of 89. Small quantities of low-severity L&T cracking were observed.

TH01GF-10. Overview.

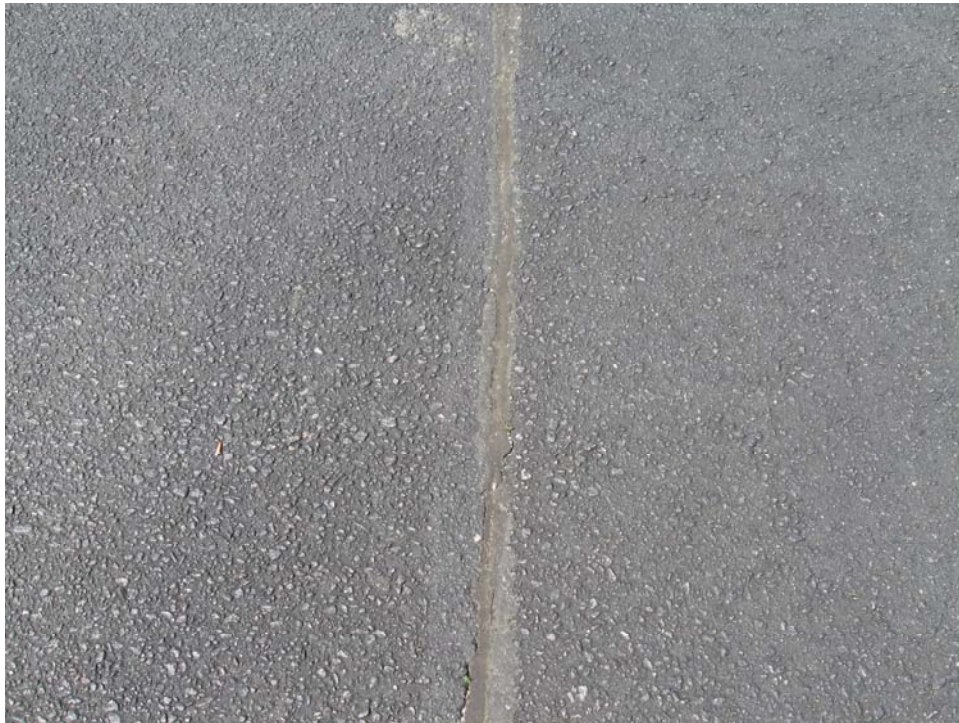
TH01GF-10. Longitudinal and Transverse Cracking (Sample Unit #09).
