2012 Jesup-Wayne County Airport Pavement Management Plan

JESUP-WAYNE COUNTY AIRPORT

PAVEMENT MANAGEMENT REPORT

DECEMBER 2012

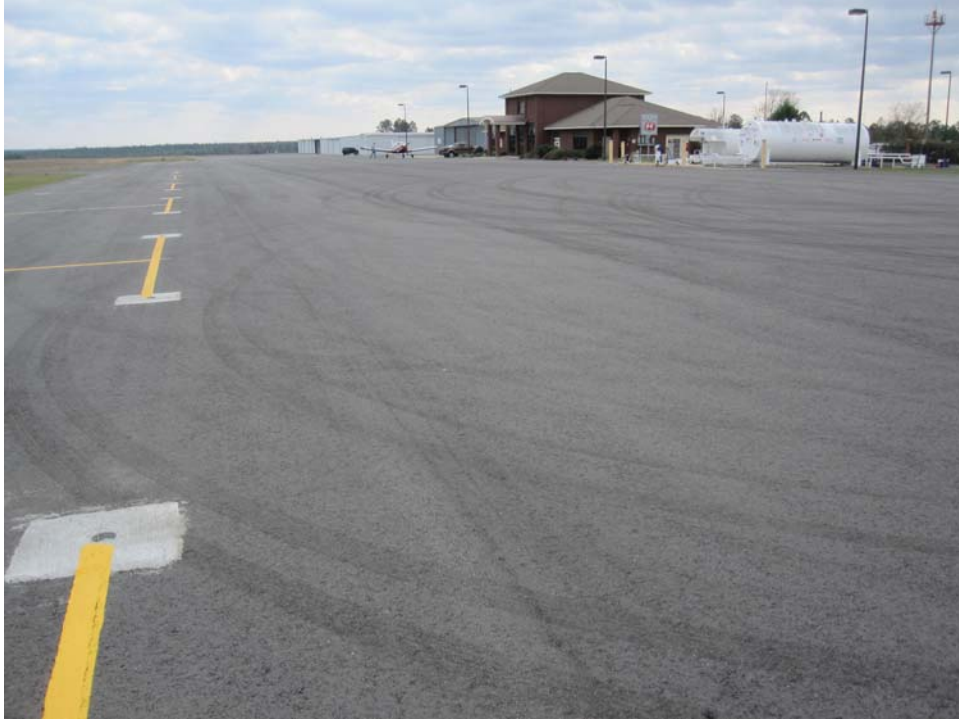
The apron area contained one section in excellent condition with a PCI value of 100. No pavement distresses were observed during the inspection.

A01JS-10. Overview.

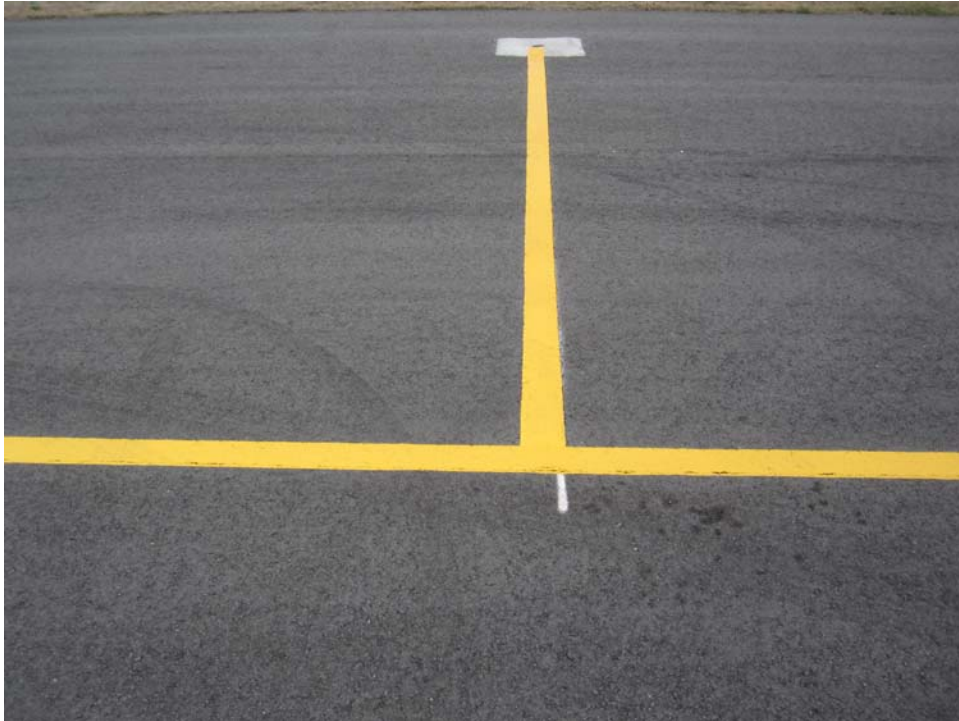
A01JS-10. Satisfactory Paint.

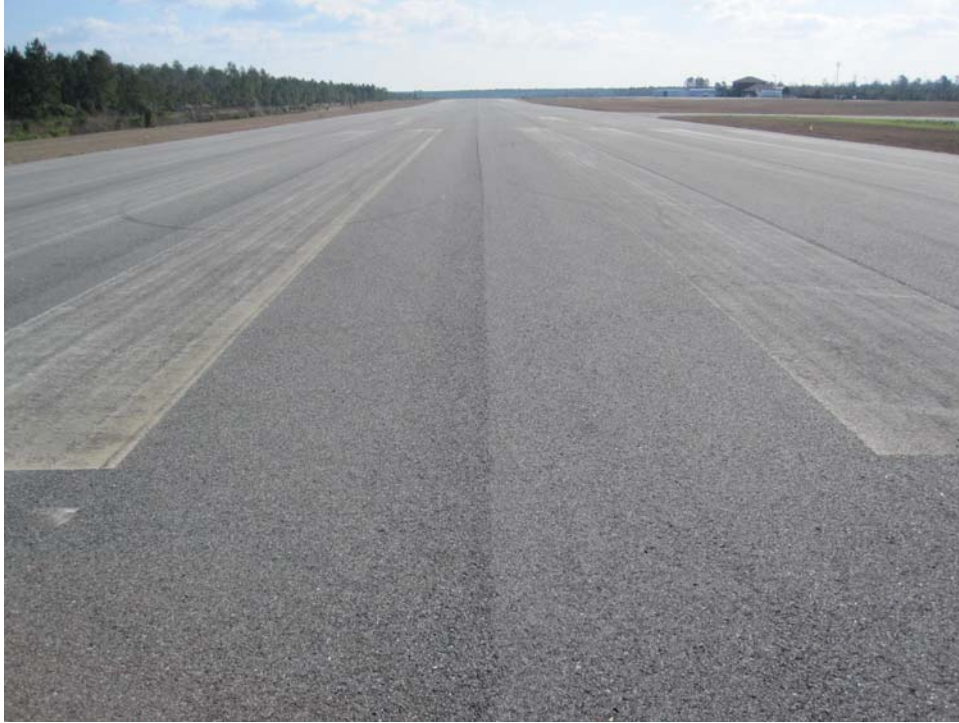
Runway 11-29 was defined by one section with a PCI value of 91. Low-severity, unsealed longitudinal and transverse (L&T) cracking was observed along some of the paving lanes. Low-severity swelling was also recorded in small quantities.

R1129JS-10. Overview.

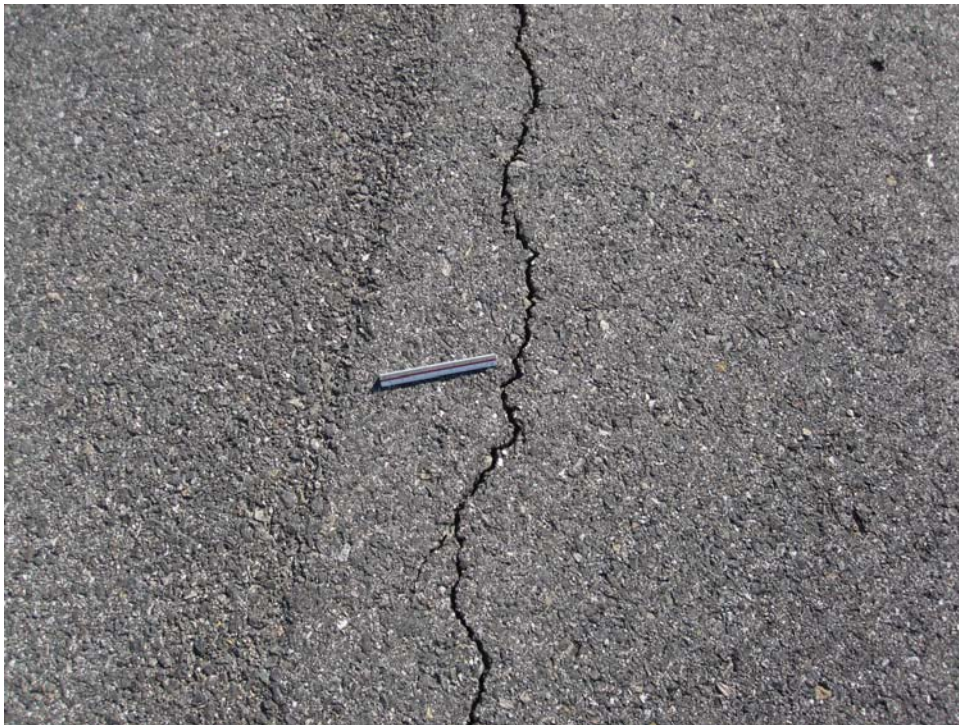
R1129JS-10. Longitudinal and Transverse Cracking (Sample Unit #03).

Sample Number: 03 Type: R Area: 5,000.00SqFt PCI = 90
 Sample Comments:
 48 LONGITUDINAL/TRANSVERSE CRACKING L 148.00 Ft Comments:lu

2. Implement a periodic crack sealing program. Sealing cracks is a proven method for cost-effectively keeping water and debris out of the pavement system and extending its life.

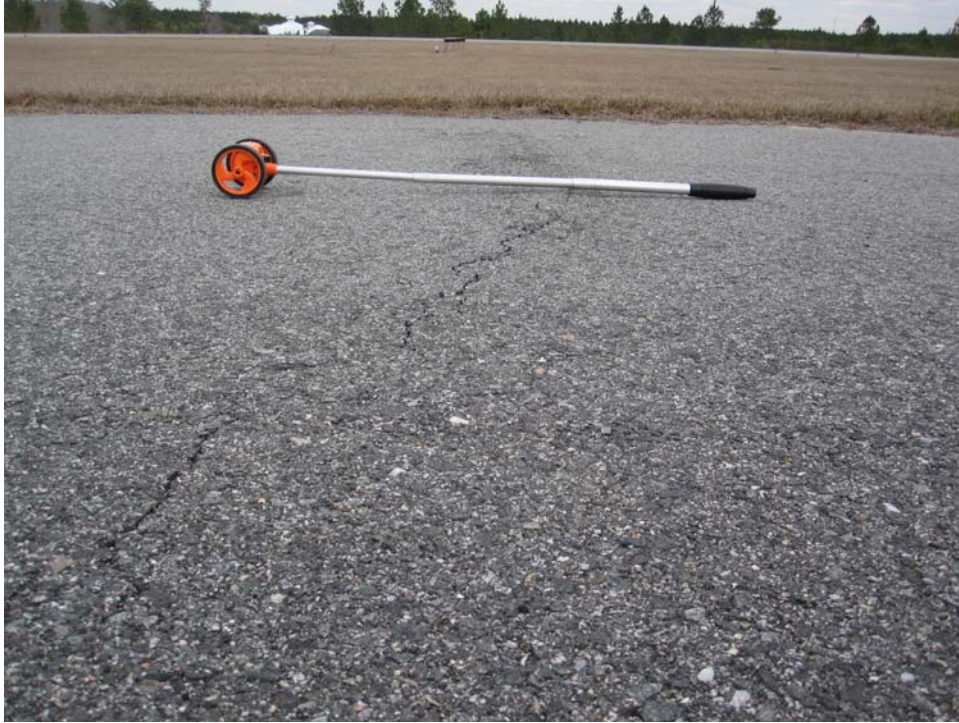
R1129JS-10. Swelling (Sample Unit #63).

Sample Number: 63 Type: R Area: 5,000.00SqFt PCI = 87
 Sample Comments:
 48 LONGITUDINAL/TRANSVERSE CRACKING L 176.00 Ft Comments:lu
 56 SWELLING L 13.00 SqFt Comments:

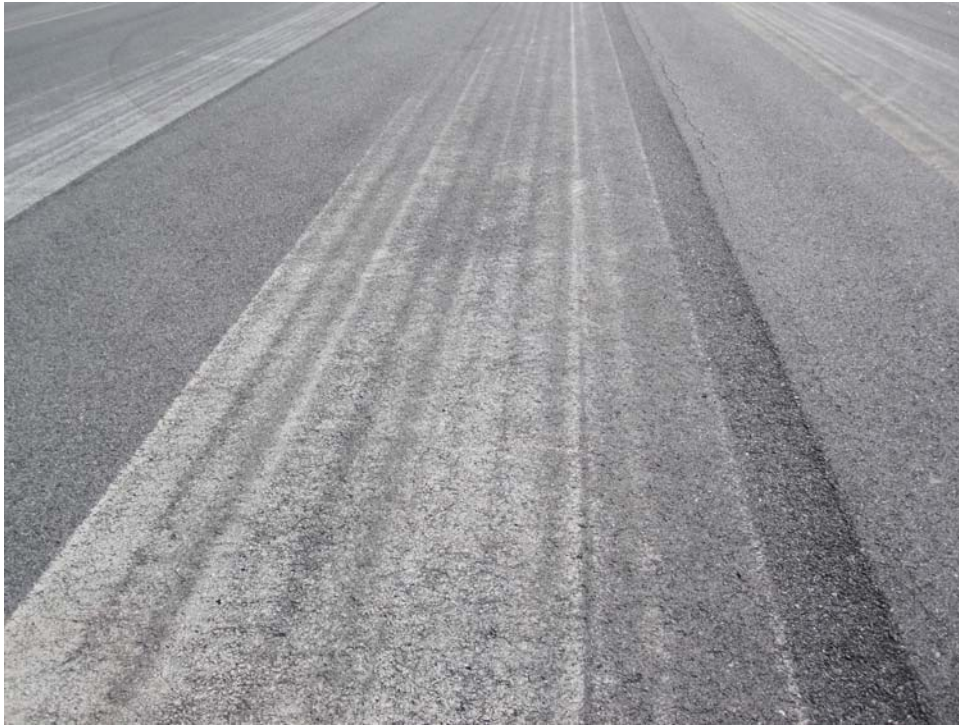
R1129JS-10. Unsatisfactory Paint.

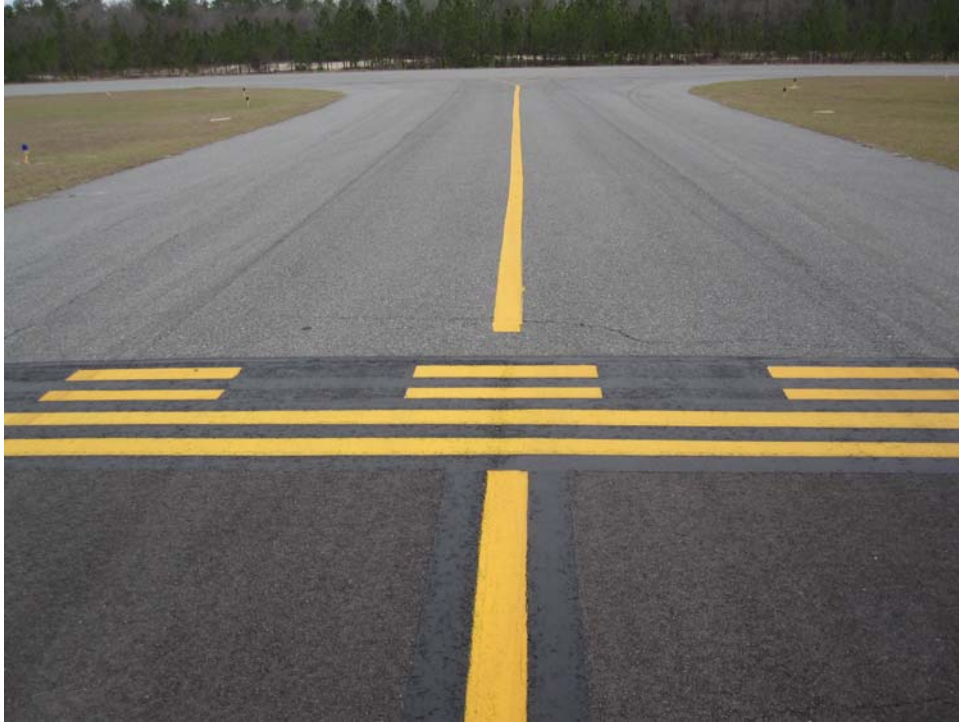
Taxiway A was comprised of one section with a PCI value of 93. Low-severity, unsealed L&T cracking was identified in Section 10. Small quantities of low-severity swelling were also recorded.

TAJS-10. Overview.

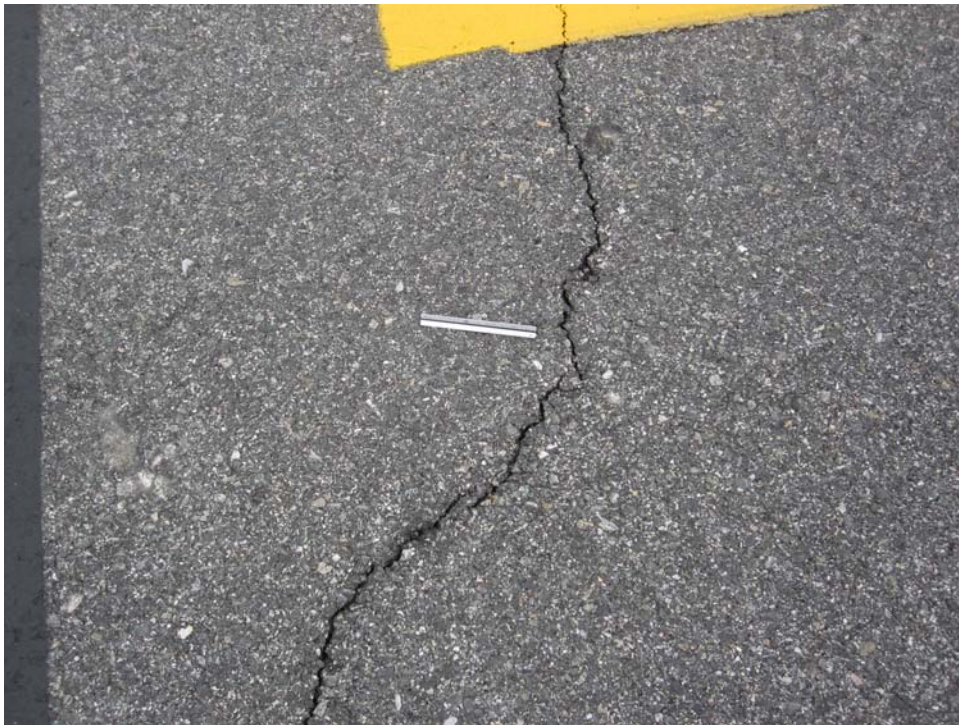
TAJS-10. Longitudinal and Transverse Cracking (Sample Unit #02).

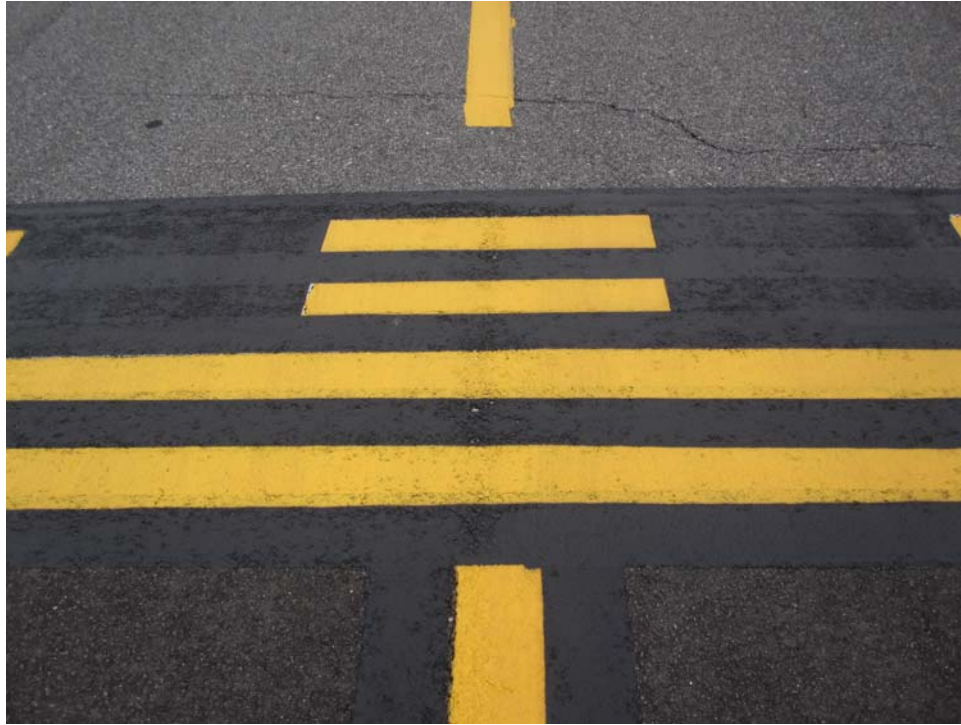
TAJS-10. Satisfactory Paint.

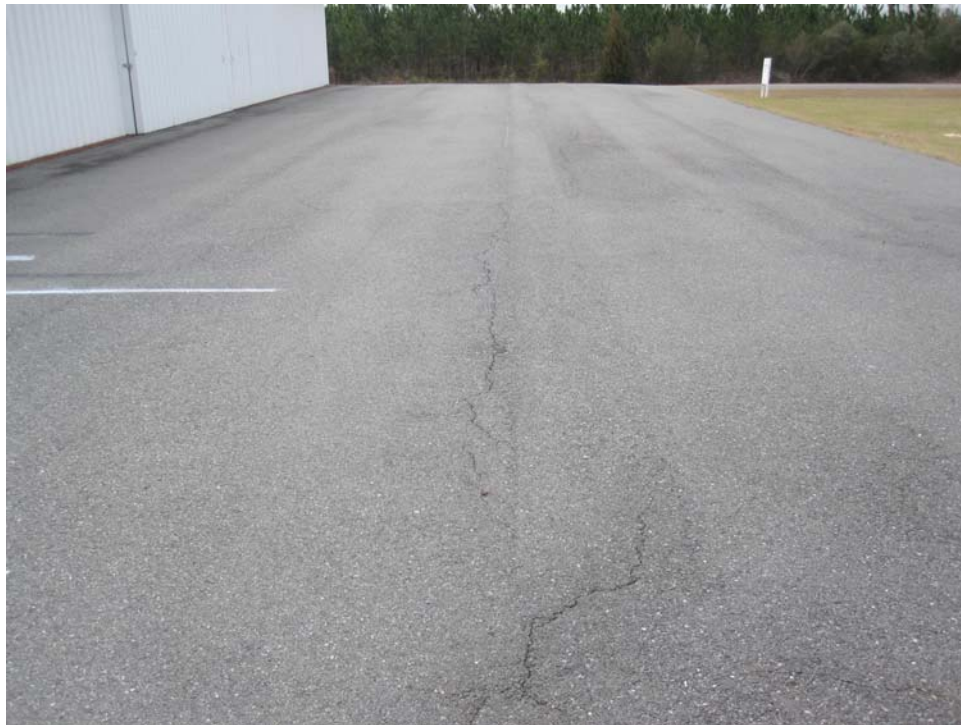
The T-Hangar area was defined by two sections. Section 10 had a PCI value of 91 with low-severity, unsealed L&T cracking identified throughout. Section 20 was in excellent condition with a PCI value of 100. No pavement distresses were observed during the inspection.

THANGJS-10. Overview.

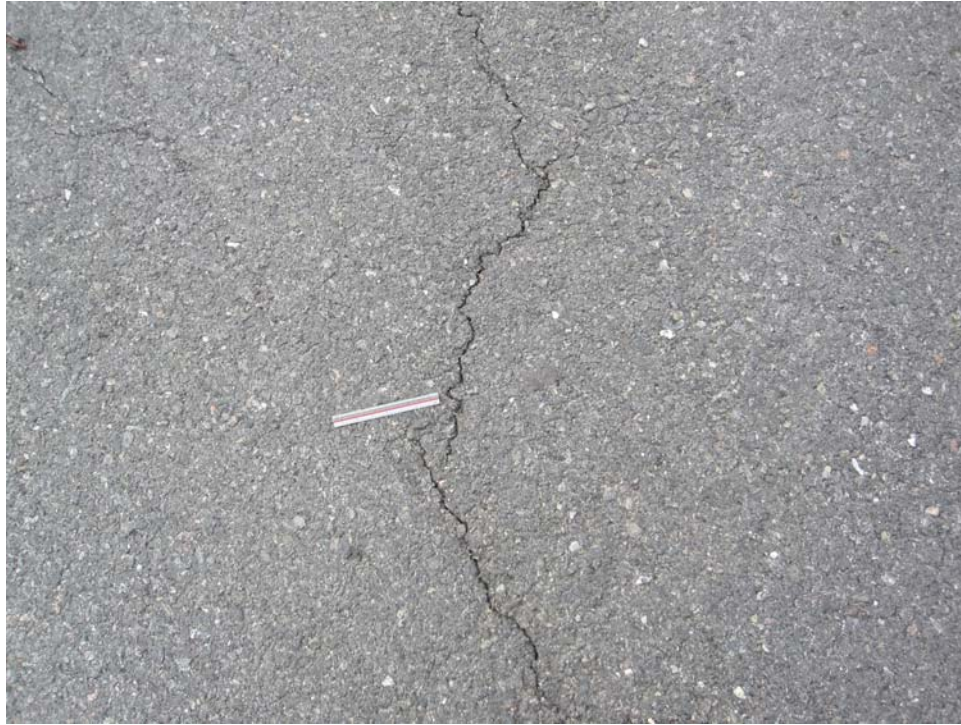
THANGJS-10. Longitudinal and Transverse Cracking (Sample Unit #05).

Sample Number: 05 Type: R Area: 4,750.00SqFt PCI = 87
Sample Comments:
48 LONGITUDINAL/TRANSVERSE CRACKING L 198.00 Ft Comments:lu

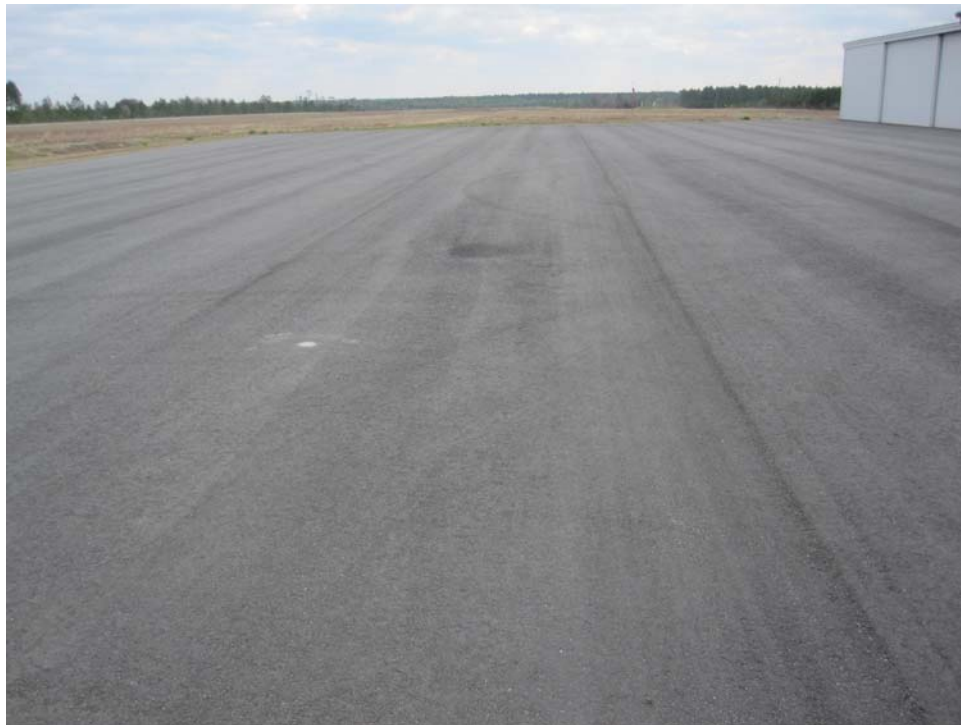
THANGJS-20. Overview.
