2012 Brantley County Airport Pavement Management Plan

BRANTLEY COUNTY AIRPORT

PAVEMENT MANAGEMENT REPORT

DECEMBER 2012

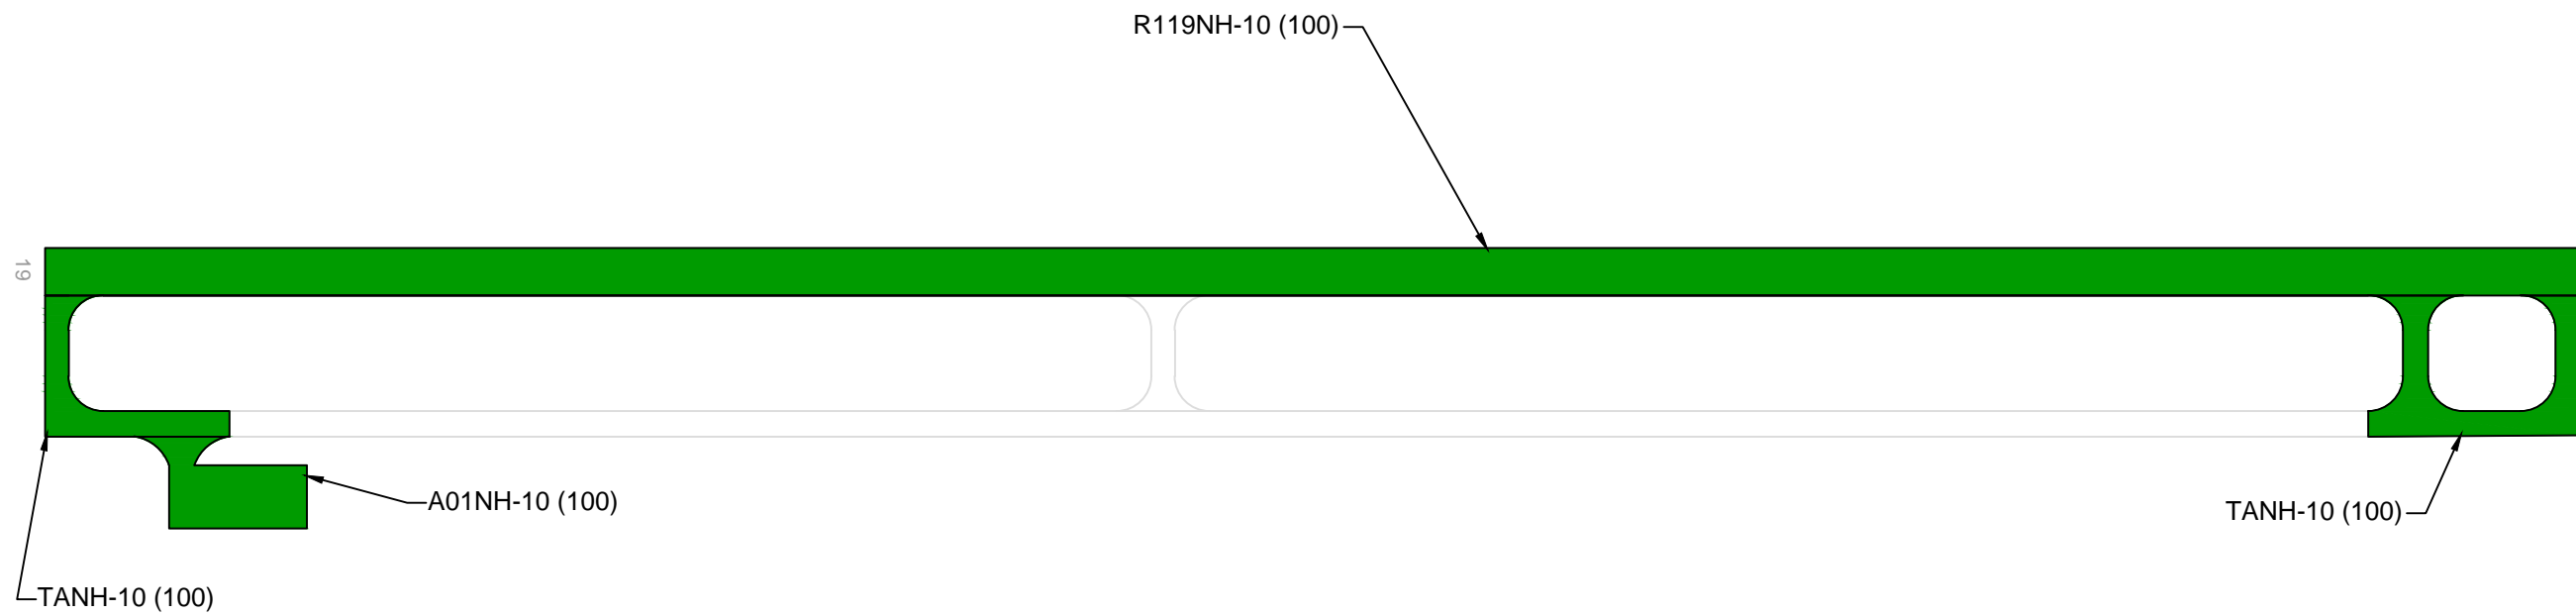
There were three pavement sections defined during the inspection. The runway, taxiway, and apron pavement sections were all in excellent condition with PCI values of 100. No distresses were observed at the time of inspection.

The 2012 area-weighted condition of Brantley County Airport is 100, with conditions ranging from 100 to 100 [on a scale of 0 (failed) to 100 (excellent)]. This compares to a 2007 PCI of 34.

Branch¹	Section	Year	Type of Repair²	Estimated Cost³
A01NH	10	2015	Rejuvenator	\$5,864
R119NH	10	2015	Rejuvenator	\$70,019
TANH	10	2015	Rejuvenator	\$11,875

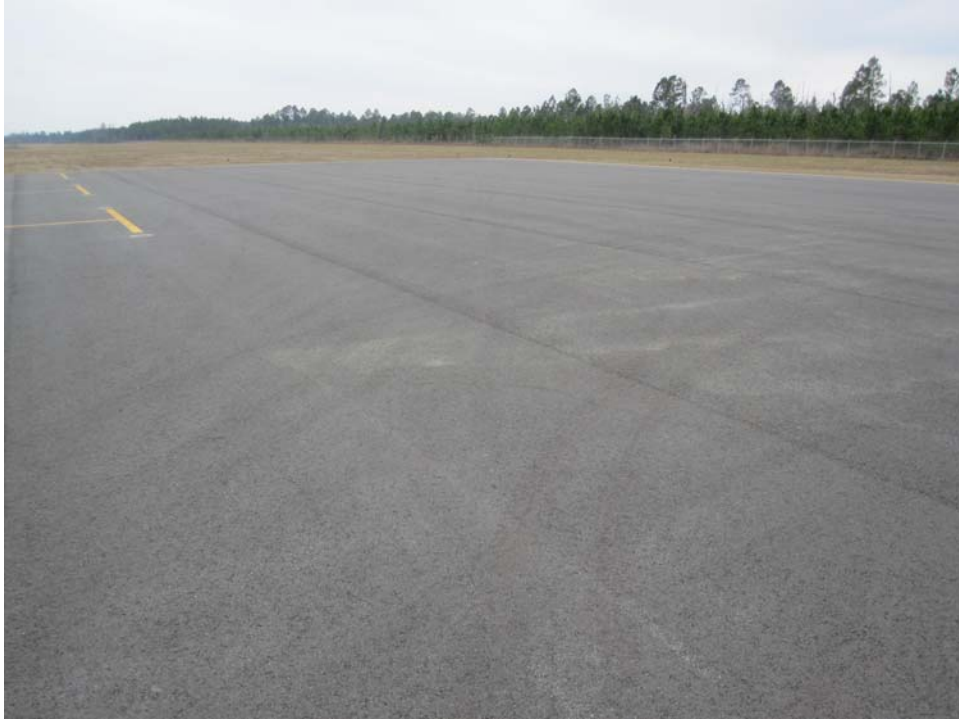
A01NH-10. Overview.

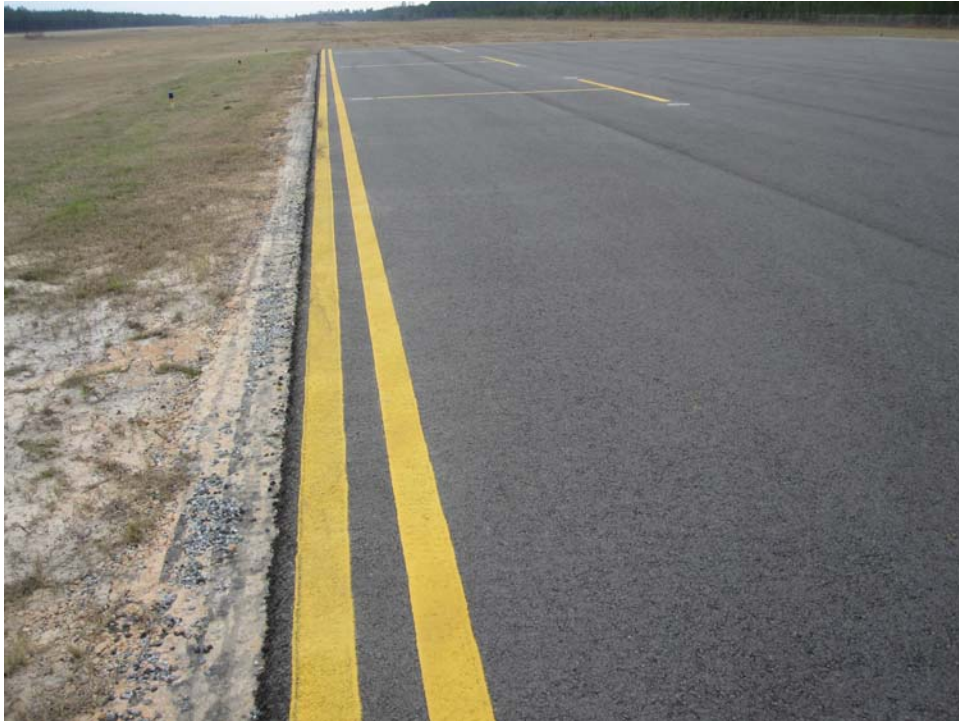
A01NH-10. Satisfactory Paint.

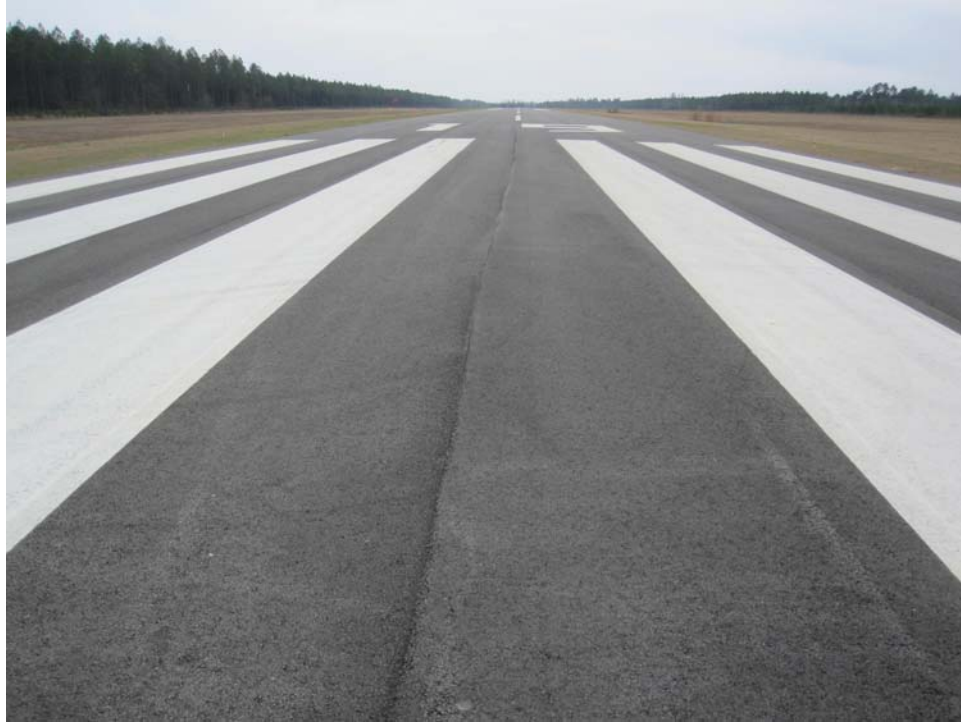
R119NH-10. Overview.

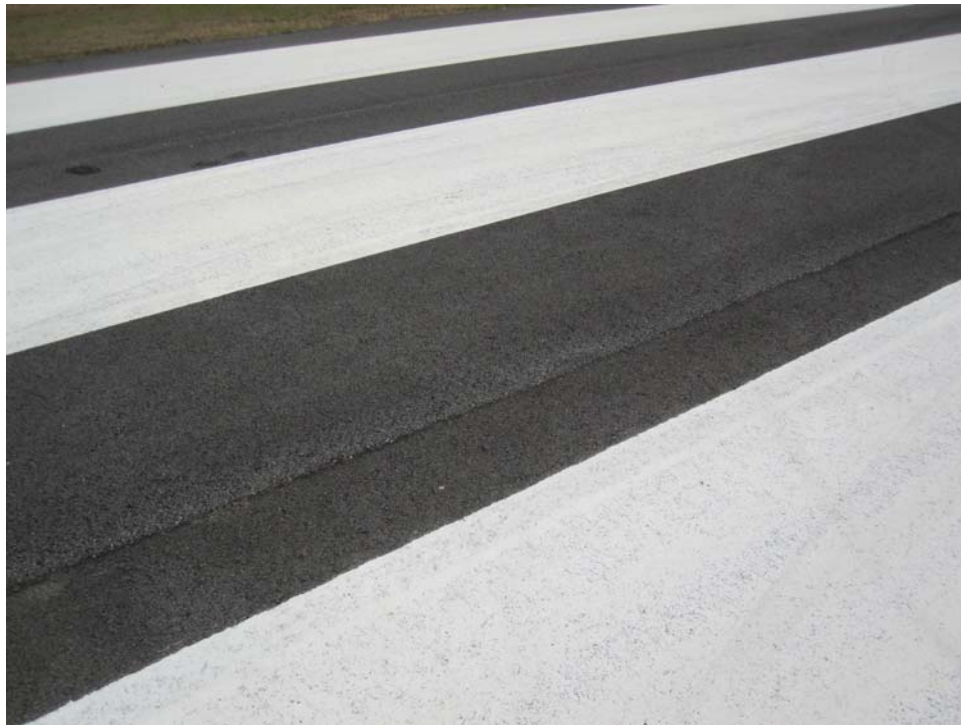
R119NH-10. Satisfactory Paint.

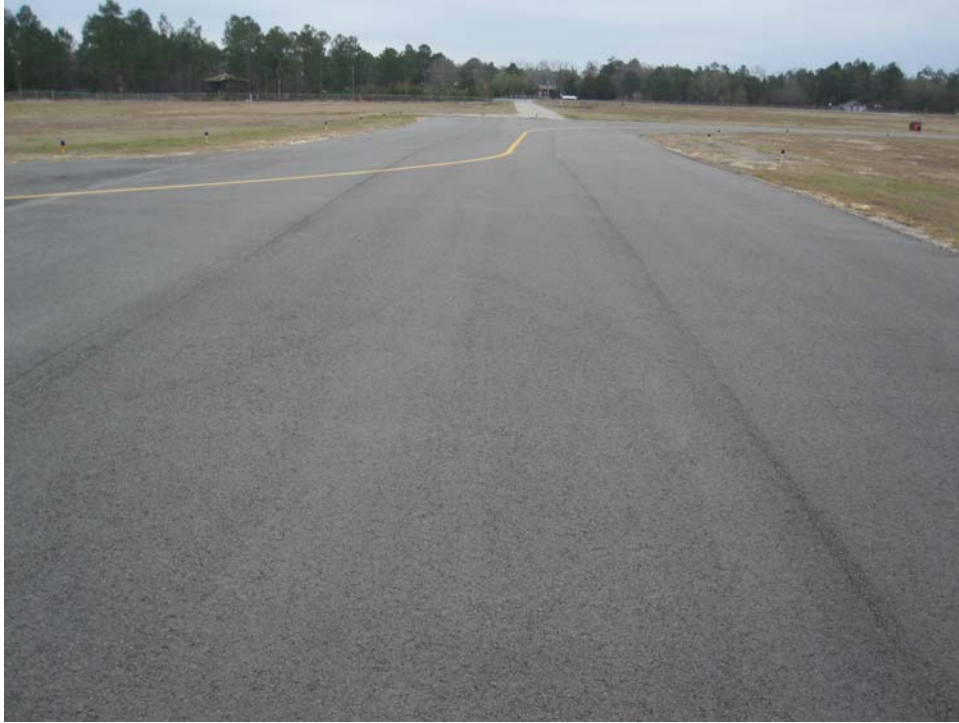
TANH-10. Overview.

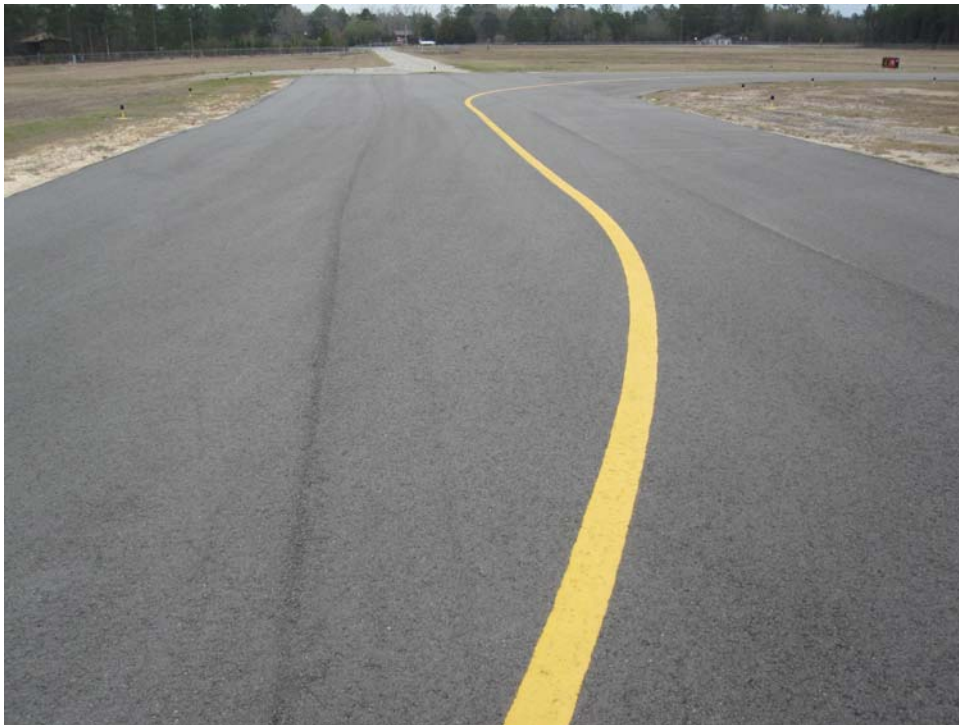
TANH-10. Satisfactory Paint.
