COCHRAN AIRPORT
PAVEMENT MANAGEMENT REPORT

2007 GEORGIA AIRPORT PAVEMENT MANAGEMENT REPORT

COCHRAN AIRPORT

JANUARY 2008

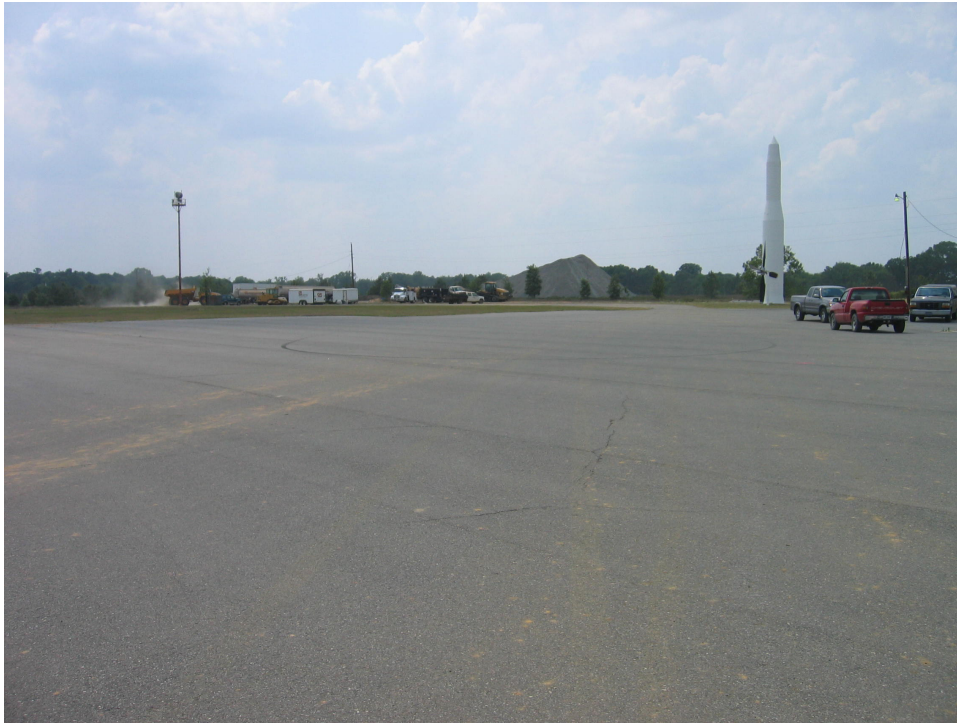
The apron area was recently rehabilitated and is defined by one section. A01CH-10 is in good condition with a PCI value of 88. Isolated amounts of unsealed L&T cracking were observed.

A01CH-10. Overview.

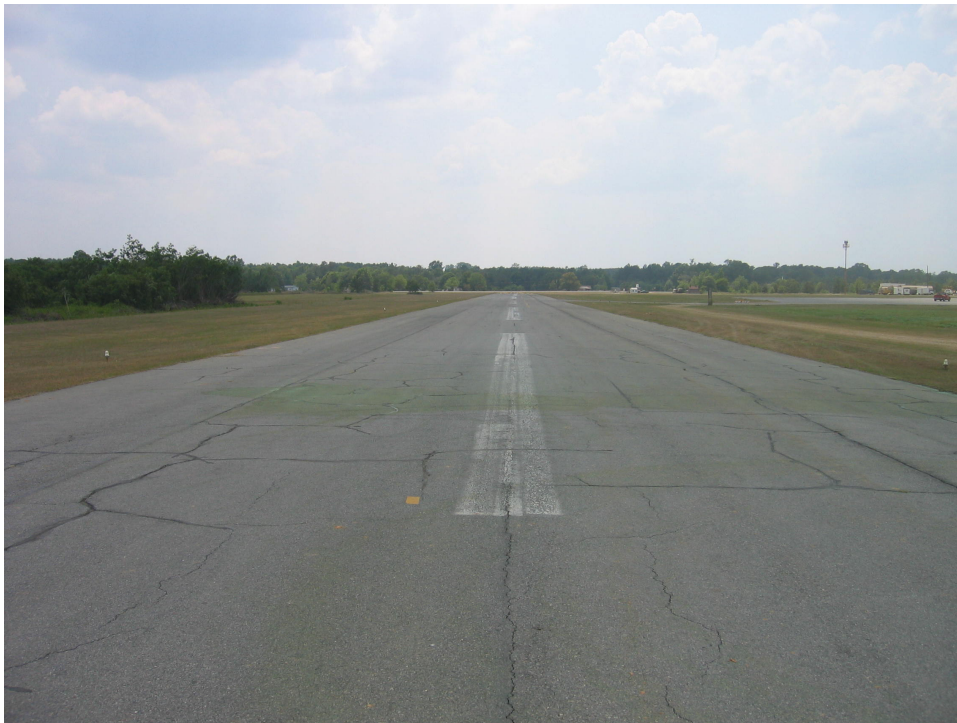
Runway 5-23 (R523CH-10) and Taxiway A (TACH-10) are each defined by one section and are both in poor condition with PCI values of 49 and 55, respectively. Low and medium-severity, sealed and unsealed, longitudinal and transverse (L&T) cracking, were found throughout each section. Block cracking and swelling were also observed on the runway.

R523CH-10. Overview.

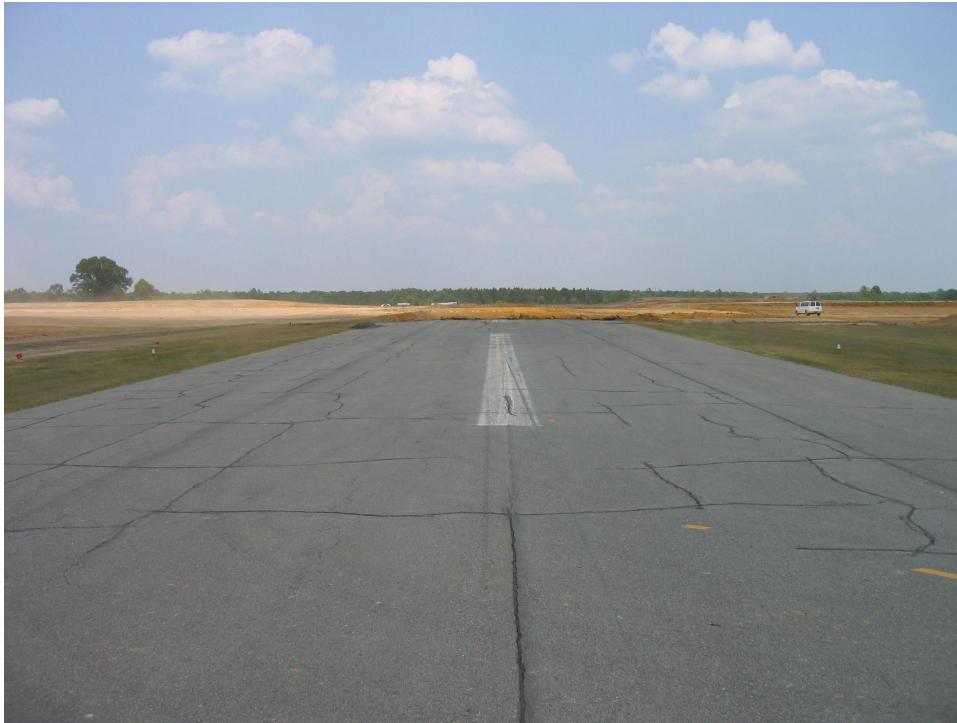
R523CH-10. Overview (new construction).

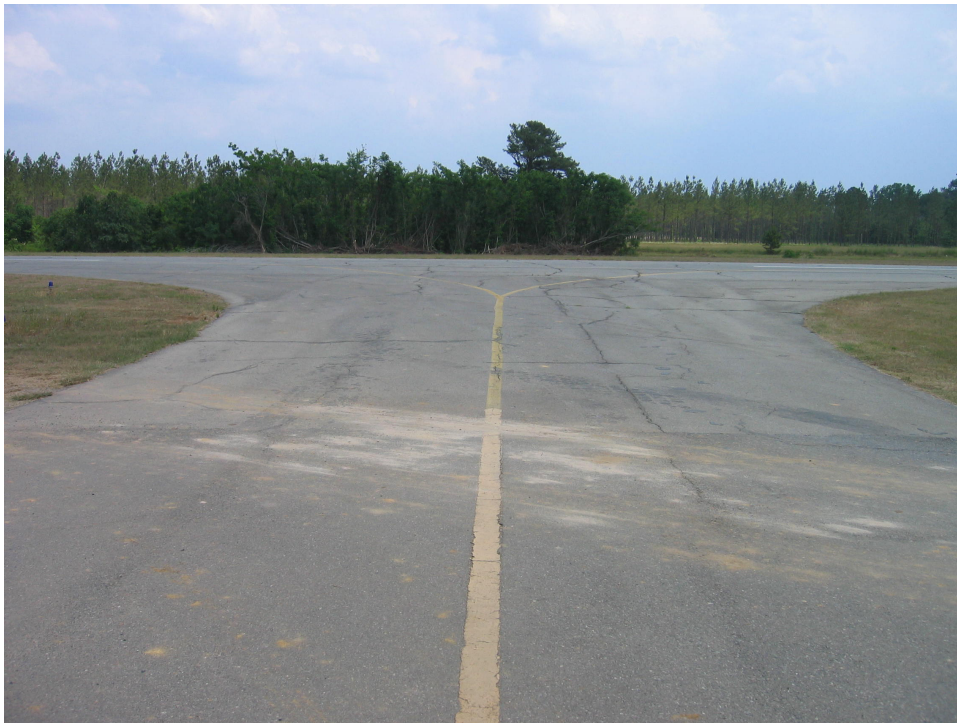
TACH-10. Overview.
