BRANTLEY COUNTY AIRPORT
PAVEMENT MANAGEMENT REPORT

**2007 GEORGIA AIRPORT
PAVEMENT MANAGEMENT REPORT**

PAVEMENT MANAGEMENT REPORT

JANUARY 2008

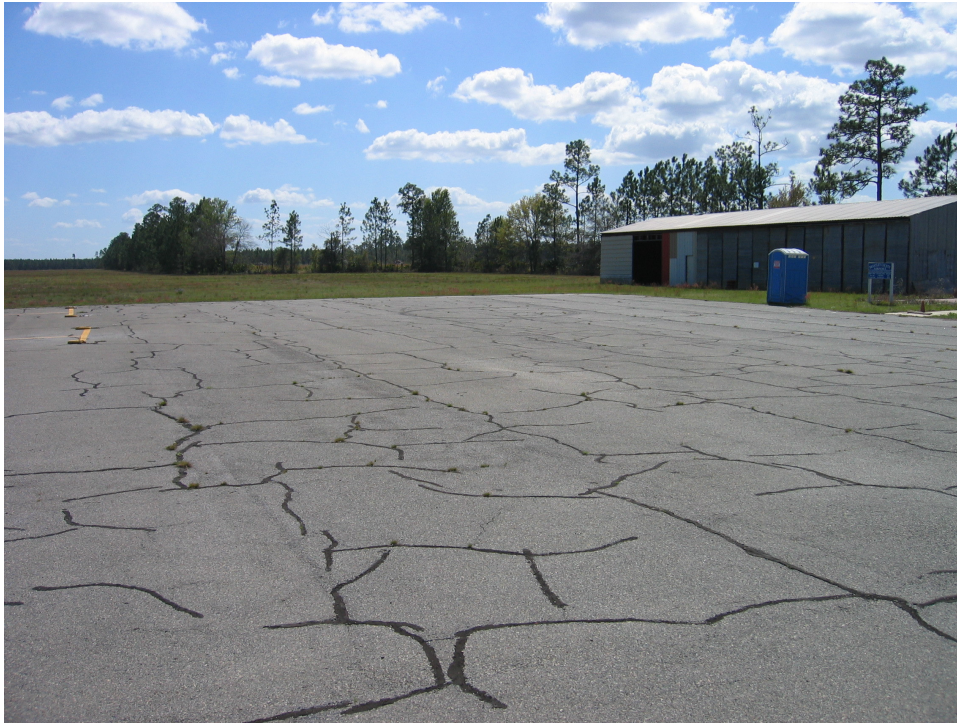
The apron pavement, section A01NH-10, is also defined by one section and is in similar condition to the runway with a PCI value of 32. Low and medium-severity L&T cracking and raveling and weathering, medium-severity block cracking, and low-severity swelling were recorded.

A01NH-10. Overview.

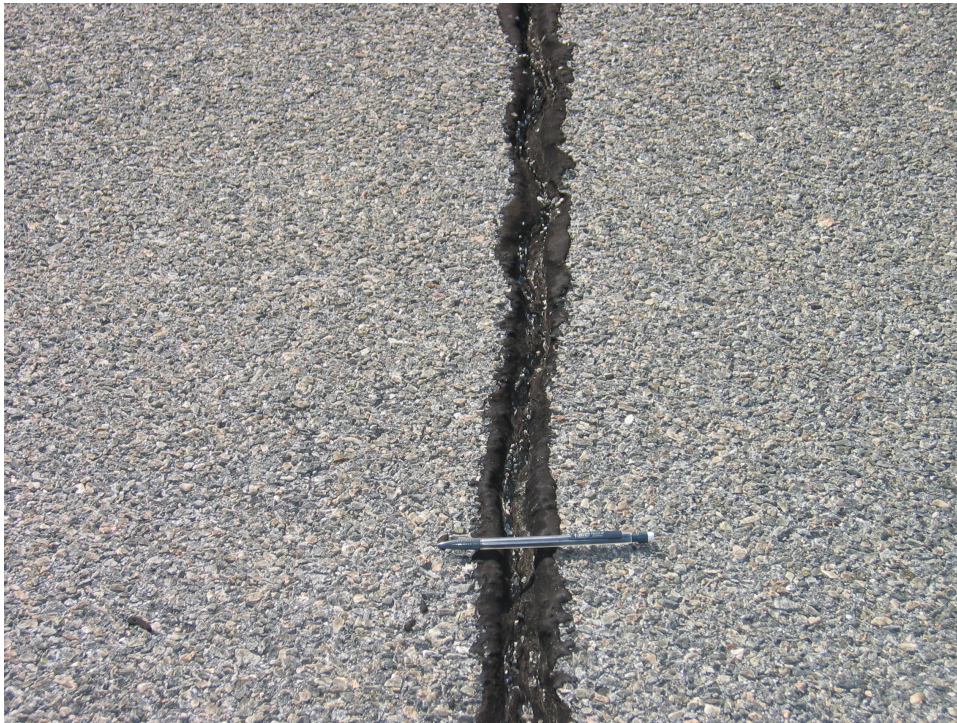
Runway 1-19 consist of one section, R119NH-10, and is in poor condition with a PCI value of 34. Large amounts of low and medium-severity, both sealed and unsealed, longitudinal and transverse (L&T) and block cracking were identified throughout the section. Raveling and weathering of all severities was also observed. Small circular, low-severity swells, approximately one square foot in size, were identified throughout the runway. Finally, isolated quantities of rutting were recorded throughout the runway.

R119NH-10. L&T cracking.

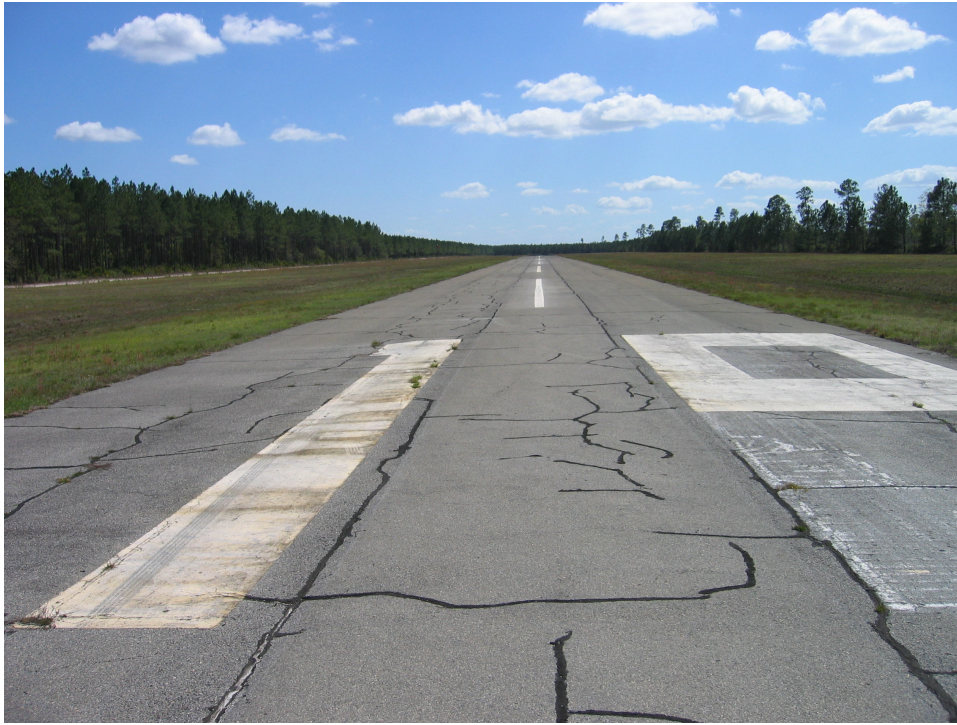
R119NH-10. Overview.

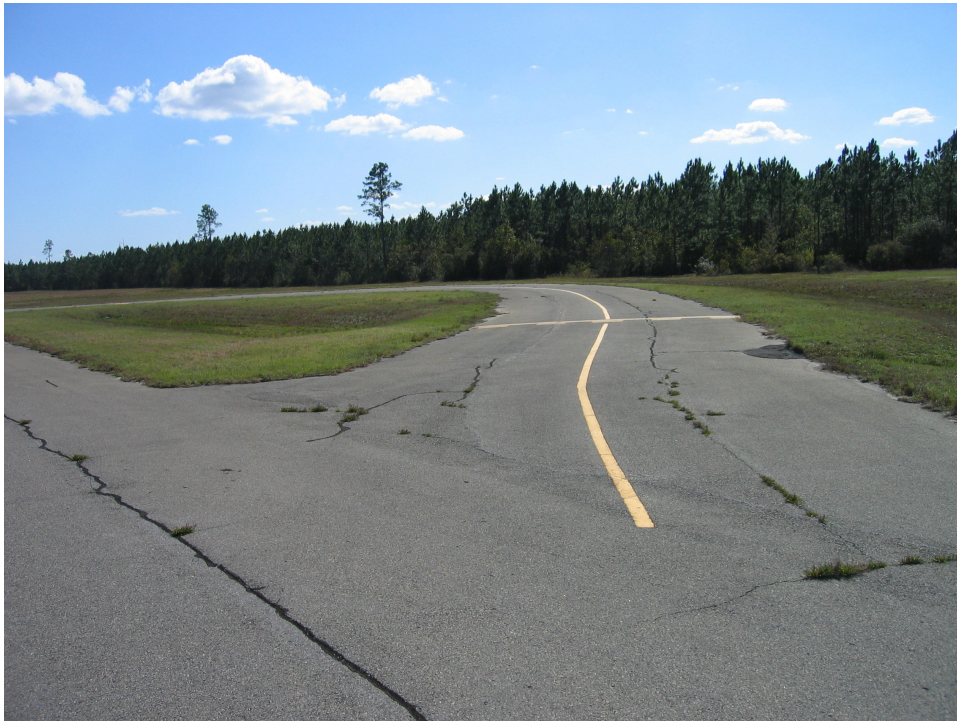
R119NH-10. Overview (turnaround).

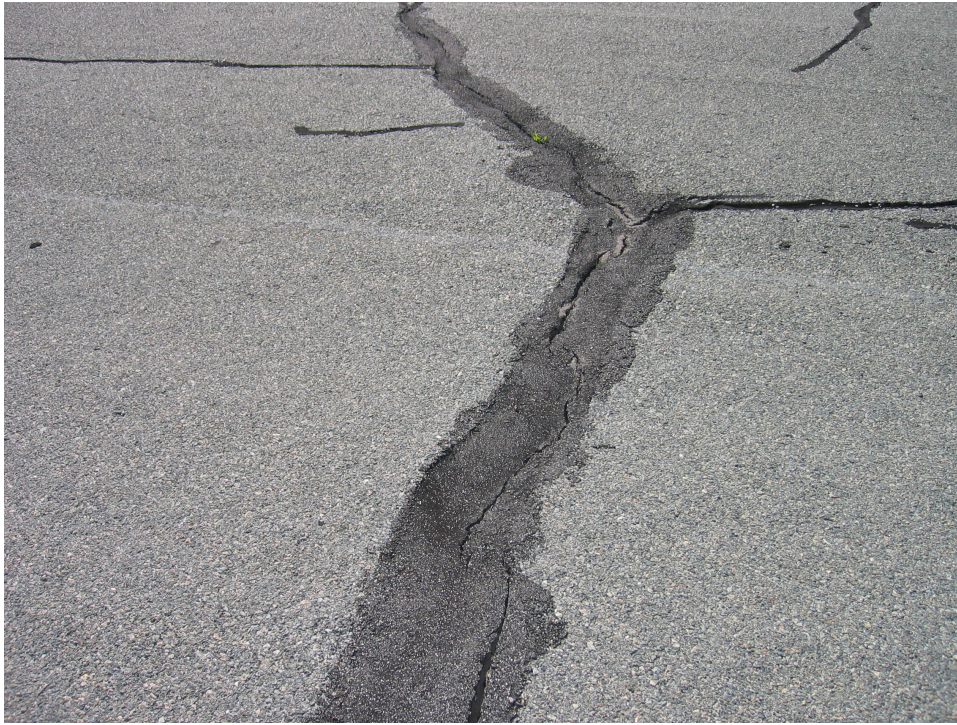
R119NH-10. Patching.

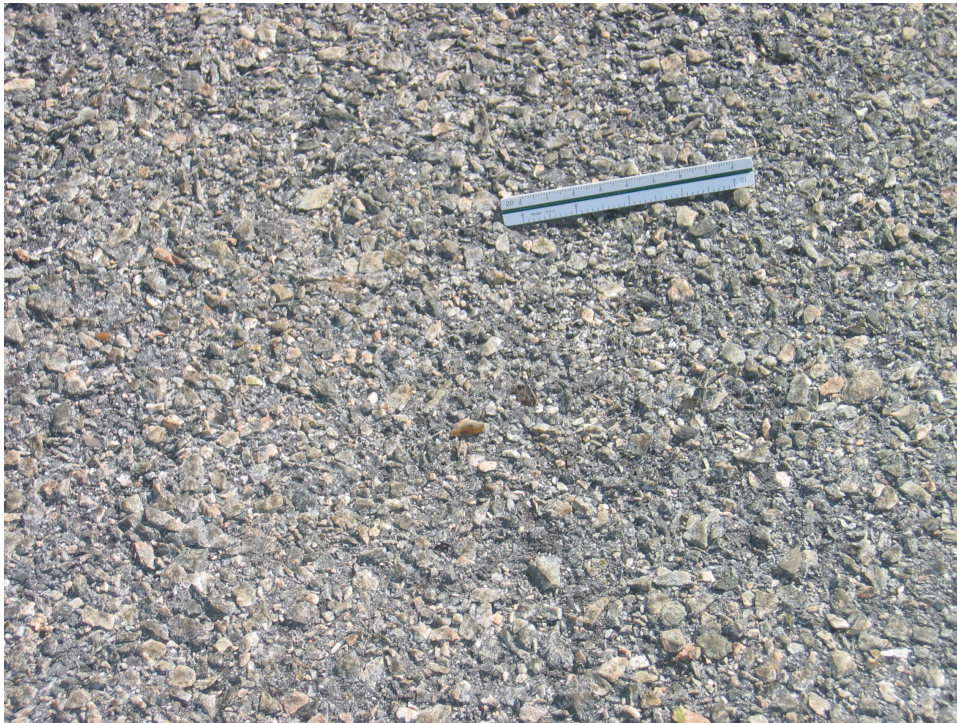
R119NH-10. Raveling and weathering.

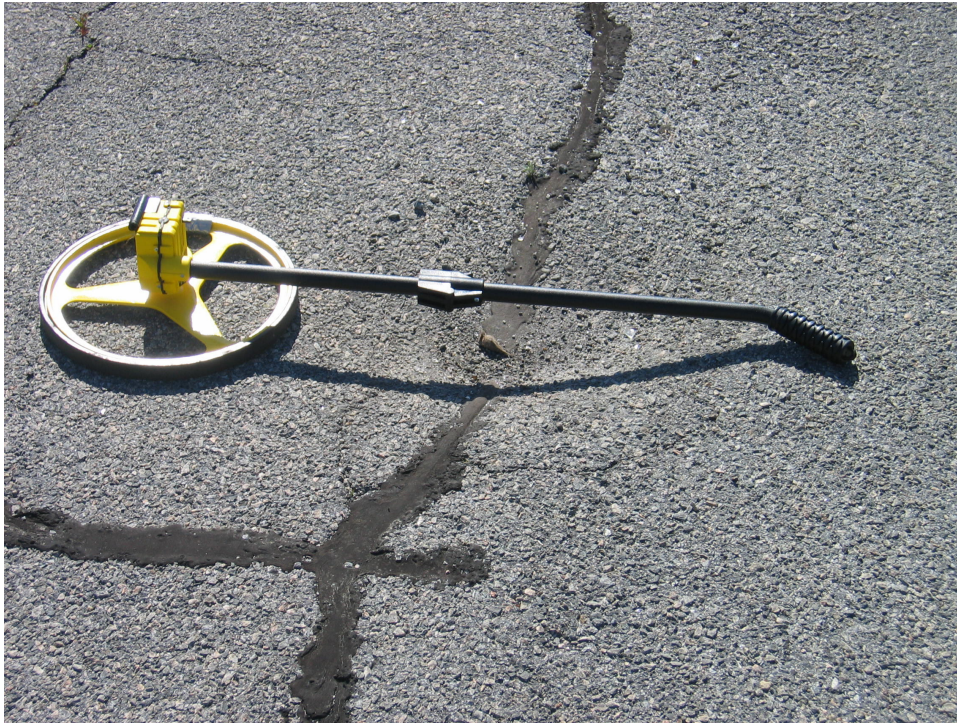
The taxiway pavement, section TANH-10, is defined by one section and is in similar condition as the runway. TANH-10 is in serious condition with a PCI value of 25. Medium-severity block cracking, high-severity depression, low-severity swelling, and low and medium-severity L&T cracking and raveling and weathering were identified in this section.

TANH-10. Depression.

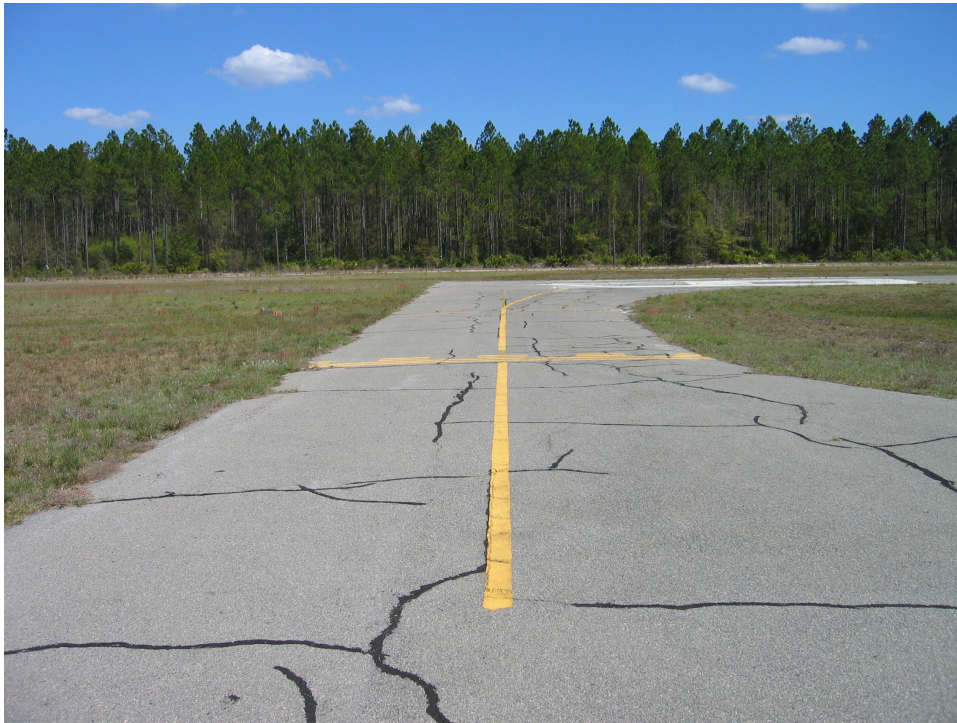
TANH-10. Overview.
