**BUTLER MUNICIPAL AIRPORT
PAVEMENT MANAGEMENT REPORT**

2007 GEORGIA AIRPORT PAVEMENT MANAGEMENT REPORT

BUTLER MUNICIPAL AIRPORT

PAVEMENT MANAGEMENT REPORT

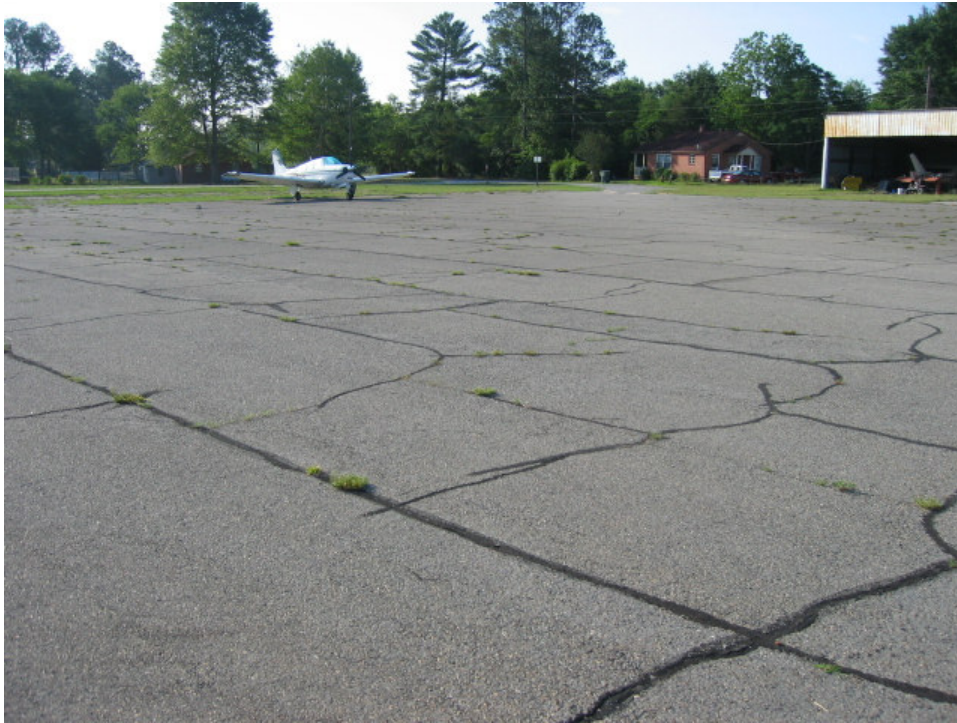
Section A01BT-10 is in poor condition with a PCI value of 46. Large amounts of both low and medium-severity block cracking were observed in this section. Most of the cracking has been sealed. However, in many areas the sealant has hardened and is no longer functioning. A significant amount of low-severity raveling and weathering was also noted.

A01BT-10. Overview.

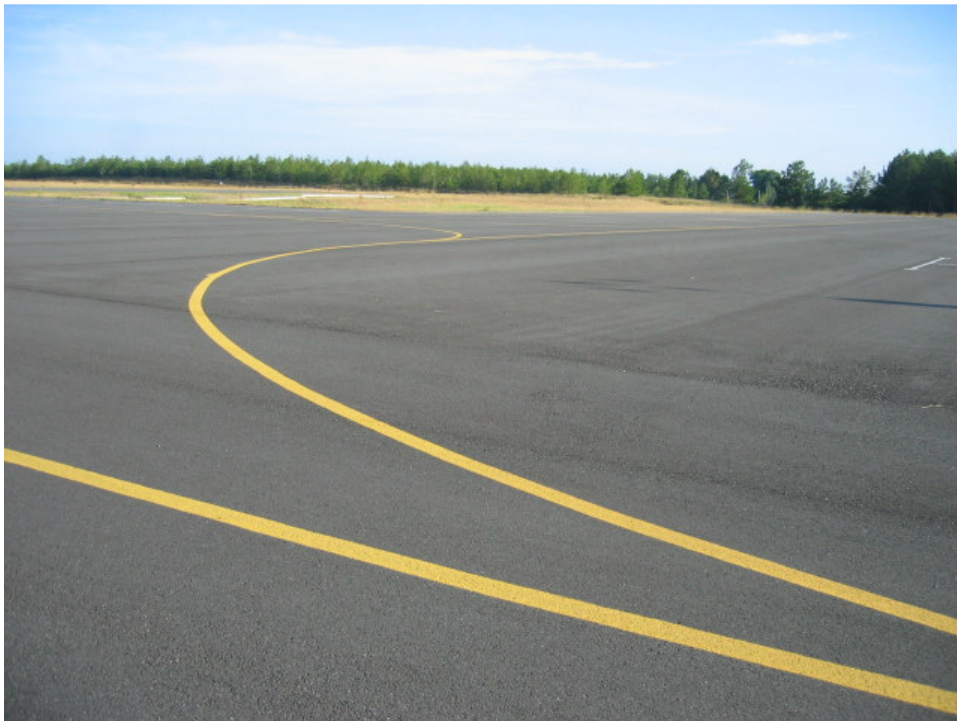
Section A02BT-10 was recently constructed and is in excellent condition with a PCI value of 100. No distresses were observed in this section.

A02BT-10. Overview.

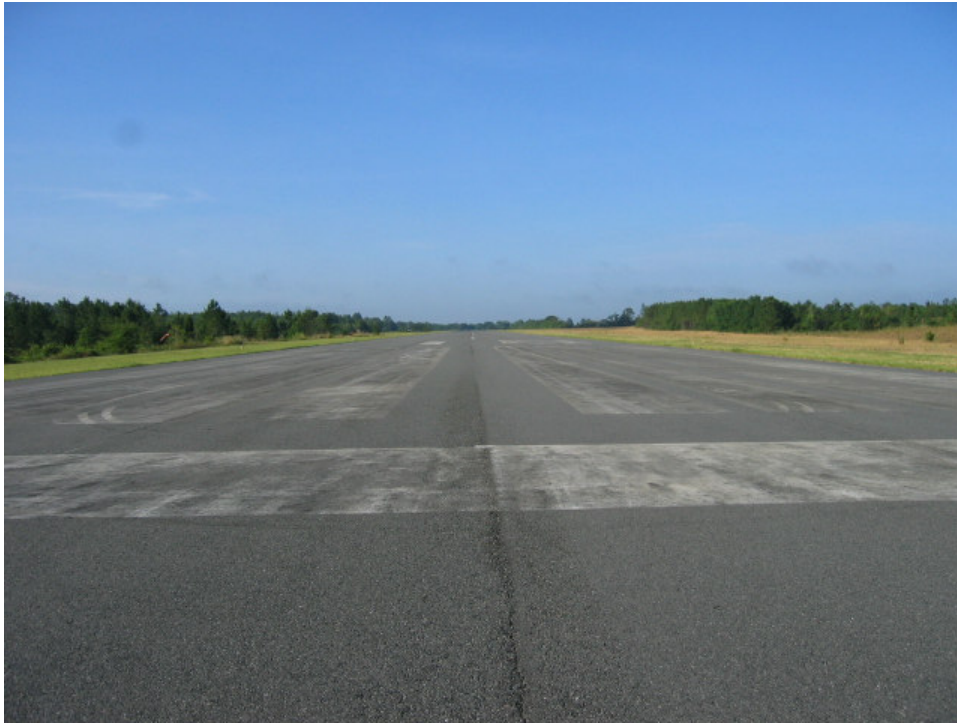
Runway 18-36 consists of a single pavement section. Section R1836BT-10 is in good condition with a PCI value of 92. Low-severity longitudinal and transverse (L&T) cracking as well as a small amount of swelling were the only two distresses observed in this section. All cracking was observed in an unsealed condition.

R1836BT-10. Overview.

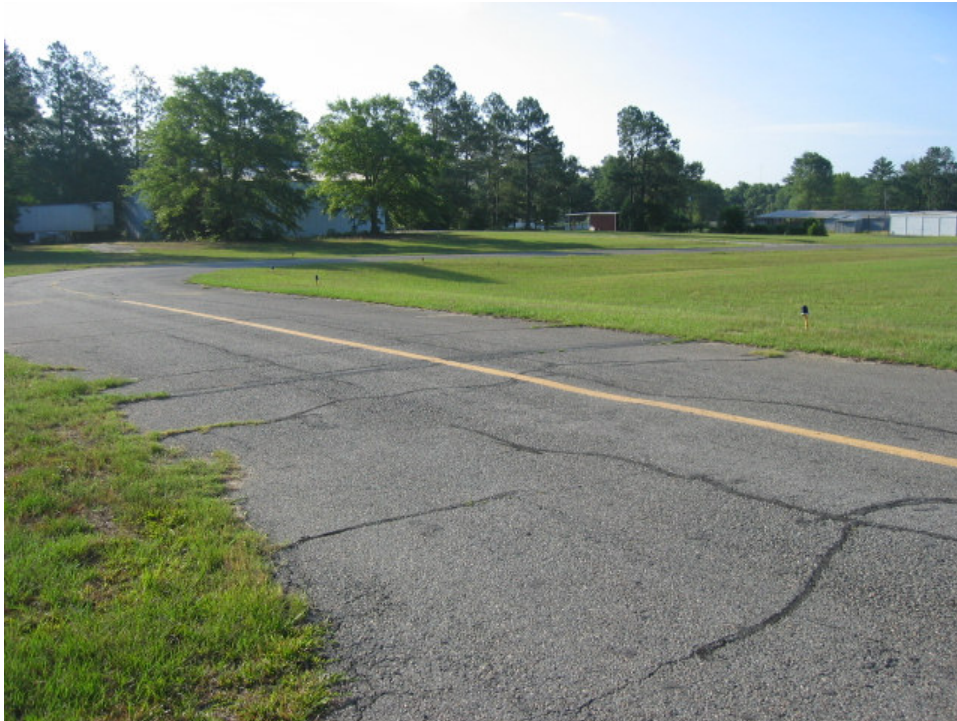
Taxiway A consists of a single pavement section. Section TABT-10 is in poor condition with a PCI value of 59. A large amount of low-severity block cracking as well as a significant amount of low-severity raveling and weathering was observed in this section. A number of both low and medium-severity patches were also recorded.

TABT-10. Overview.
