**GRIFFIN-SPALDING COUNTY AIRPORT
PAVEMENT MANAGEMENT REPORT**

2007 GEORGIA AIRPORT PAVEMENT MANAGEMENT REPORT

GRIFFIN-SPALDING COUNTY AIRPORT

PAVEMENT MANAGEMENT REPORT

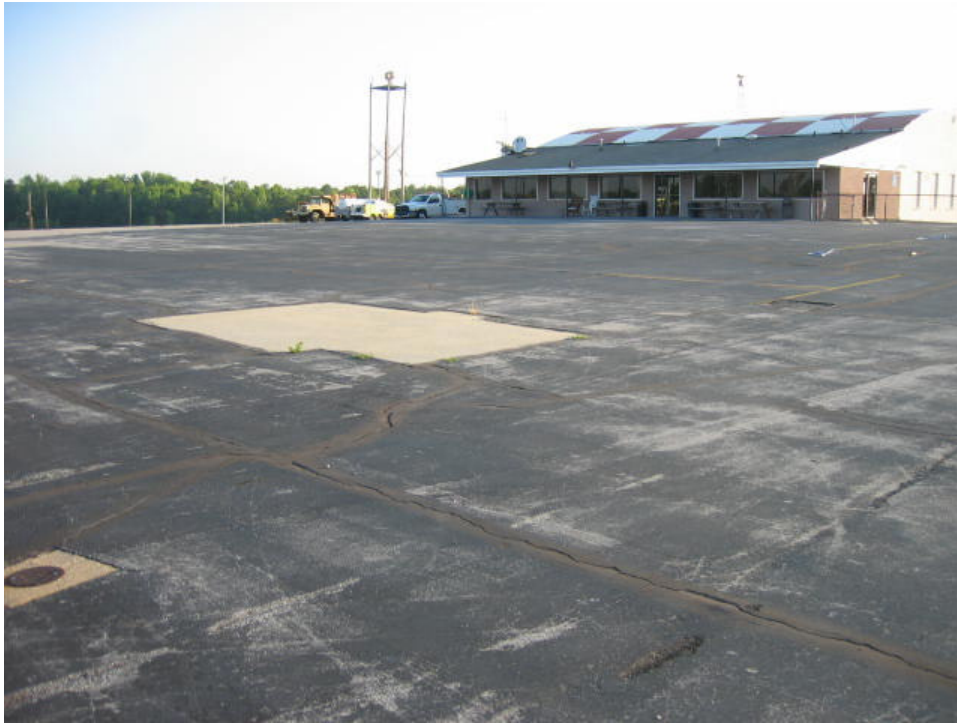
Apron 01 is located in the northeastern portion of the airfield and is defined by two sections. Sections A01GF-10 and A01GF-20 are each in poor condition with PCI values of 49 and 43, respectively. Areas of both low and medium-severity L&T cracking and raveling and weathering were observed in both sections. Instances of bleeding, low-severity depression, oil spillage, and patching were identified in section A01GF-10 while alligator cracking at all severity levels, as well as high-severity raveling and weathering were observed in section A01GF-20.

A01GF-10. Overview.

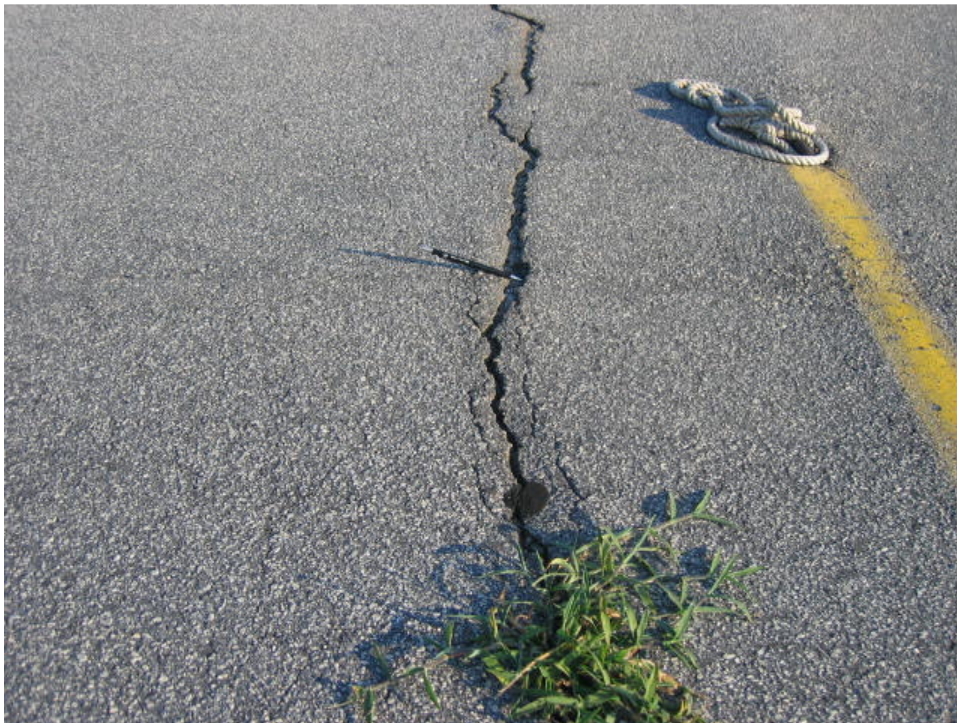
A01GF-10. L&T cracking.

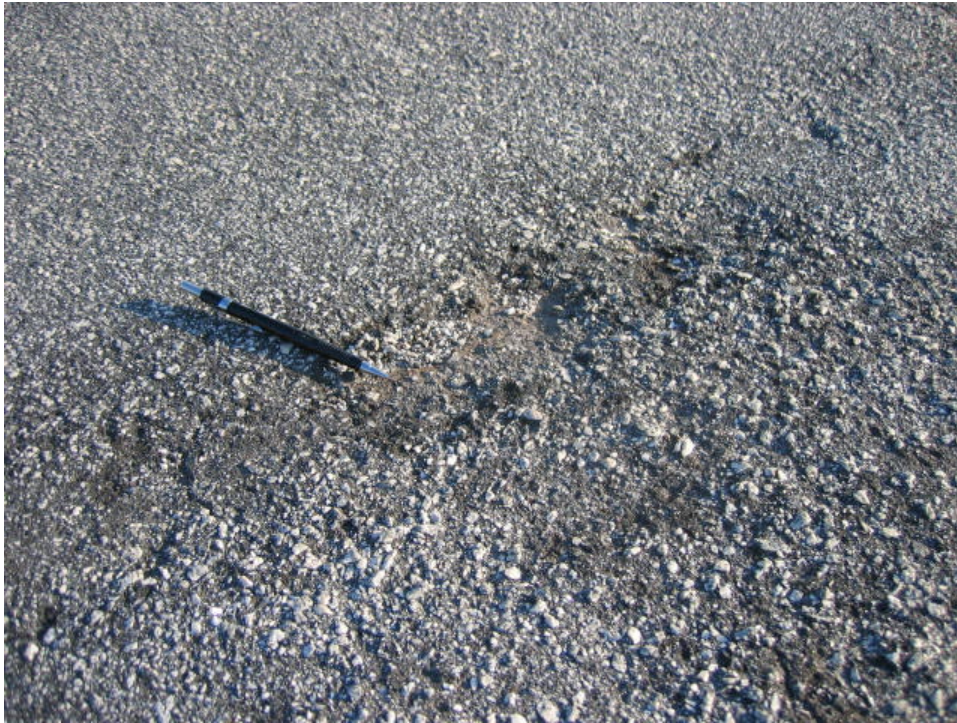
A01GF-10. Raveling and weathering.

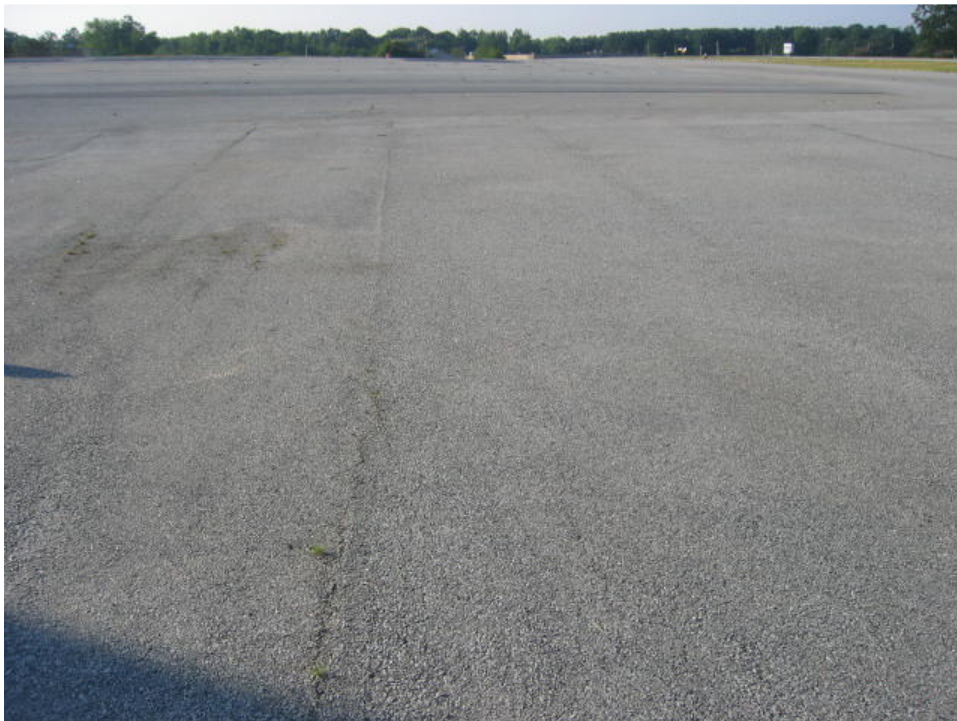
A01GF-20. Overview.

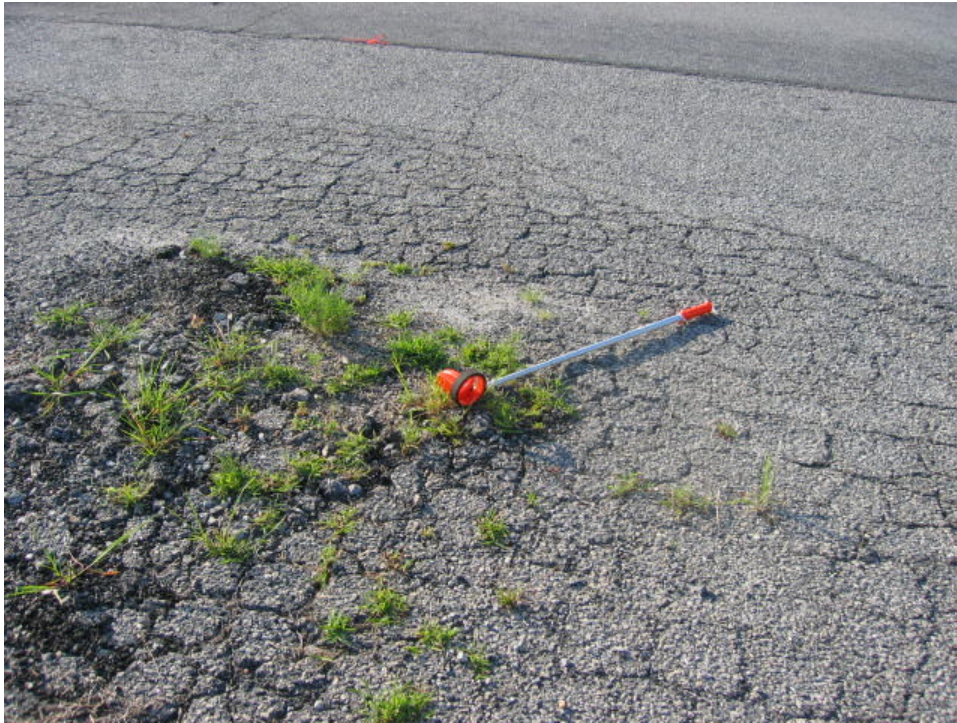
A01GF-20. Alligator cracking.

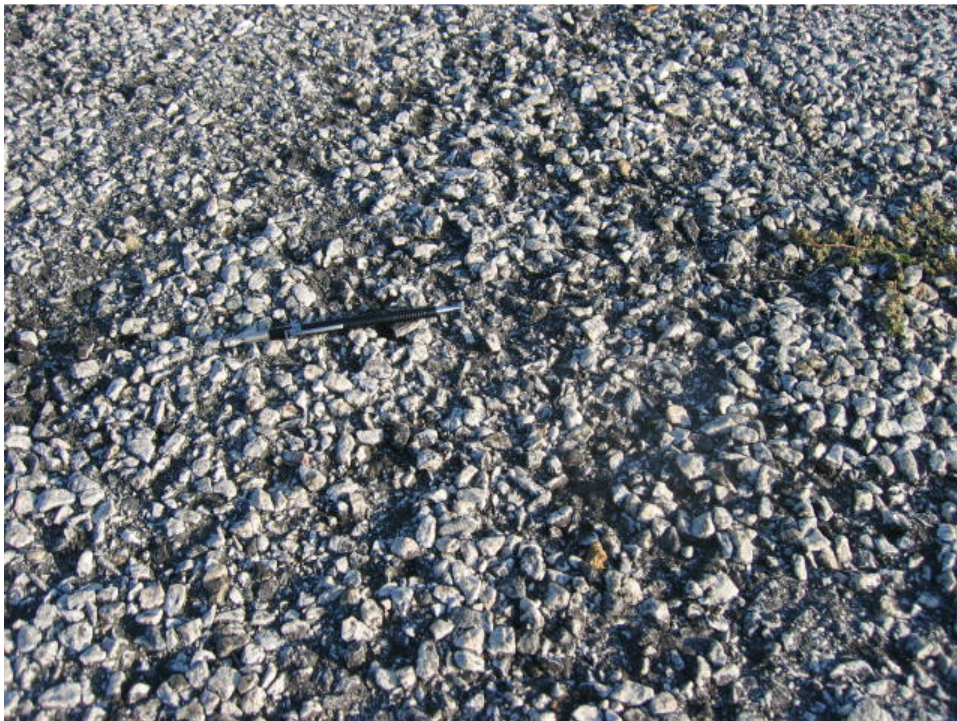
A01GF-20. Raveling and weathering.

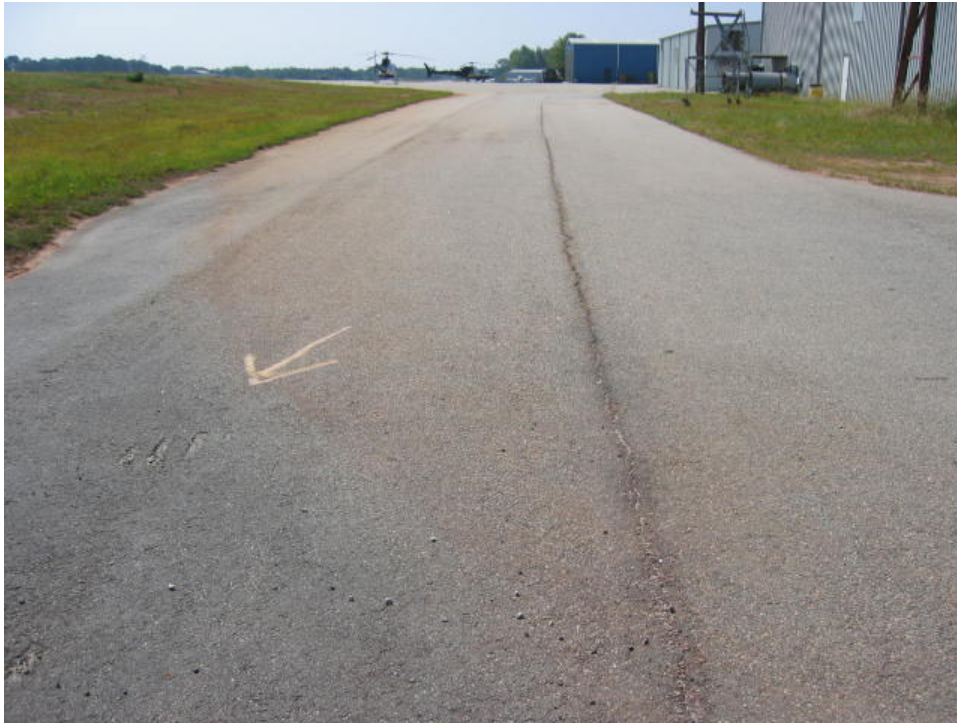
The primary apron area (A02GF) consists of seven sections. Section A02GF-10 is in good condition with a PCI value of 81. Quantities of both low and medium-severity L&T cracking as well as low-severity patching and raveling and weathering were observed in this section.

A02GF-10. Overview.

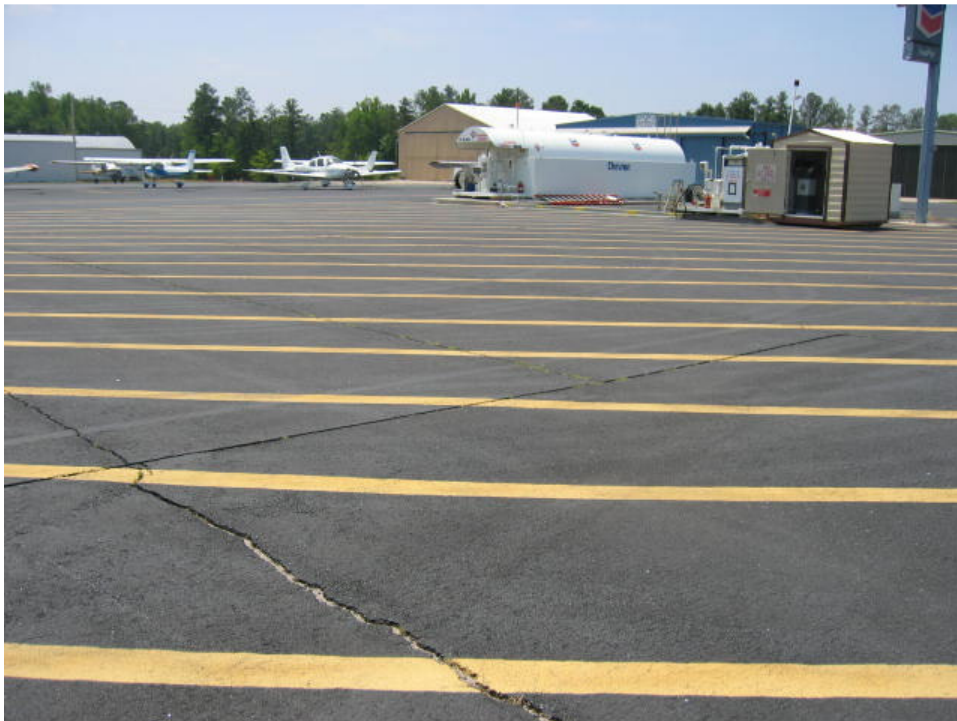
Section A02GF-20 is in fair condition with a PCI value of 61. Large quantities of low and medium severity L&T cracking, all in an unsealed condition were noted in this section. A fair amount of high-severity L&T cracking was also observed. Additionally, a number of low-severity patches were recorded.

A02GF-20. Overview.

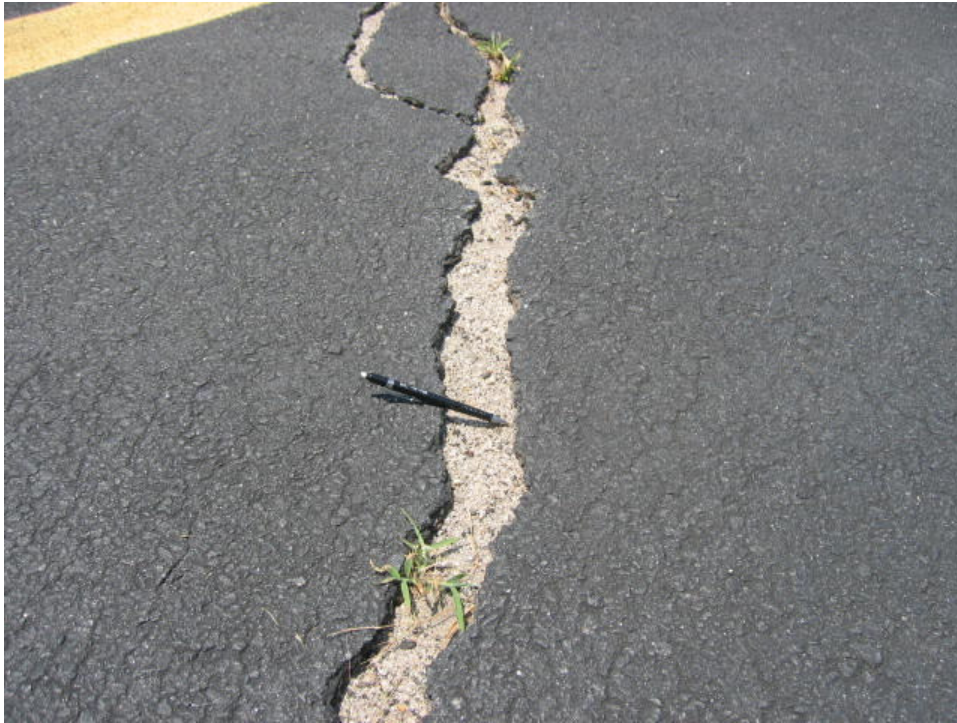
A02GF-20. L&T cracking.

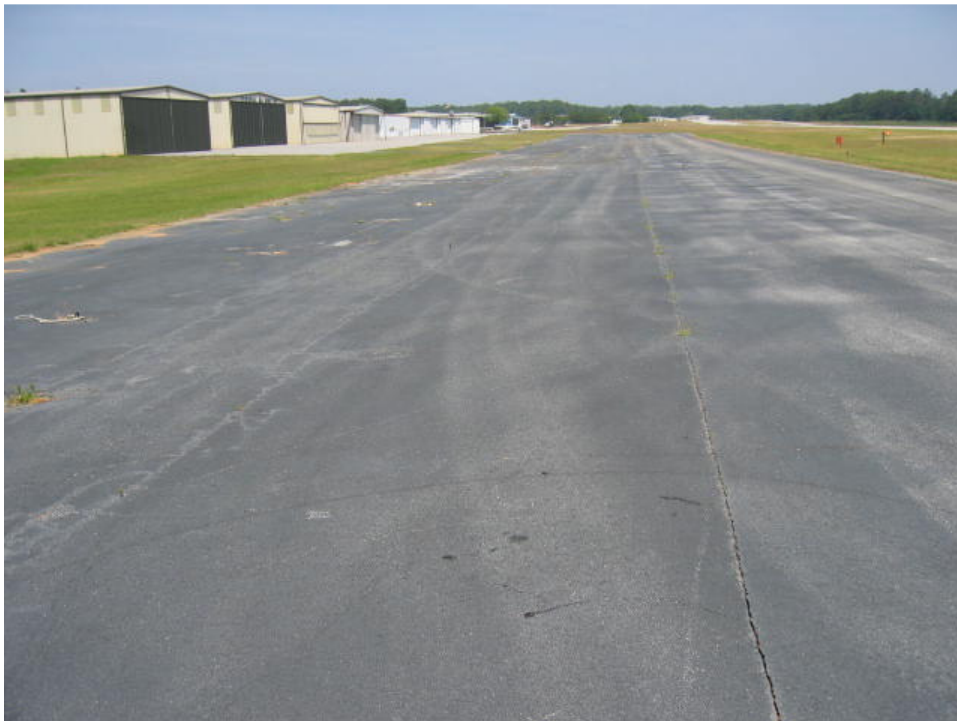
Section A02GF-30 is in poor condition with a PCI value of 32. Quantities of low, medium, and high-severity alligator cracking were observed in this section. Additionally, a significant quantity of medium-severity L&T cracking was recorded. Other distress types observed in this section included low-severity patching, medium-severity rutting, and both low and medium-severity raveling and weathering. A sizable amount of oil spillage was also recorded.

A02GF-30. Overview.

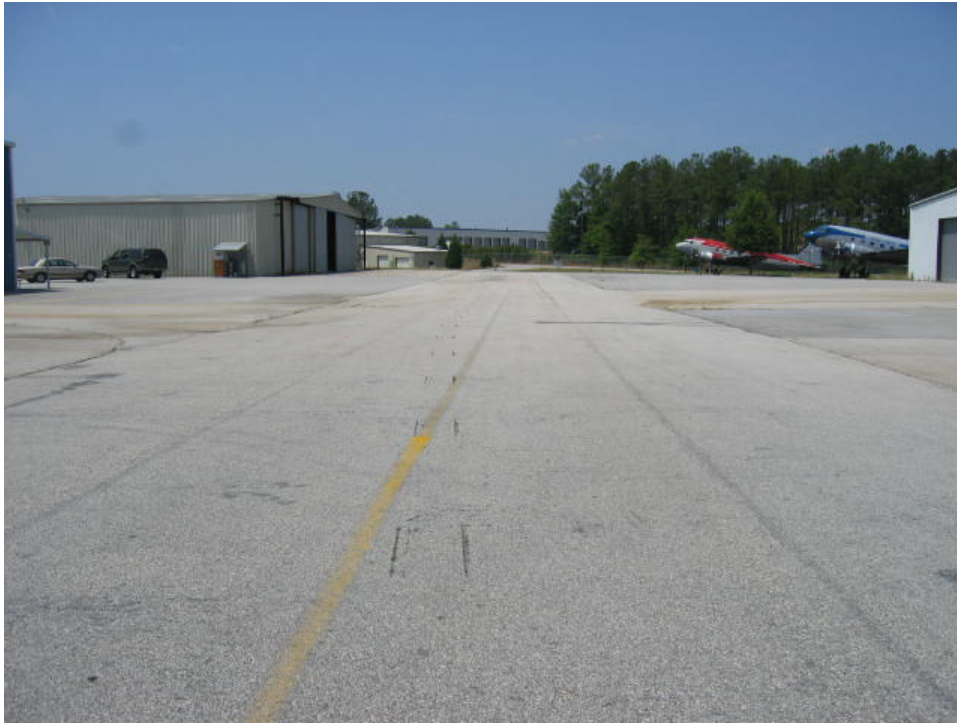
Section A02GF-40 consists of three non-contiguous pavement areas which lie on either side of section A02GV-10. This section was recently constructed and is in excellent condition with a PCI value of 100. No distresses were observed in this section.

A02GF-40. Overview.

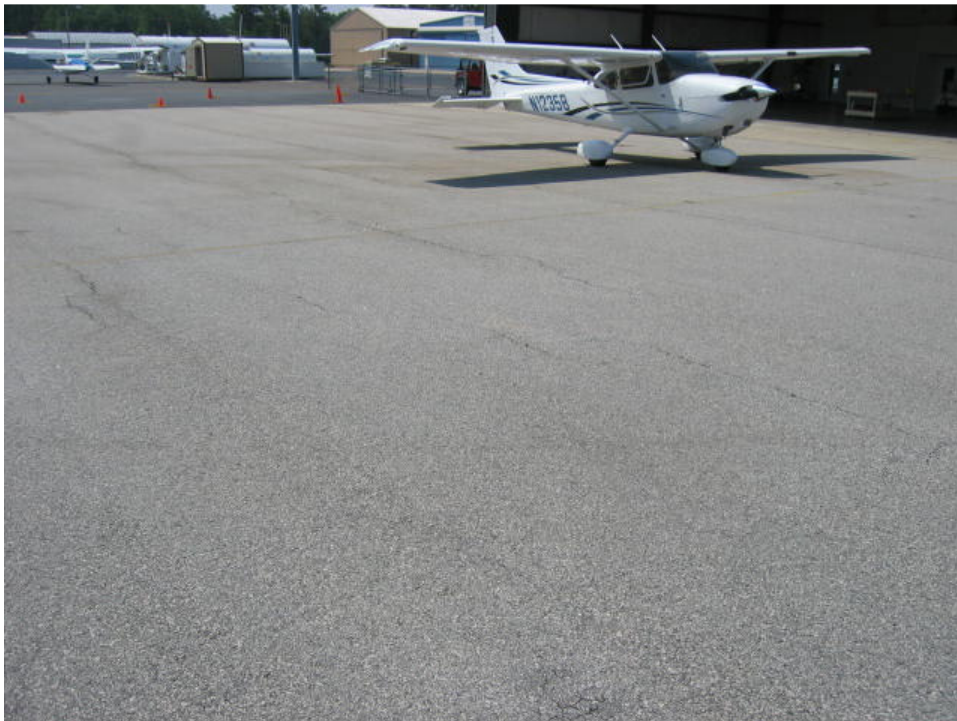
Section A02GF-60 is in good condition with a PCI value of 87. Small quantities of low and medium-severity L&T cracking, all in an unsealed condition, and a small amount of low-severity raveling and weathering were observed in this section.

A02GF-60. Overview.

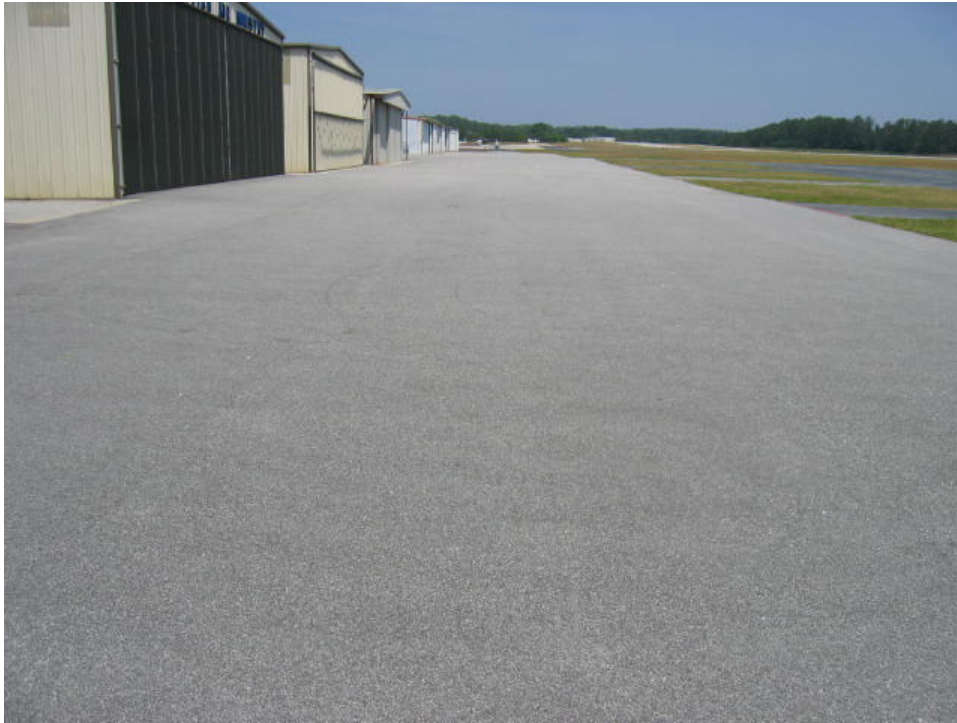
Section A02GF-70 is in excellent condition with a PCI value of 100. A small area of low-severity depression was the only distress recorded in this section.

A02GF-70. Overview.

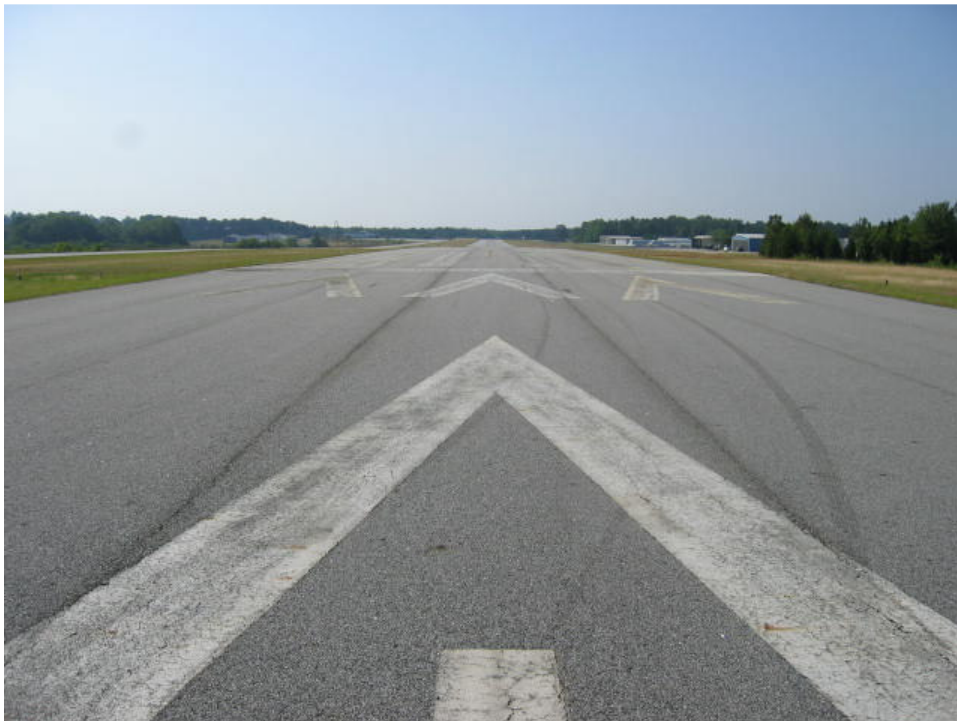
Runway 14-32 at Griffin-Spaulding County Airport consists of a single pavement section. Section R1432GF-10 is in fair condition with a PCI value of 78. A significant amount of low and medium-severity longitudinal and transverse (L&T) cracking as well as low-severity raveling and weathering was observed in this section. A significant quantity of low-severity patching was also noted. All cracking on Runway 14-32 was observed in an unsealed condition.

R1432GF-10. Overview.

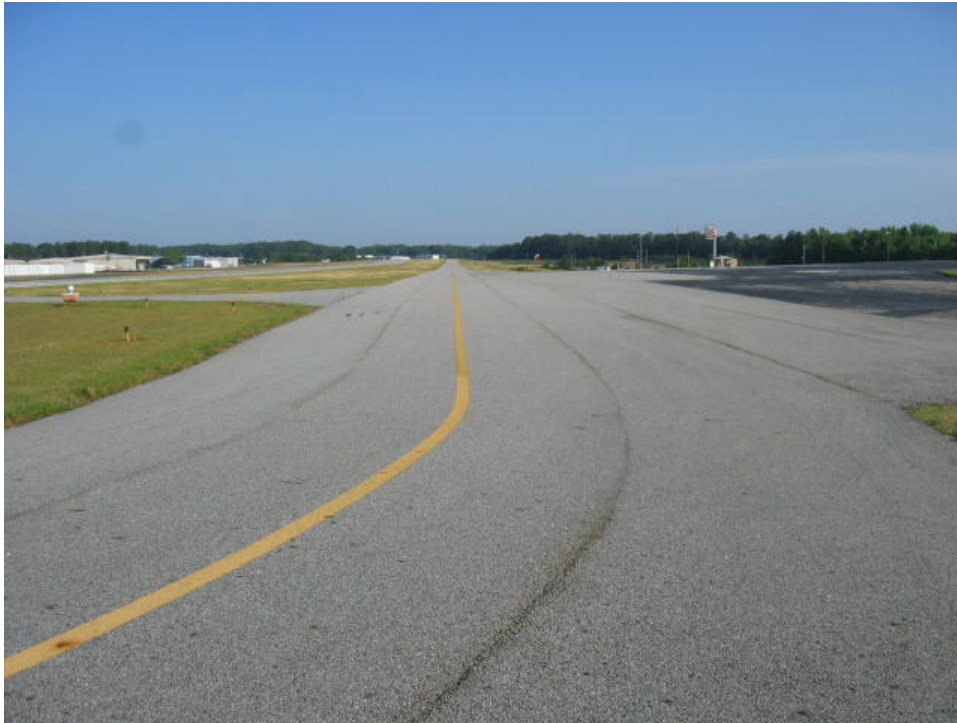
Taxiway A at Griffin-Spaulding County Airport consists of a single pavement section. Section TAGF-10 is in good condition with a PCI value of 83. Small amounts of low-severity L&T cracking as well as small amounts of low-severity raveling and weathering were observed in this section. Additionally, isolated, small amounts of the above distresses at a medium-severity level were also recorded.

TAGF-10. Overview.

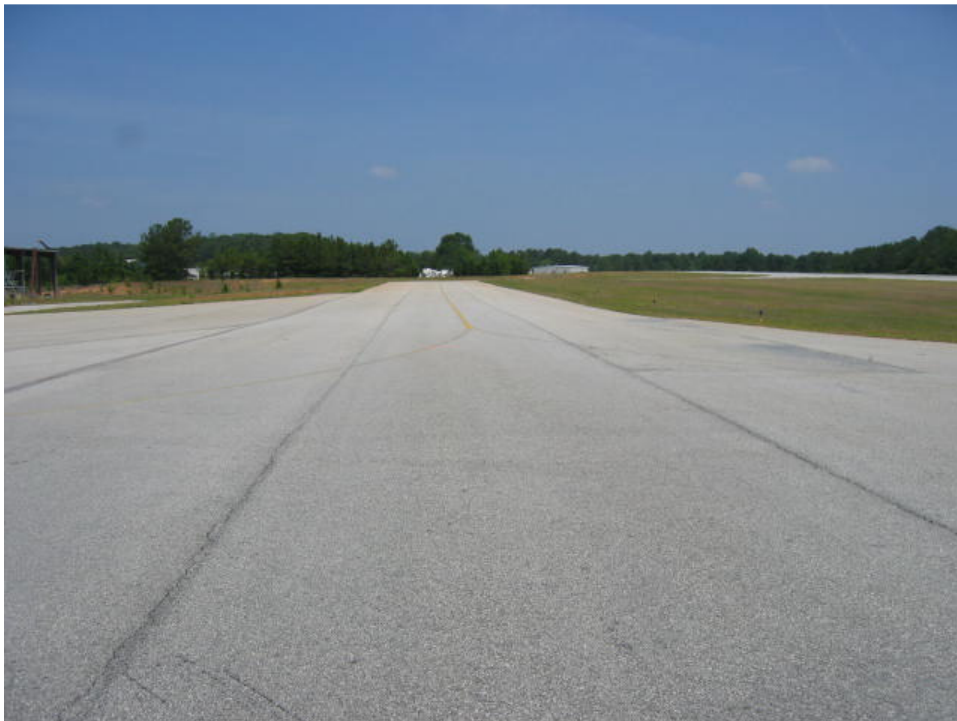
Taxiway B is composed of four pavement sections. Section TBGF-10 is in good condition with a PCI value of 81. Distresses observed in this section include low and medium-severity L&T cracking.

TBGF-10. Overview.

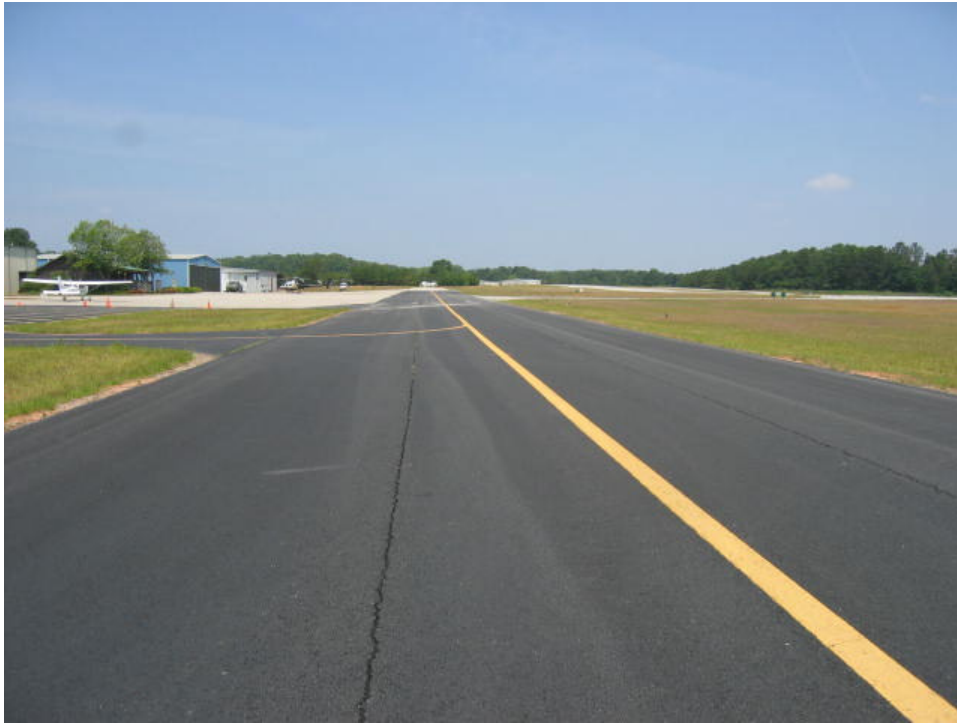
Section TBGF-20 is in fair condition with a PCI value of 63. Low and medium-severity L&T cracking as well as areas of low-severity patching were observed in this section.

TBGF-20. Overview.

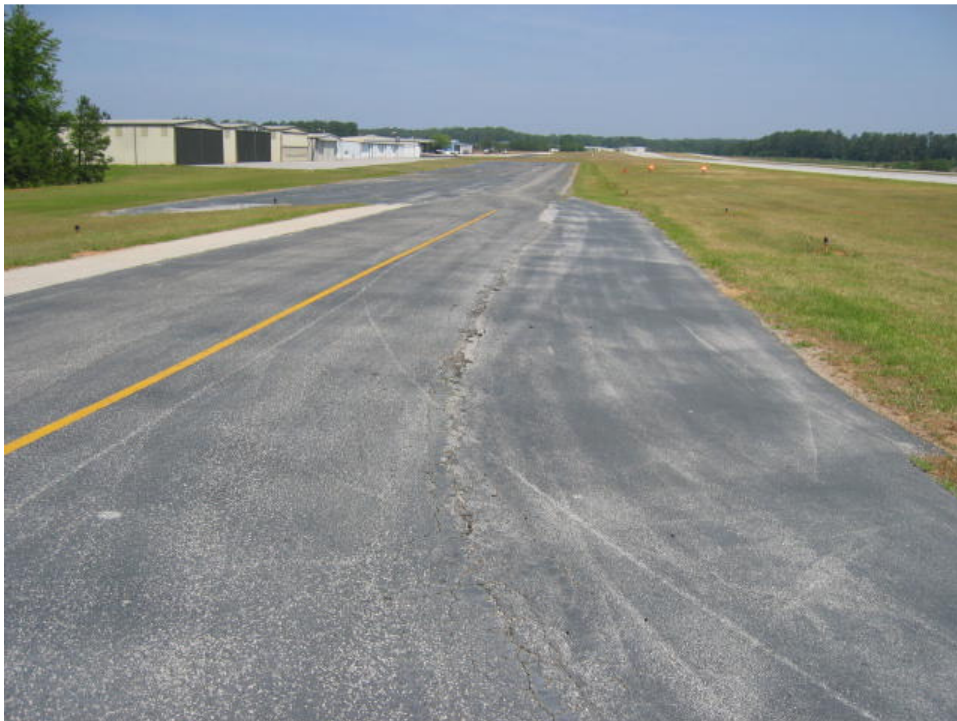
Section TBGF-30 is in serious condition with a PCI value of 29. Quantities of low, medium, and high-severity alligator cracking as well as low-severity patching and block cracking were observed. Medium-severity L&T cracking, rutting, and raveling and weathering were also noted in this section.

TBGF-30. Overview.

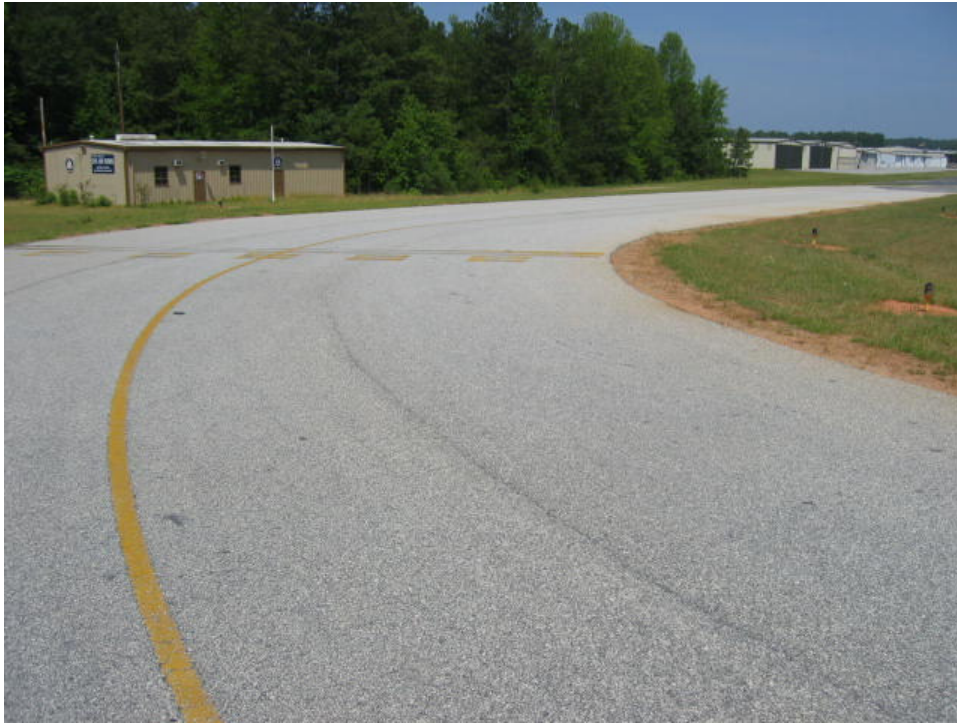
Section TBGF-40 is in good condition with a PCI value of 88. Distresses observed in this section include low-severity L&T cracking and raveling and weathering.

TBGF-40. Overview.

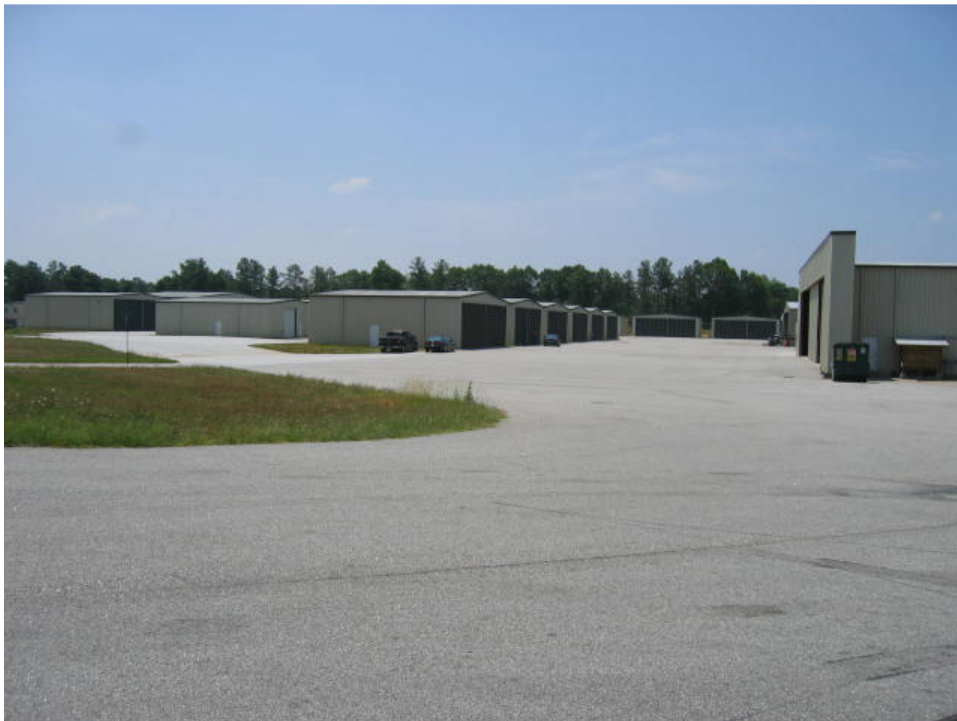
The new t-hangar area at Griffin-Spaulding County Airport is composed of a single pavement section. Section TH01GF-10 was recently constructed and is in excellent condition with a PCI value of 100. No distresses were observed in this section.

TH01GF-10. Overview.
