**Report:**

# Butler Municipal Airport Pavement Management Plan

PRESERVING  
GEORGIA'S  
CRITICAL  
PAVEMENT  
INFRASTRUCTURE

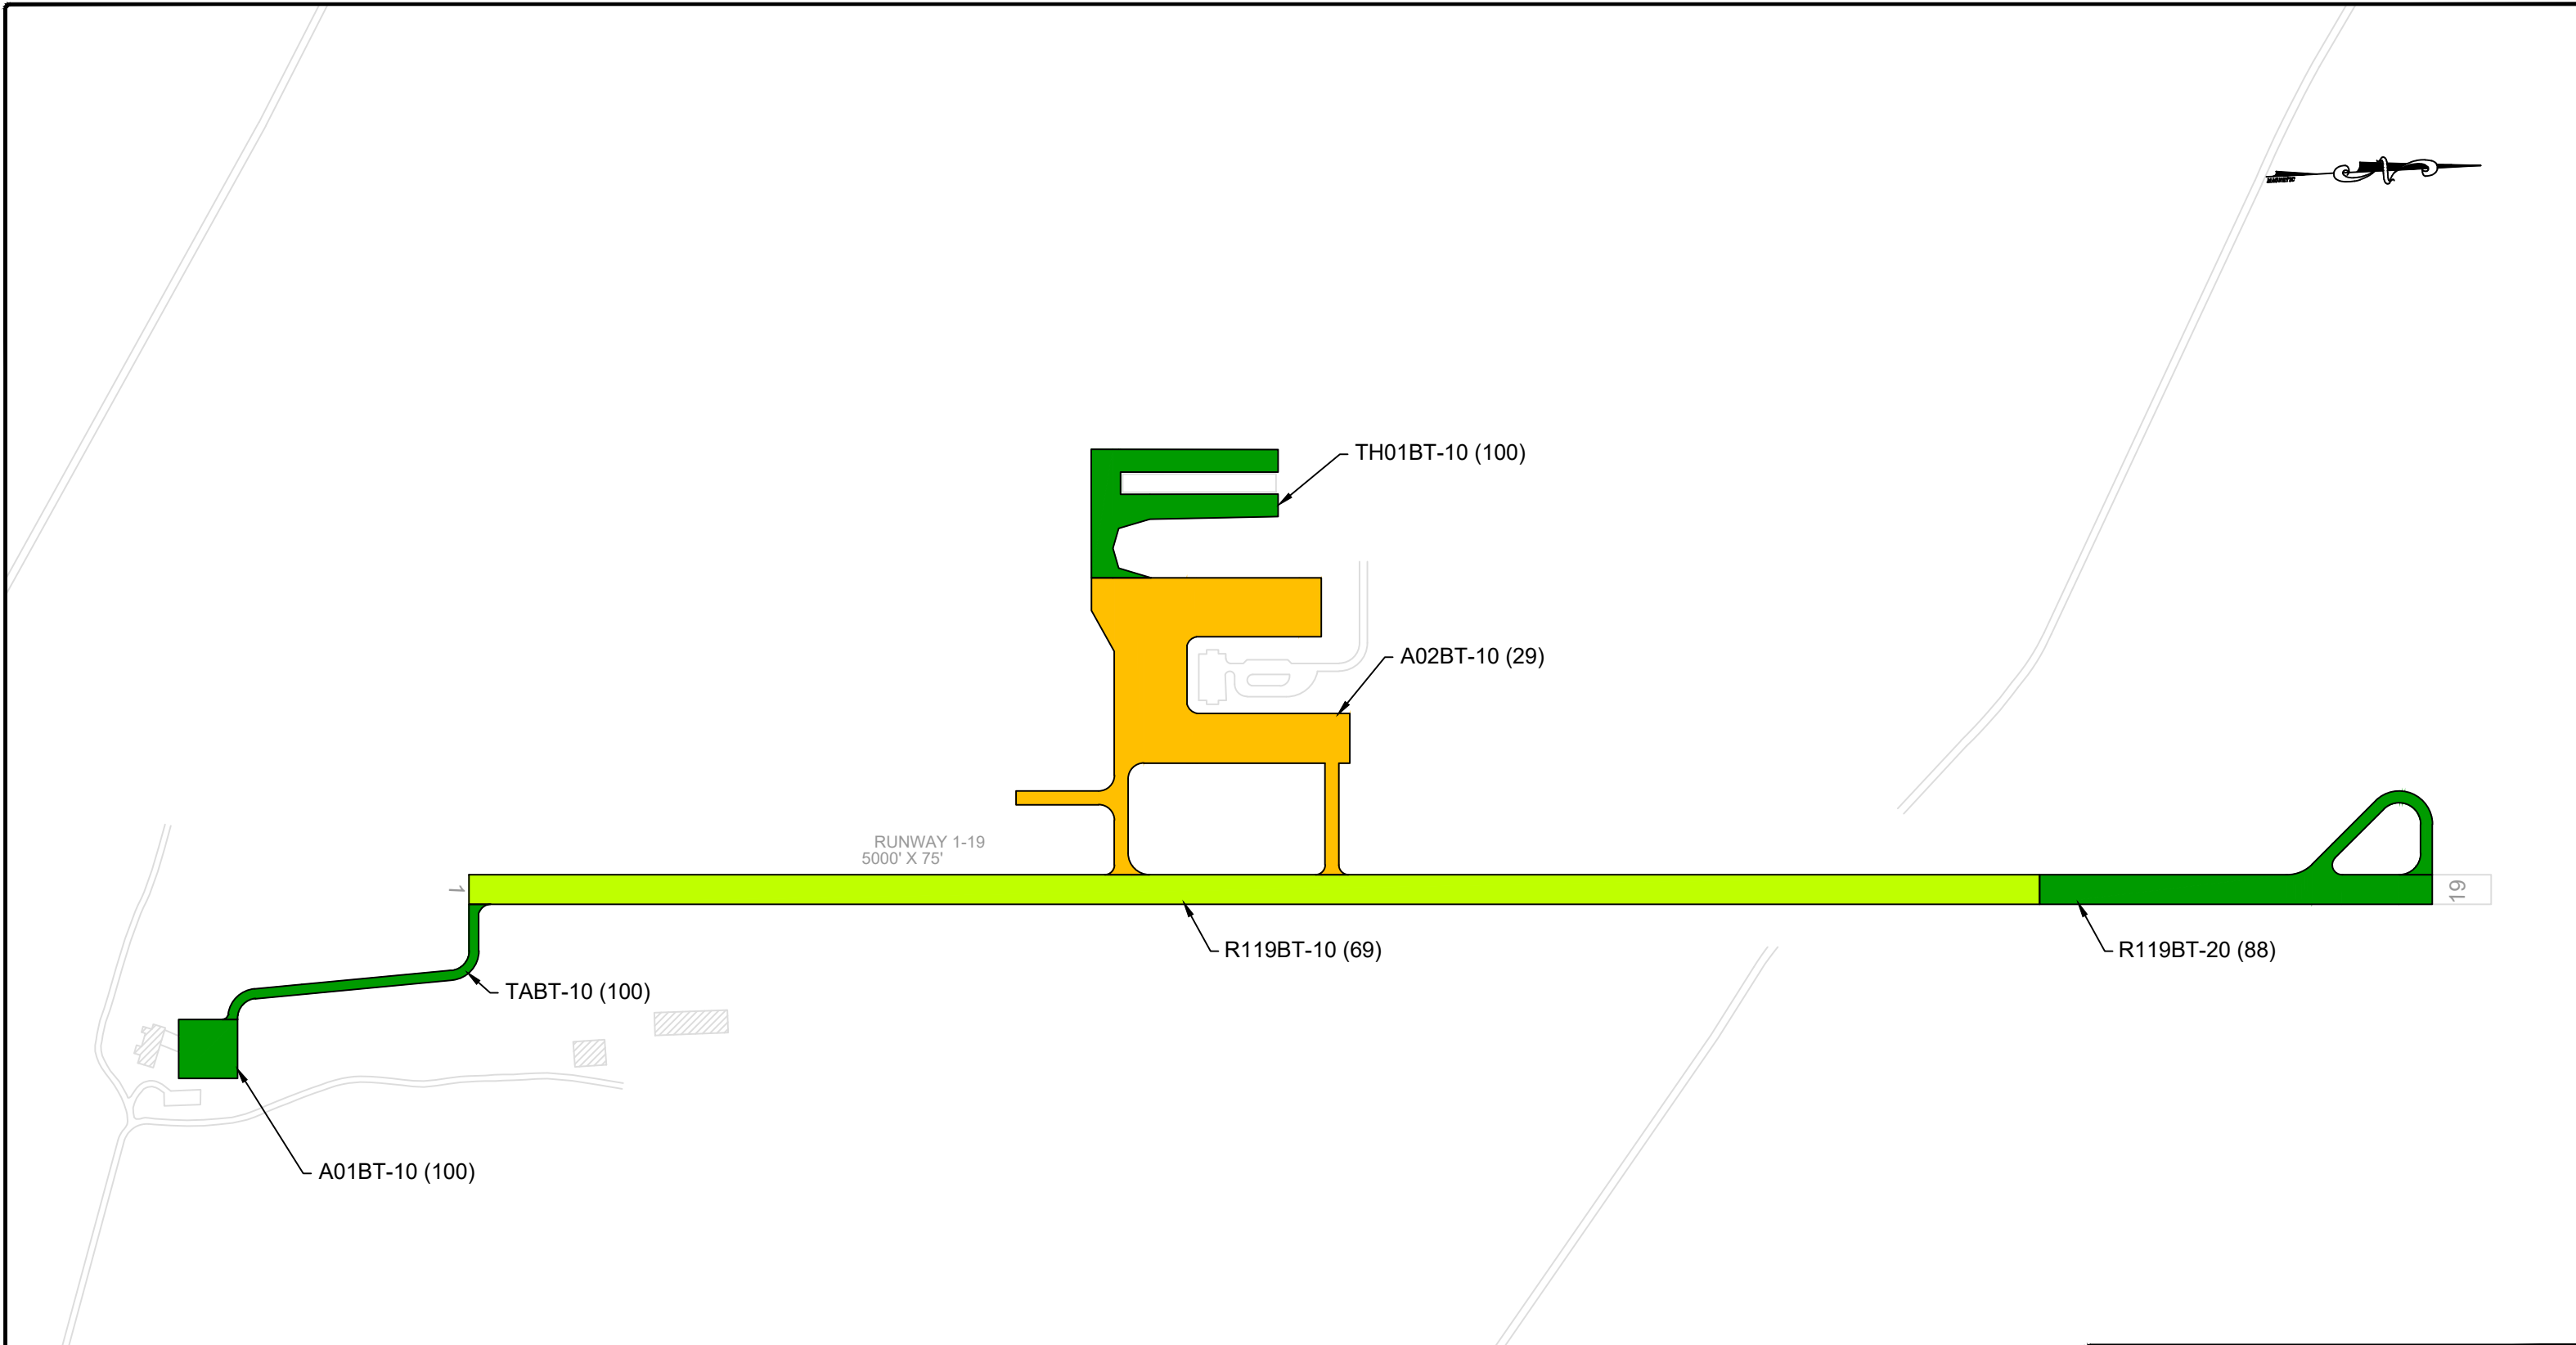
The 2018 area-weighted condition of Butler Municipal Airport is 64, with conditions ranging from 29 to 100 [on a scale of 0 (failed) to 100 (excellent)]. This compares to a 2012 PCI of 84.

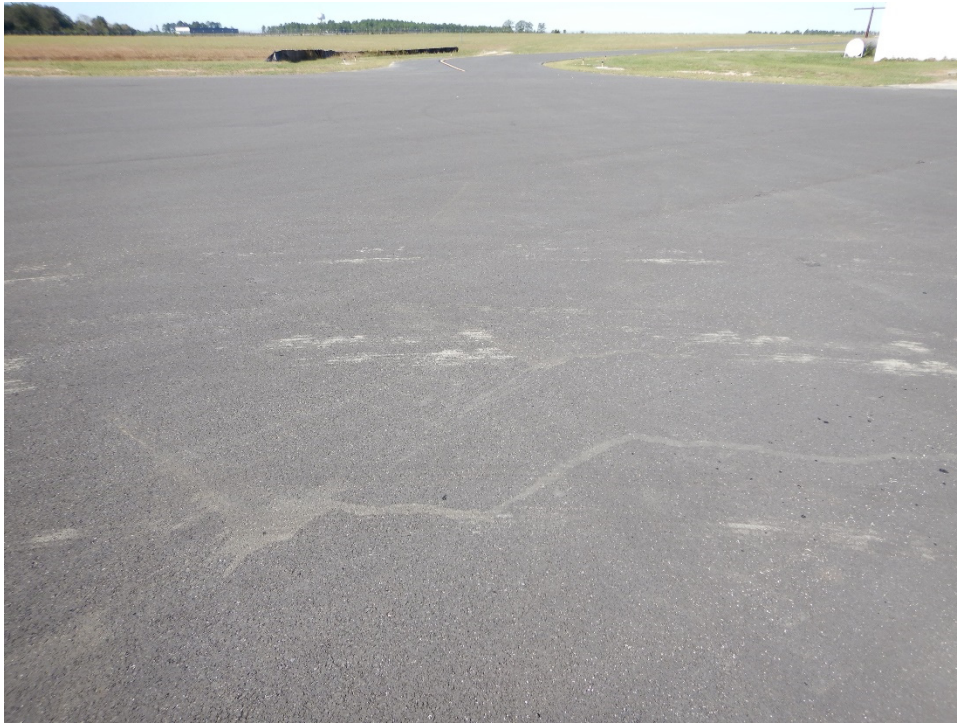
A01BT-10. Overview.

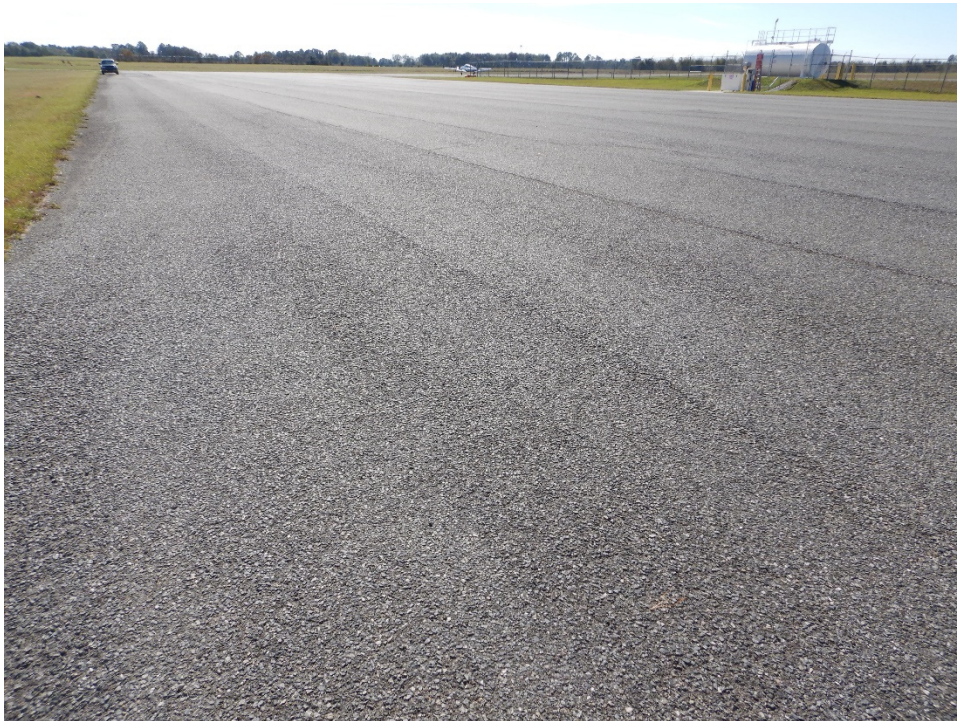
A02BT-10. Overview.

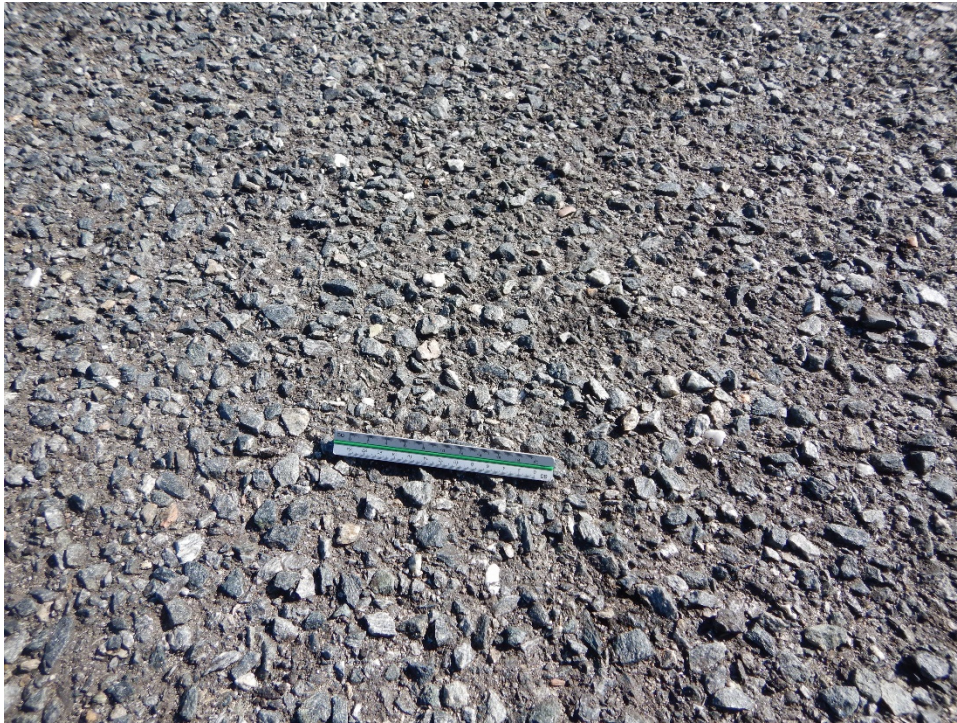
A02BT-10. Raveling (Sample Unit No. 41).

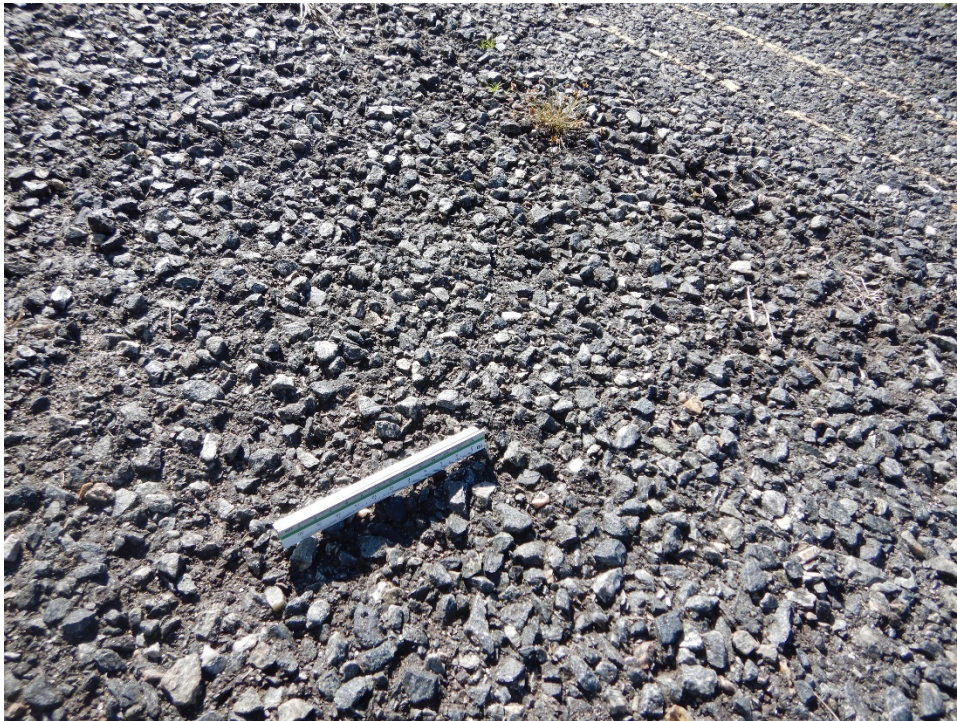
A02BT-10. Raveling (Sample Unit No. 46) (1).

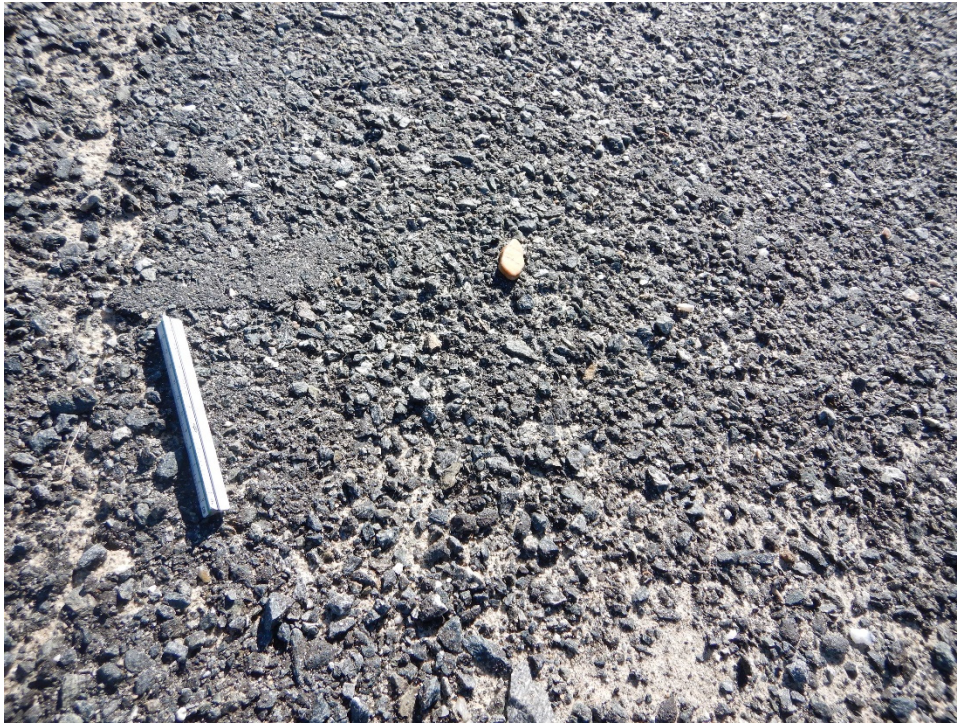
A02BT-10. Raveling (Sample Unit No. 46) (2).

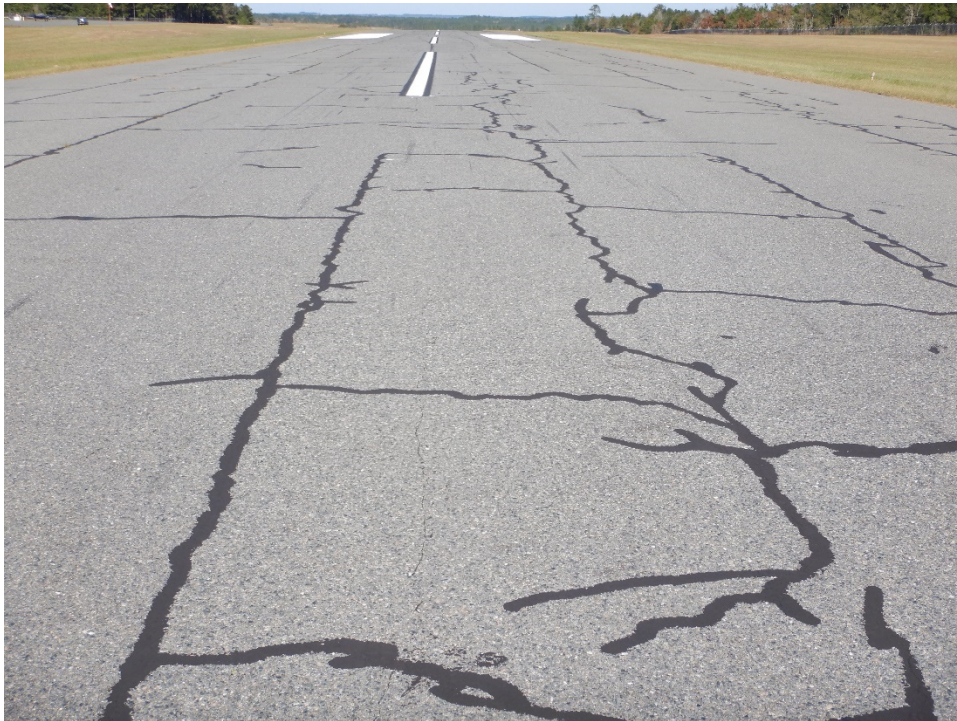
R119BT-10. Overview.

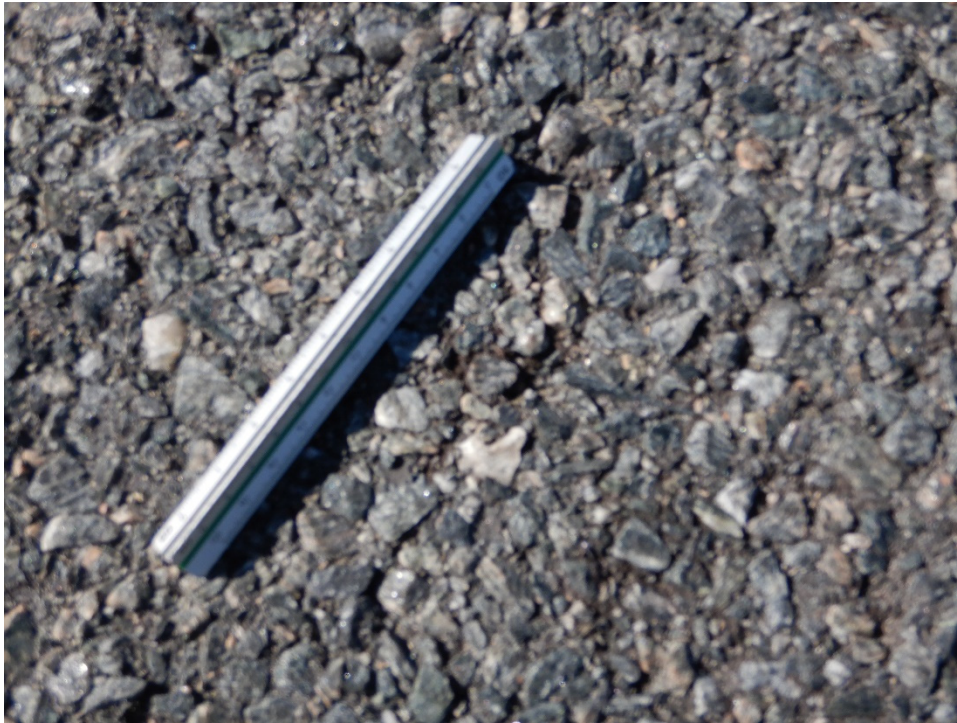
R119BT-10. Weathering (Sample Unit No. 08).

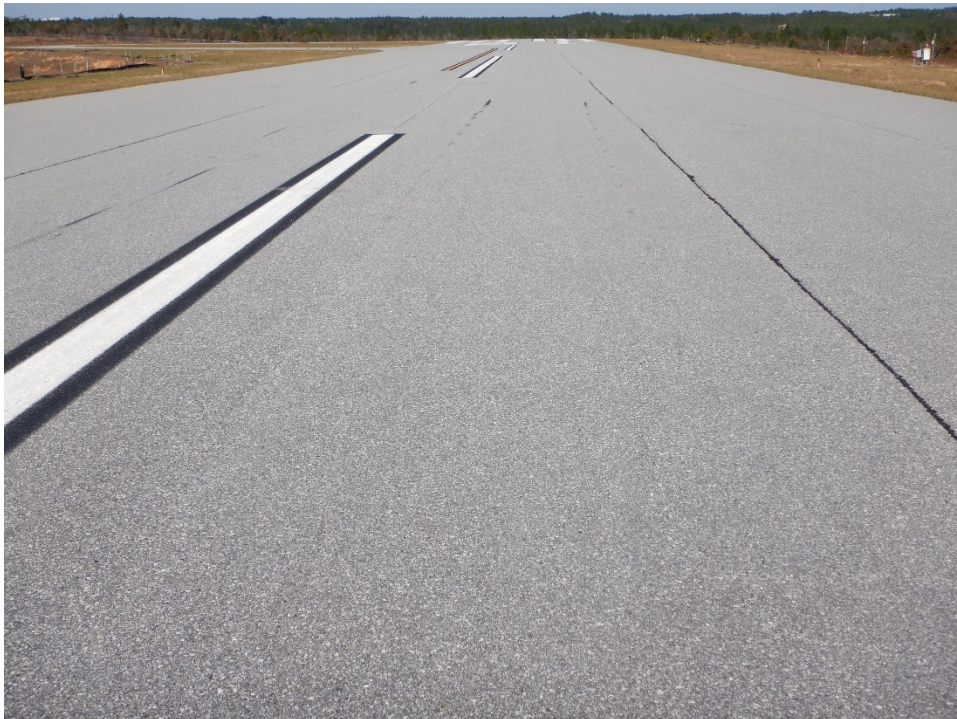
R119BT-20. Overview.

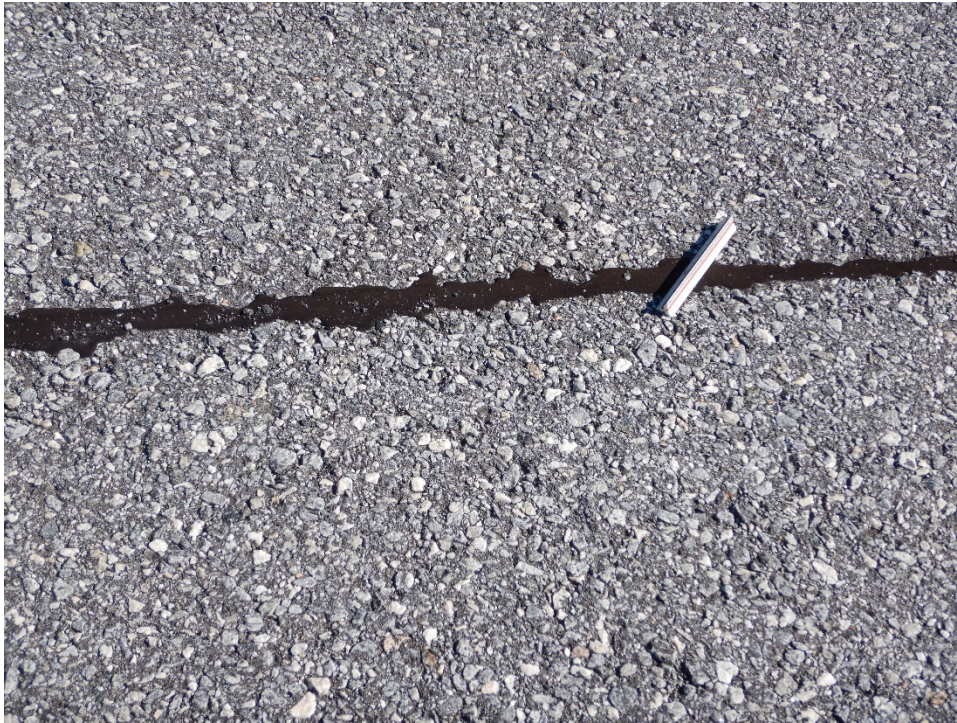
R119BT-20. L&T Cracking (Sample Unit No. 04).

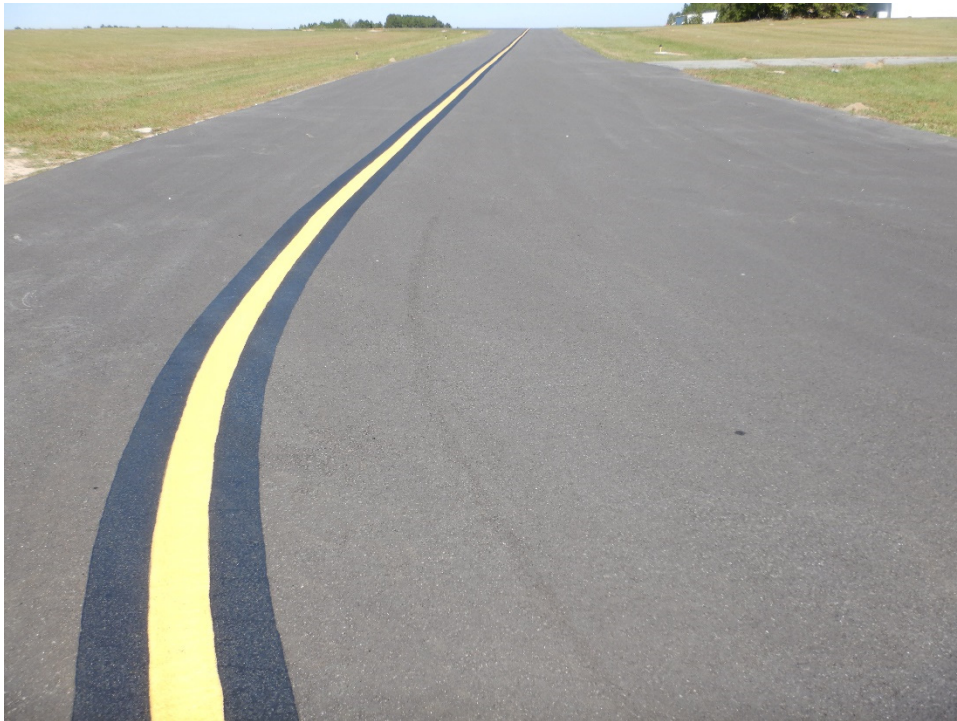
TABT-10. Overview.

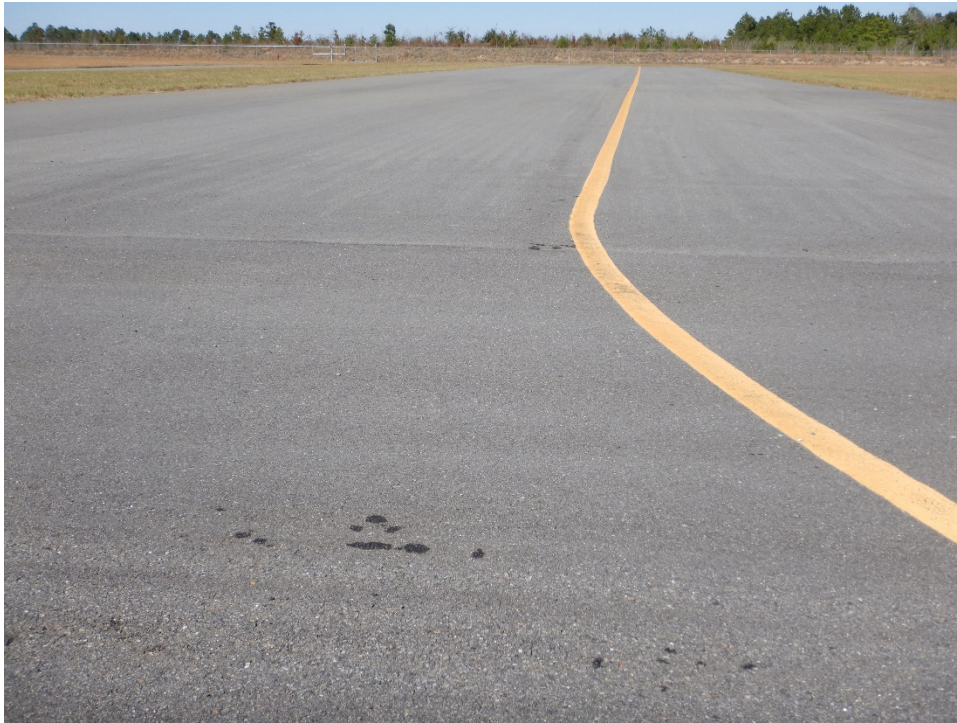
TH01BT-10. Overview.
