WILLIAM A. ZORN AIRPORT
PAVEMENT MANAGEMENT REPORT

2007 GEORGIA AIRPORT PAVEMENT MANAGEMENT REPORT

WILLIAM A. ZORN AIRPORT

PAVEMENT MANAGEMENT REPORT

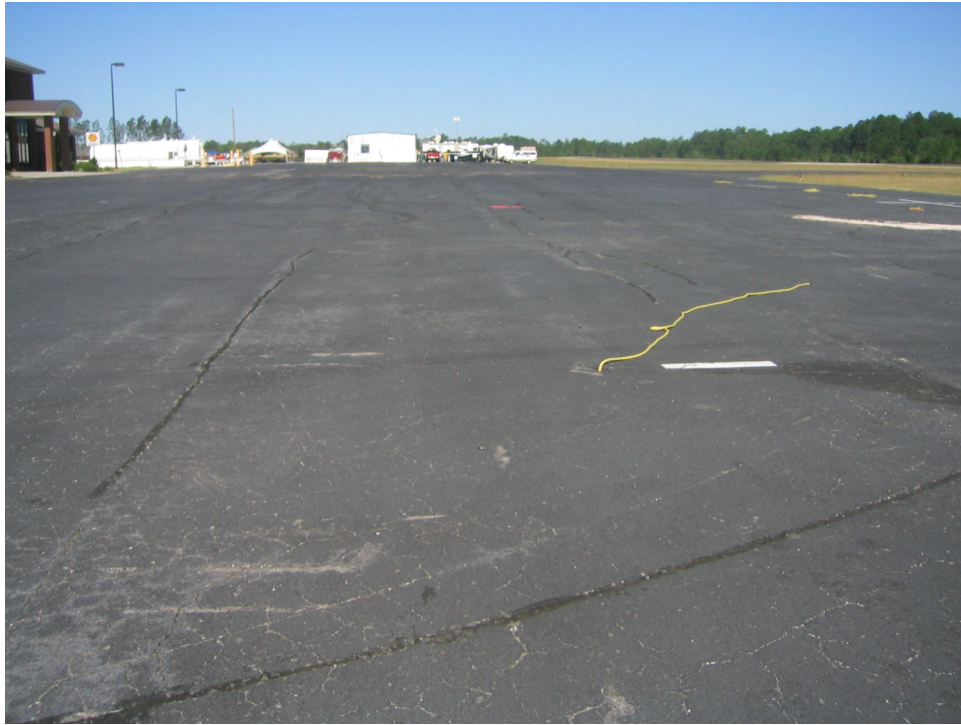
One section is defined in the apron area. A01JS-10 is in fair condition with a PCI value of 61. Aside from a considerable amount of low-severity patching, all of the distress observed in this section was low and medium-severity block and longitudinal and transverse (L&T) cracking. The majority of this cracking was unsealed.

A01JS-10. Overview.

Branch¹	Section	Year	Type of Repair²	Estimated Cost³
THANGJS	10	2008	Rejuvenator	\$4,475
A01JS	10	2009	Major M&R	\$117,805
THANGJS	10	2012	Preventive Maintenance	\$139

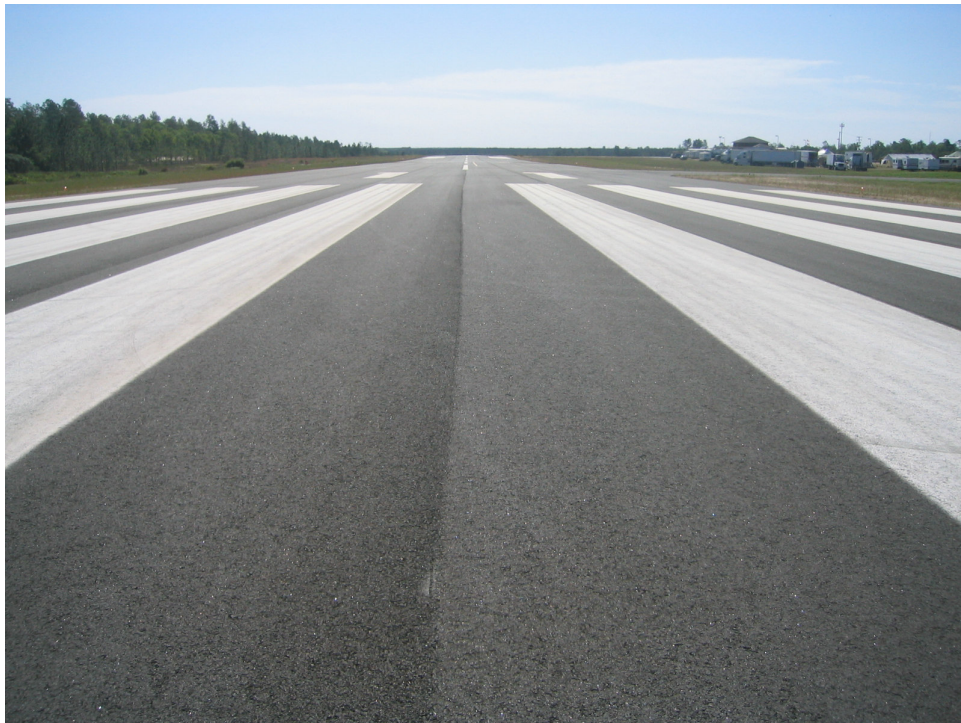
Runway 10-28 is defined by one section. R1028JS-10 was recently rehabilitated and is in excellent condition with a PCI value of 100.

R1028JS-10. Overview.

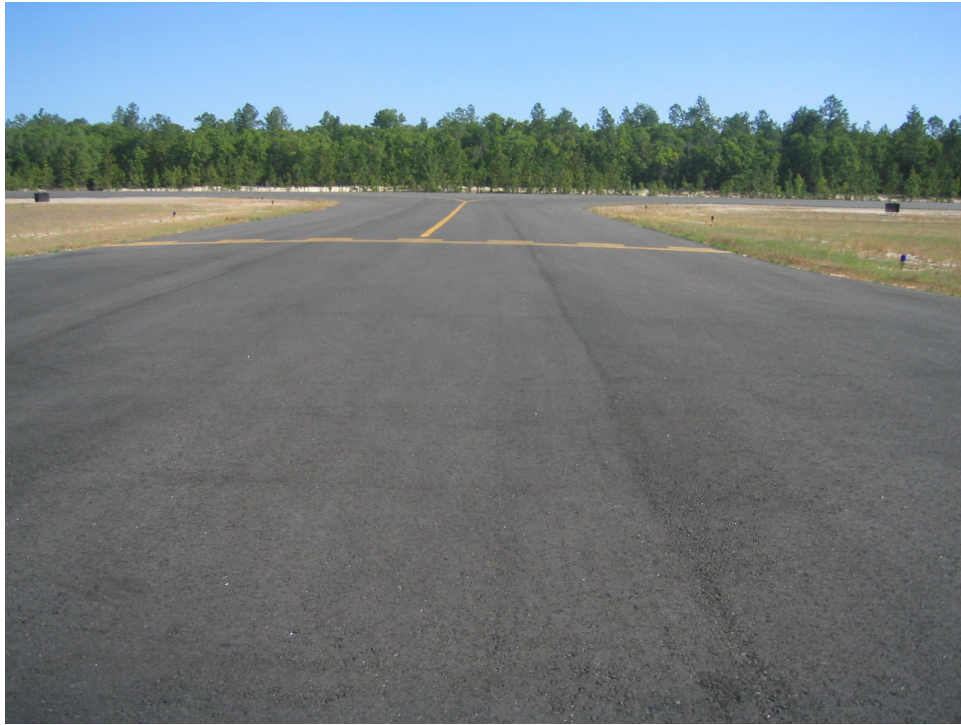
Taxiway A consists of one recently rehabilitated section, TAJJS-10, that is in excellent condition with a PCI value of 100.

TAJS-10. Overview.

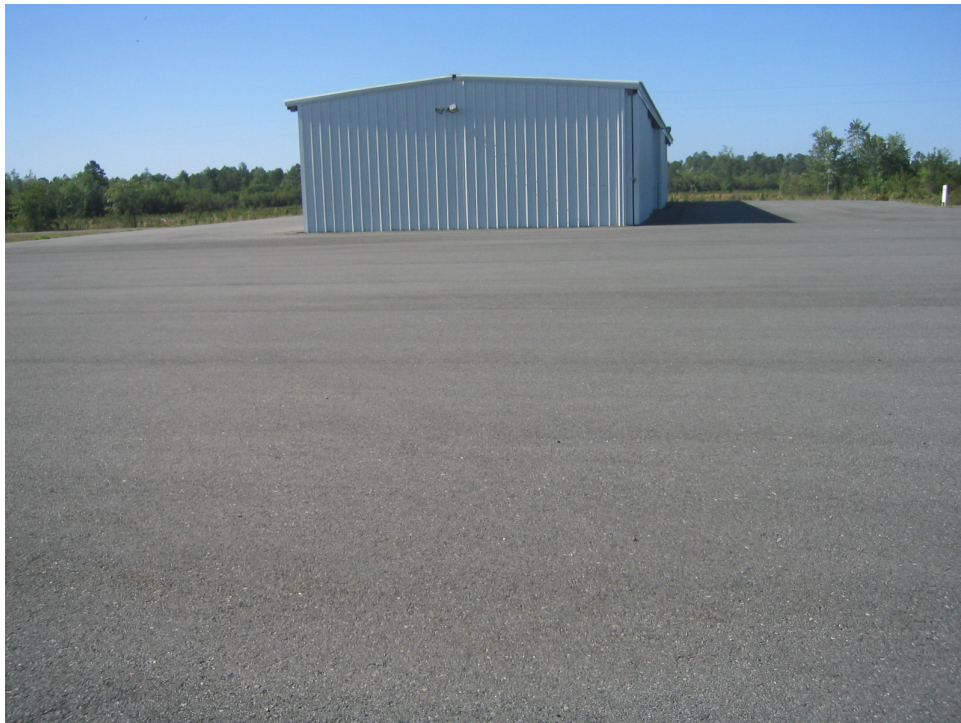
The T-Hangar is comprised of one section. THANGJS-10 was recently rehabilitated and is in excellent condition with a PCI value of 98. A small amount of low-severity L&T cracking was recorded.

THANGJS-10. Overview.
