Report:

Brantley County Airport Pavement Management Plan

PRESERVING
GEORGIA'S
CRITICAL
PAVEMENT
INFRASTRUCTURE

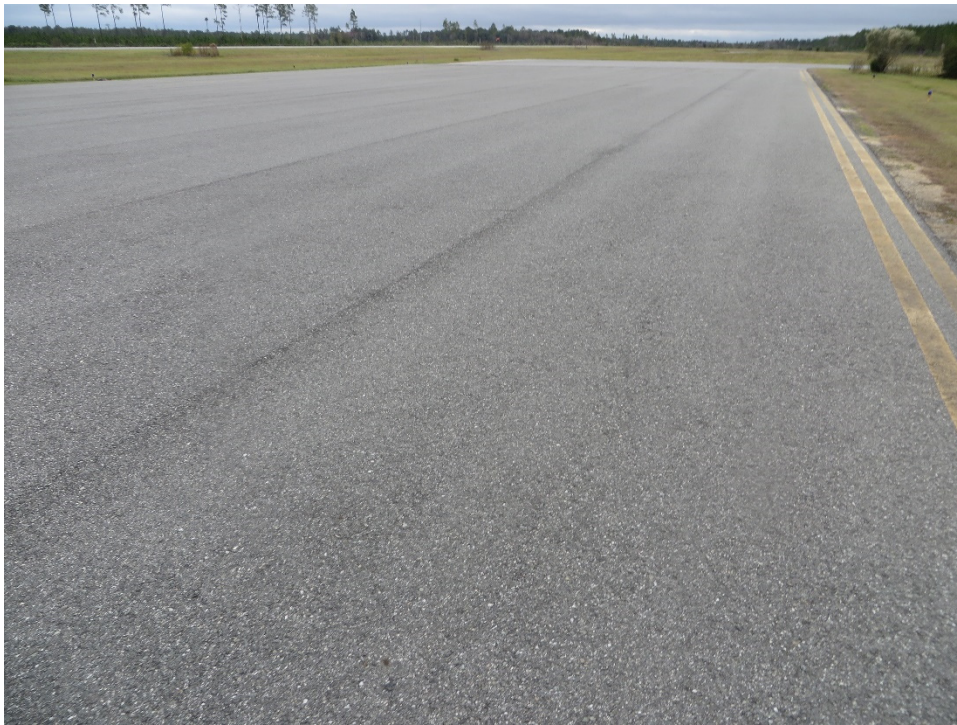
A01NH-10. Overview.

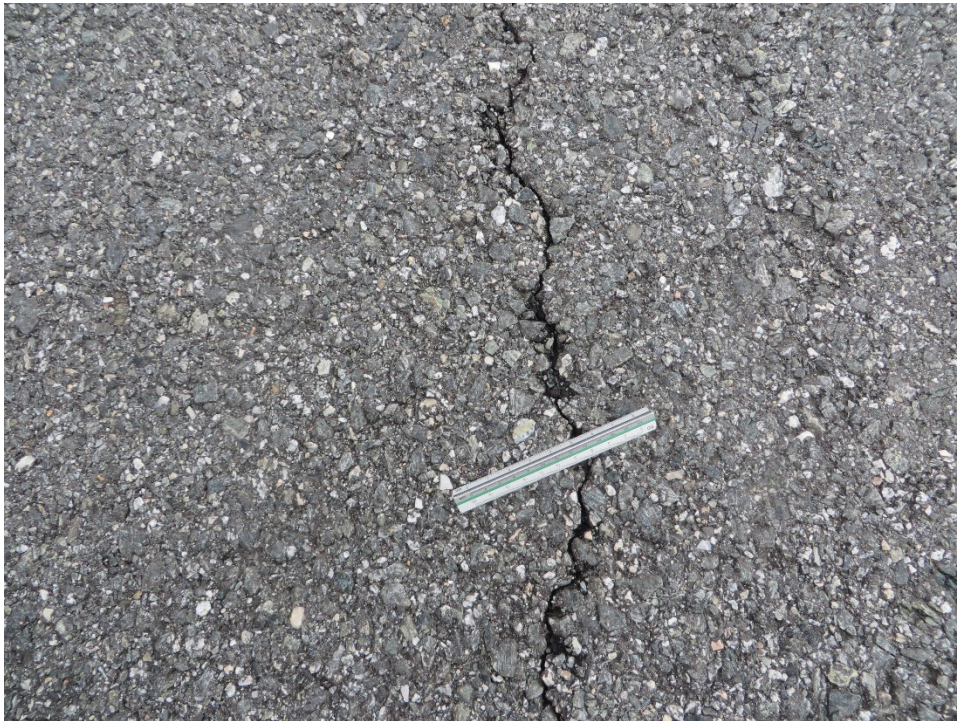
A01NH-10. L&T Cracking (Sample Unit No. 02).

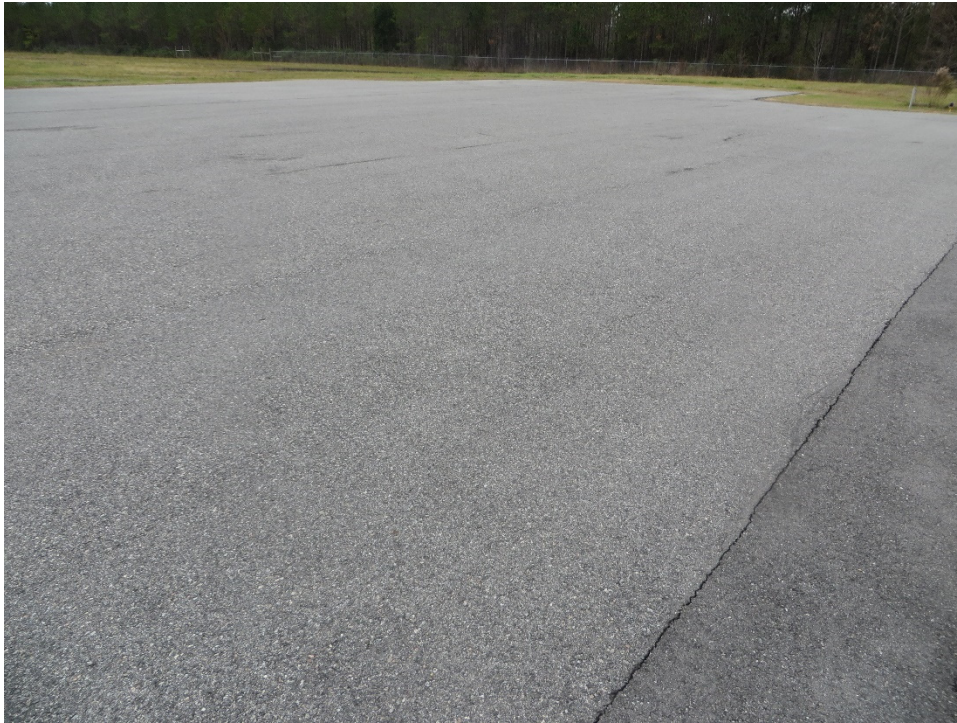
A01NH-20. Overview.

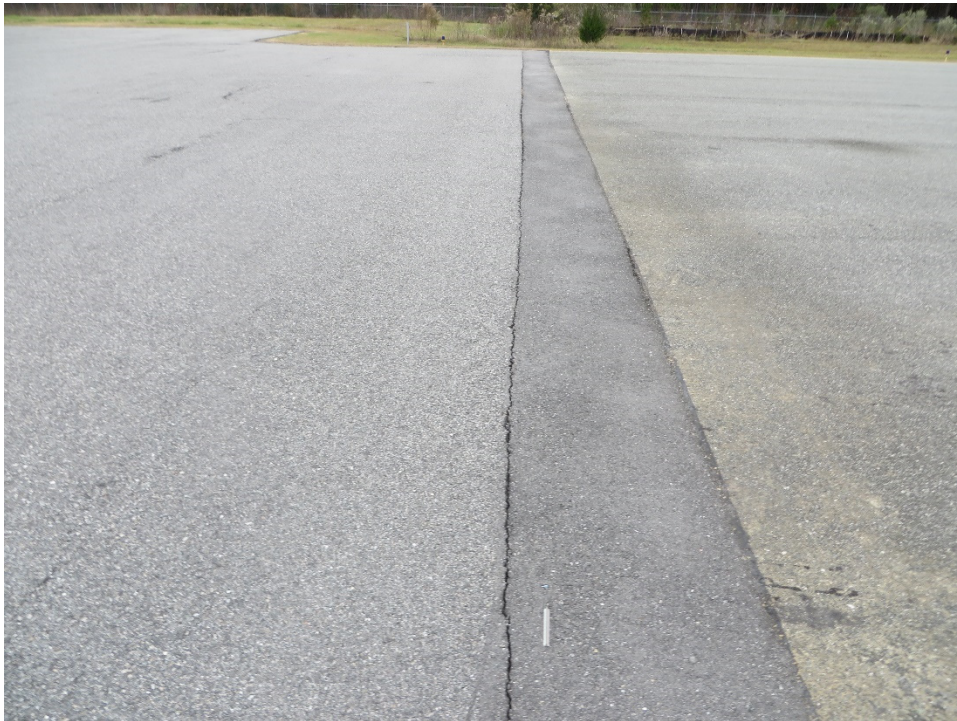
A01NH-20. Patching (Sample Unit No. 01).

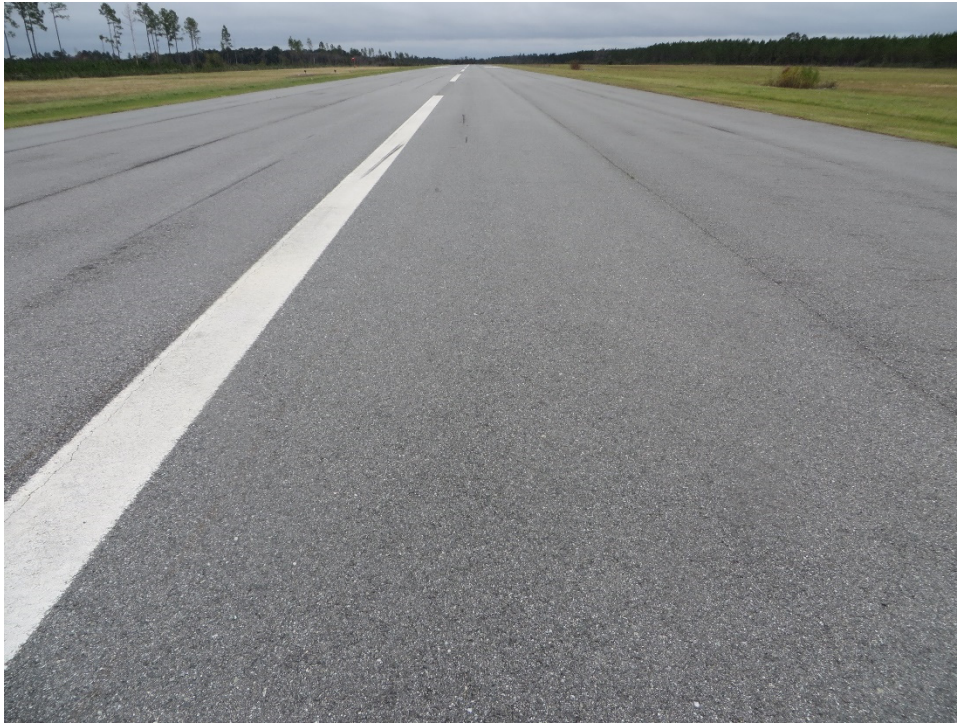
R119NH-10. Overview.

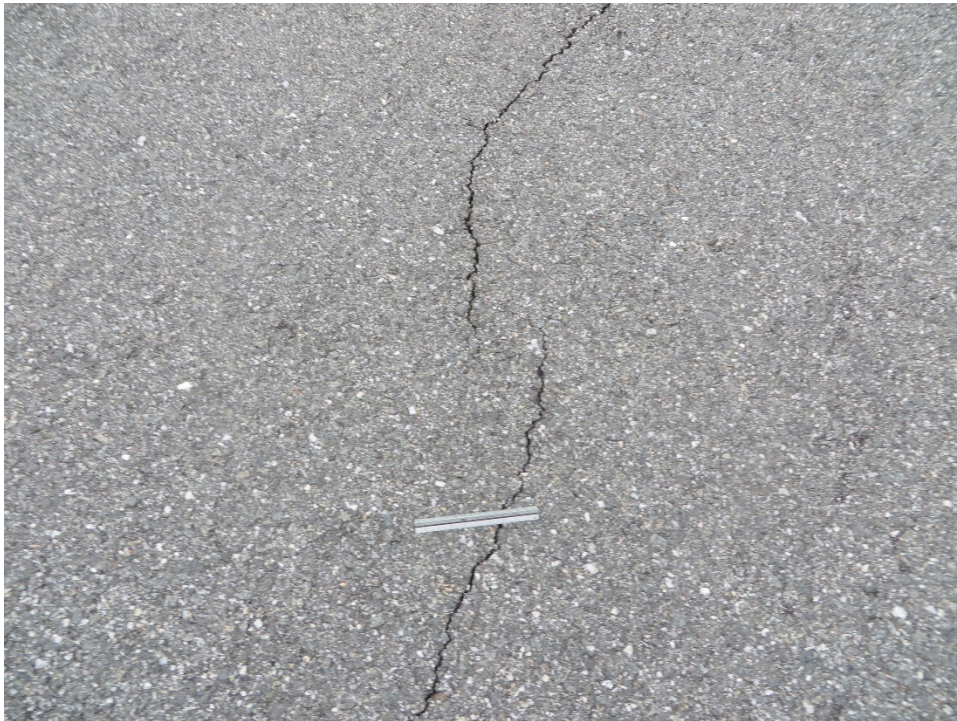
R119NH-10. L&T Cracking (Sample Unit No. 05).

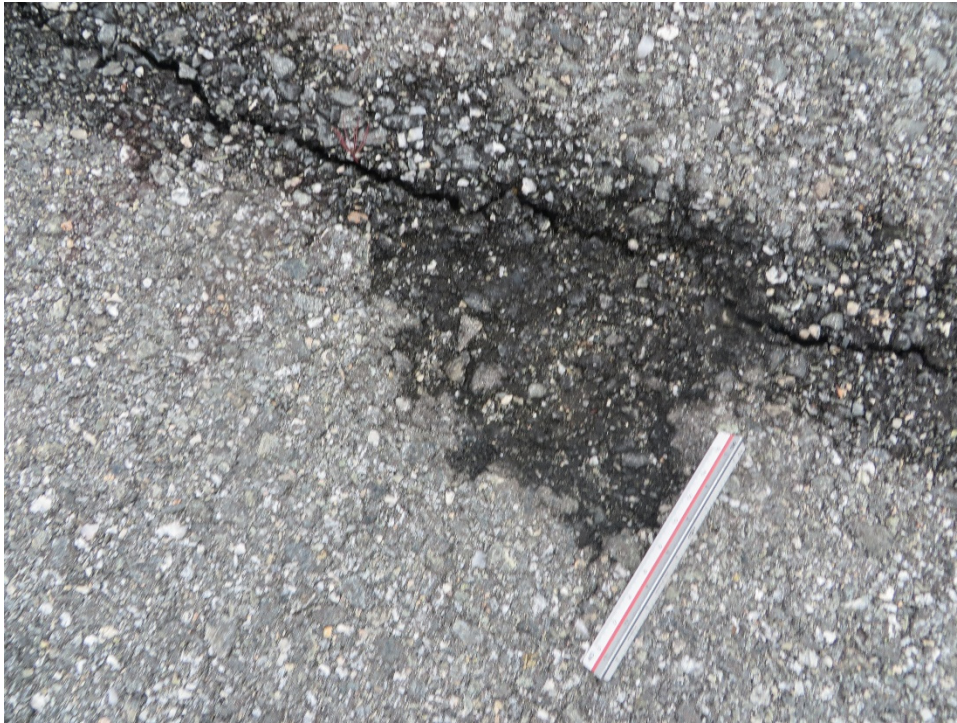
R119NH-10. Raveling (Sample Unit No. 19).

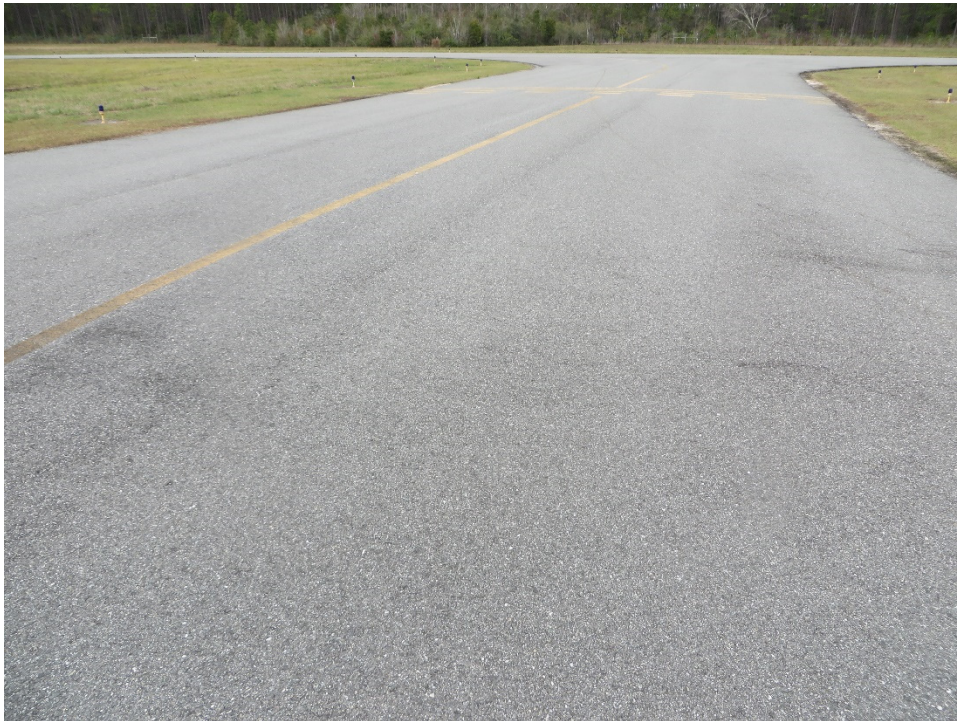
TANH-10. Overview.

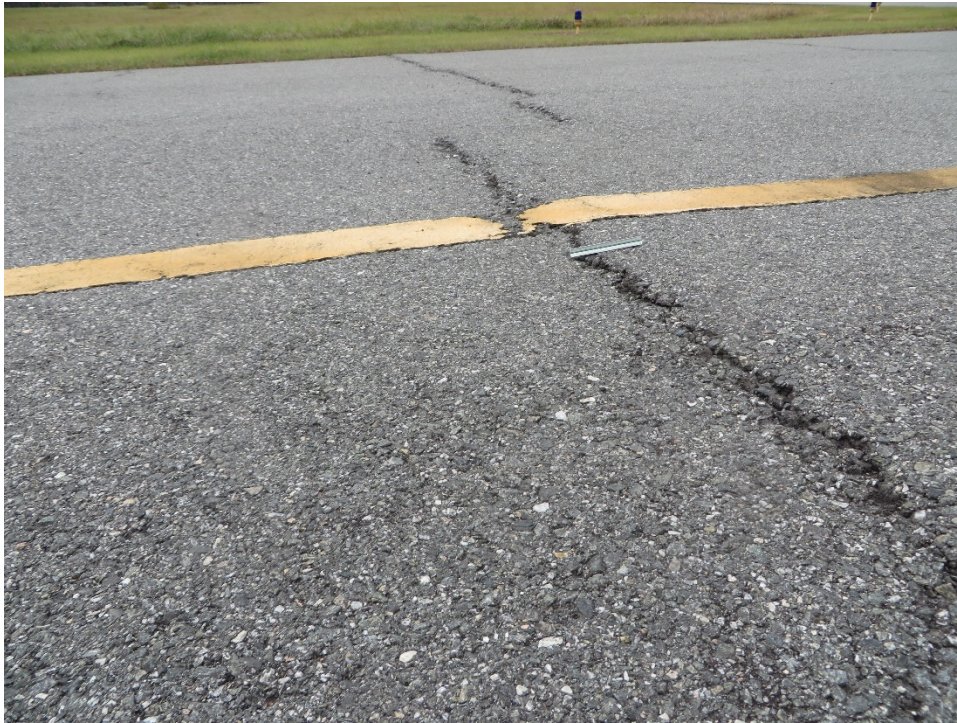
TANH-10. Swelling (Additional Sample Unit No. 01).

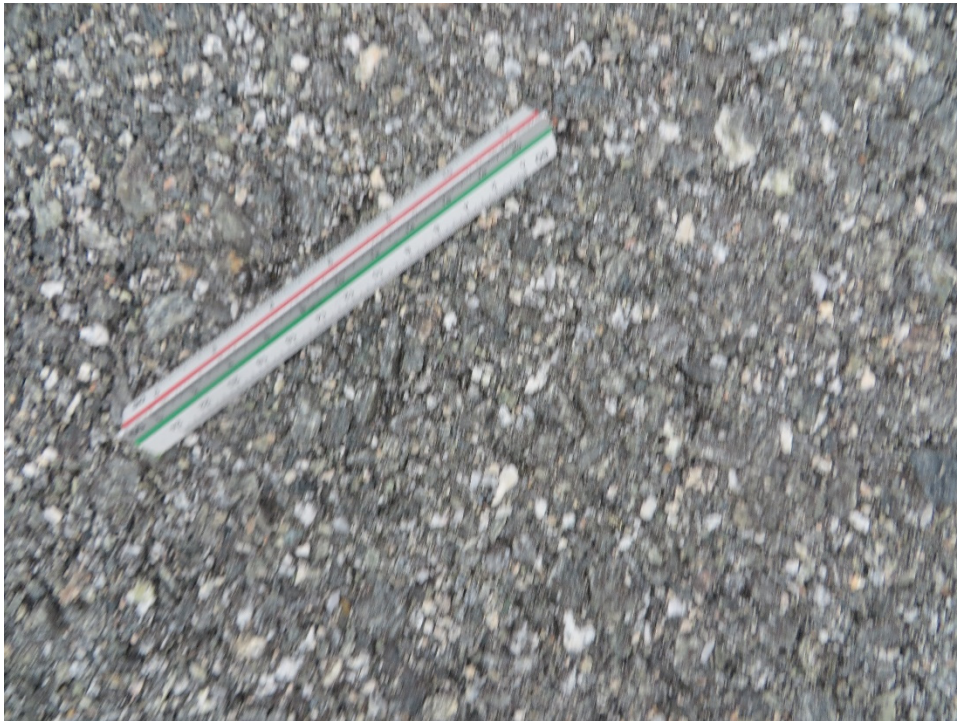
TANH-10. Weathering (Sample Unit No. 08).
