# COCHRAN MUNICIPAL AIRPORT

# PAVEMENT EVALUATION REPORT

JULY 2002

Applied Pavement Technology, Inc. 3001 Research Road, Suite C Champaign, Illinois 61822 217-398-3977 www.pavementsolutions.com

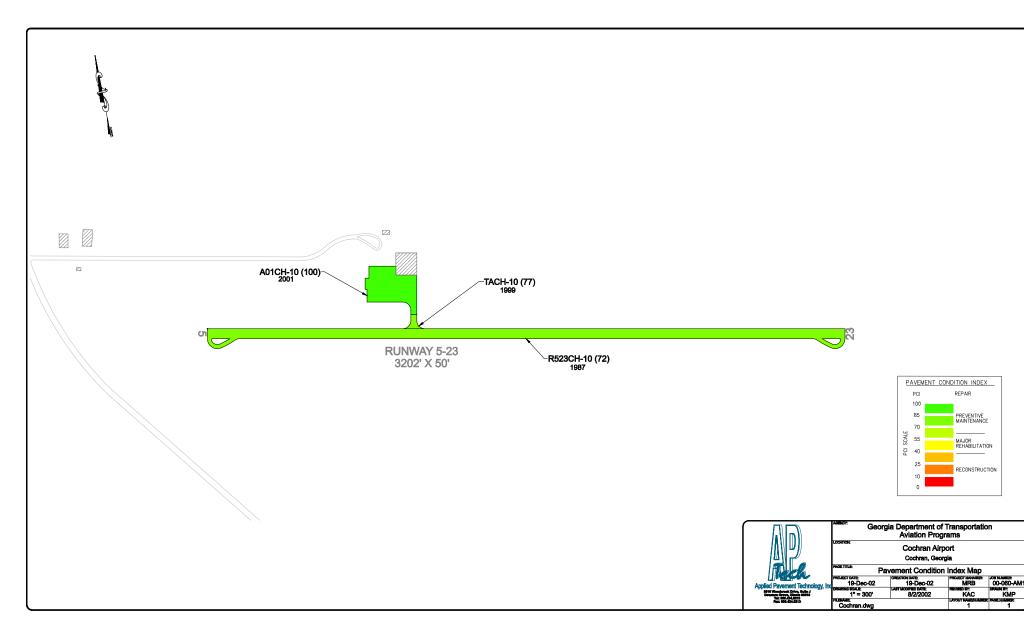
Figure 8. INSERT PCI MAP (11 x 17)

The 2001 area-weighted condition of Cochran Municipal Airport is 78, with conditions ranging from 72 to 100 [on a scale of 0 (failed) to 100 (excellent)]. Figures 6 and 7 provide graphs summarizing the overall condition of the pavements at Cochran Municipal Airport. Figure 8 is a map that displays the condition of the pavements evaluated. Table 1 summarizes the results of the pavement evaluation.

COCHRAN MUNICIPAL AIRPORT									
BRANCH	SECTION	SURFACE	SECTION		2001	% Distress due to:			
ID	ID	TYPE 1	AREA (sf)	LCD <sup>2</sup>	PCI	LOAD 3	CLIMATE OR DURABILITY 4	DISTRESS TYPES 5	
A01CH	10	AAC	42,468	2001	100	0	0	N/A	
R523CH	10	AAC	165,814	1987	72	0	100	WEATH/RAVEL, L & T CR	
TACH	10	AAC	3,592	1999	77	0	100	L & T CR
