WILLIAM A. ZORN AIRPORT

PAVEMENT EVALUATION REPORT

JULY 2002

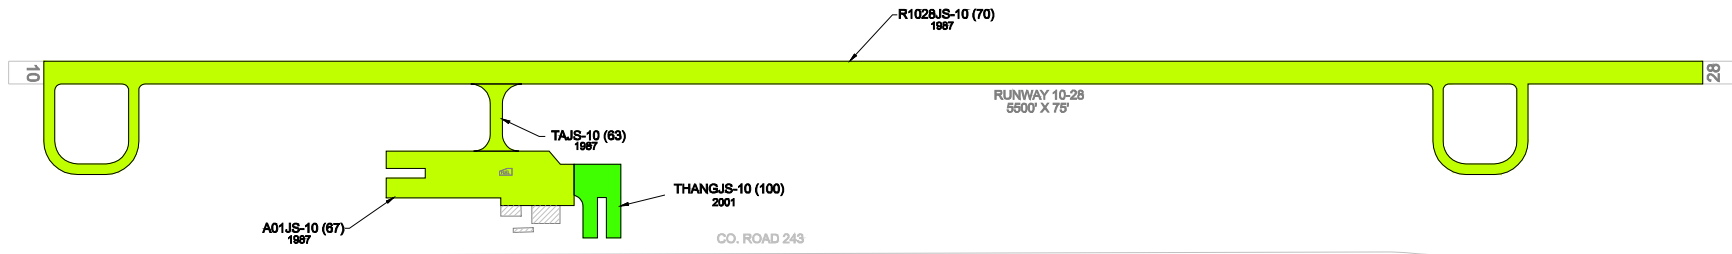
Figure 8. INSERT PCI MAP
(11 x 17)

The 2001 area-weighted condition of William A. Zorn Airport is 71, with conditions ranging from 63 to 100 [on a scale of 0 (failed) to 100 (excellent)]. Figures 6 and 7 provide graphs summarizing the overall condition of the pavements at William A. Zorn Airport. Figure 8 is a map that displays the condition of the pavements evaluated. Table 1 summarizes the results of the pavement evaluation.
