# 2012 Griffin-Spalding County Airport Pavement Management Plan

# GRIFFIN-SPALDING COUNTY AIRPORT

## PAVEMENT MANAGEMENT REPORT

**DECEMBER 2012**

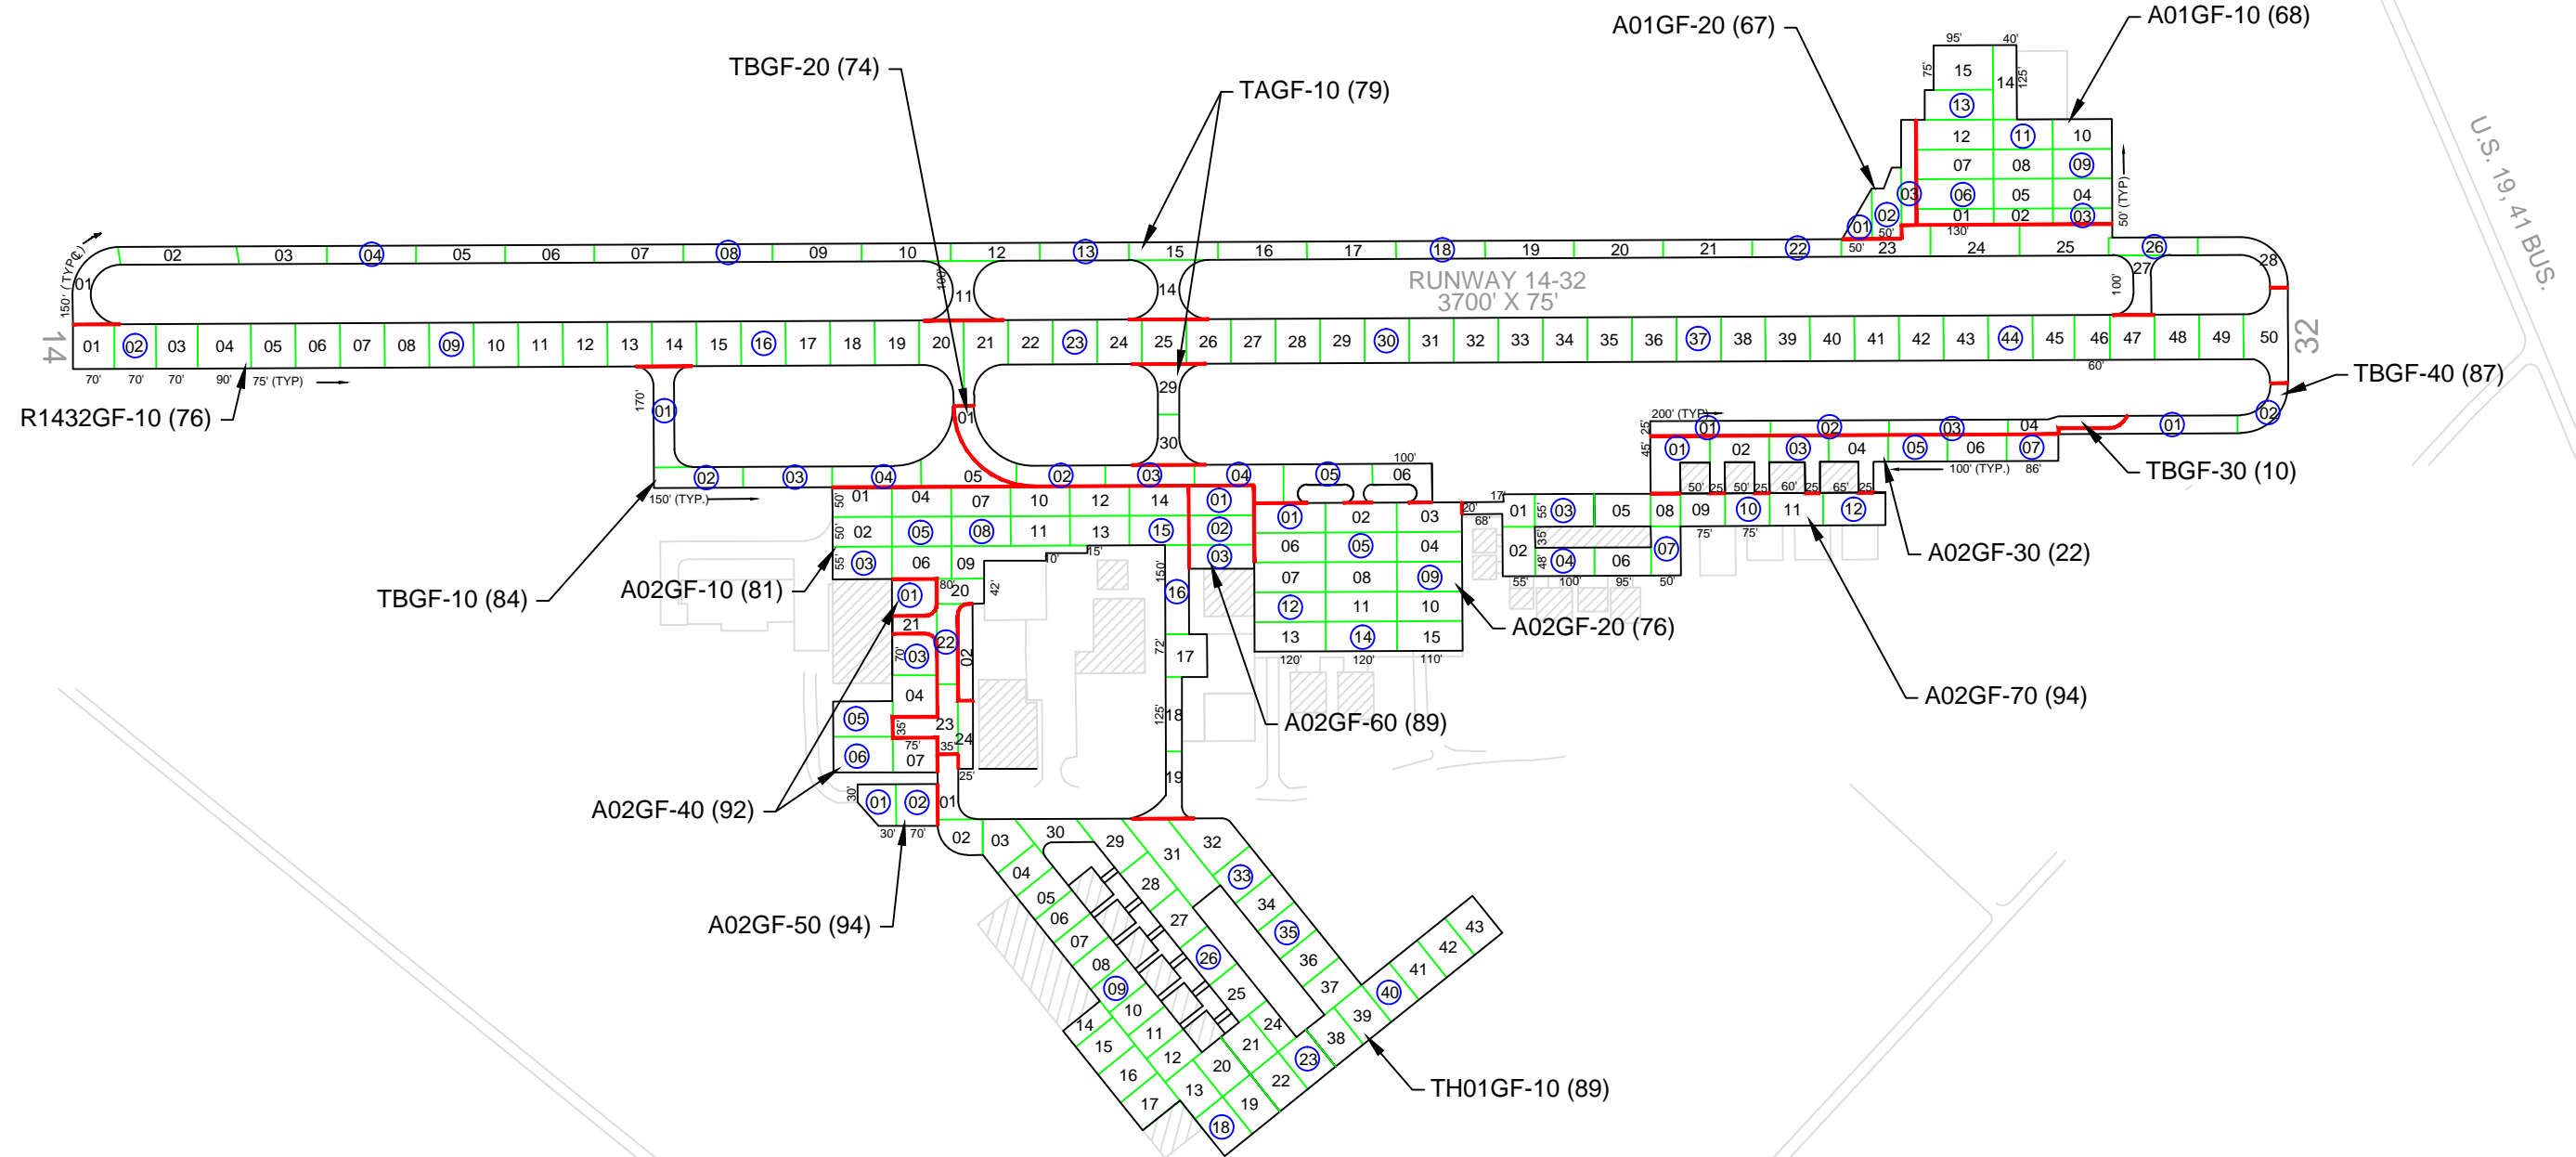
The inspection of Griffin-Spalding County Airport was completed on March 19, 2012 using the PCI procedure described previously. The map presented in Figure 5 identifies the sample units inspected during the pavement evaluation.

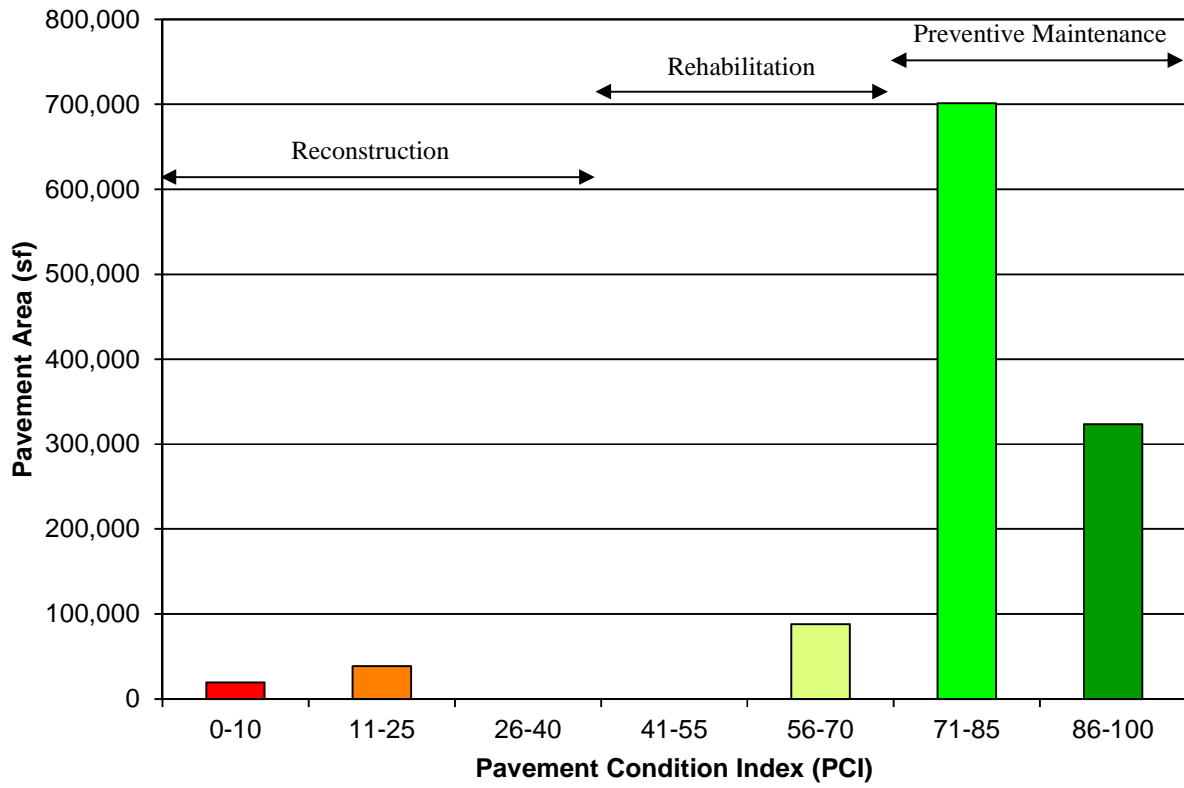
Figure 6. Condition Distribution.

Figures 6 and 7 provide graphs summarizing the overall condition of the pavements at Griffin-Spalding County Airport. Figure 8 is a map that displays the condition of the pavements evaluated. Table 2 summarizes the results of the pavement evaluation and paint assessment and also presents both the 2007 and 2012 PCI values. Please note that modifications have been made to the PCI methodology since the time of the last pavement inspection in 2007, as detailed in ASTM 5340-11. These changes include the separation of the raveling and weathering distress type on asphalt-surfaced pavements into two distress types along with the addition of the alkali silica reaction (ASR) distress type on PCC pavements.
