2012 Jesup-Wayne County Airport Pavement Management Plan

JESUP-WAYNE COUNTY AIRPORT

PAVEMENT MANAGEMENT REPORT

DECEMBER 2012

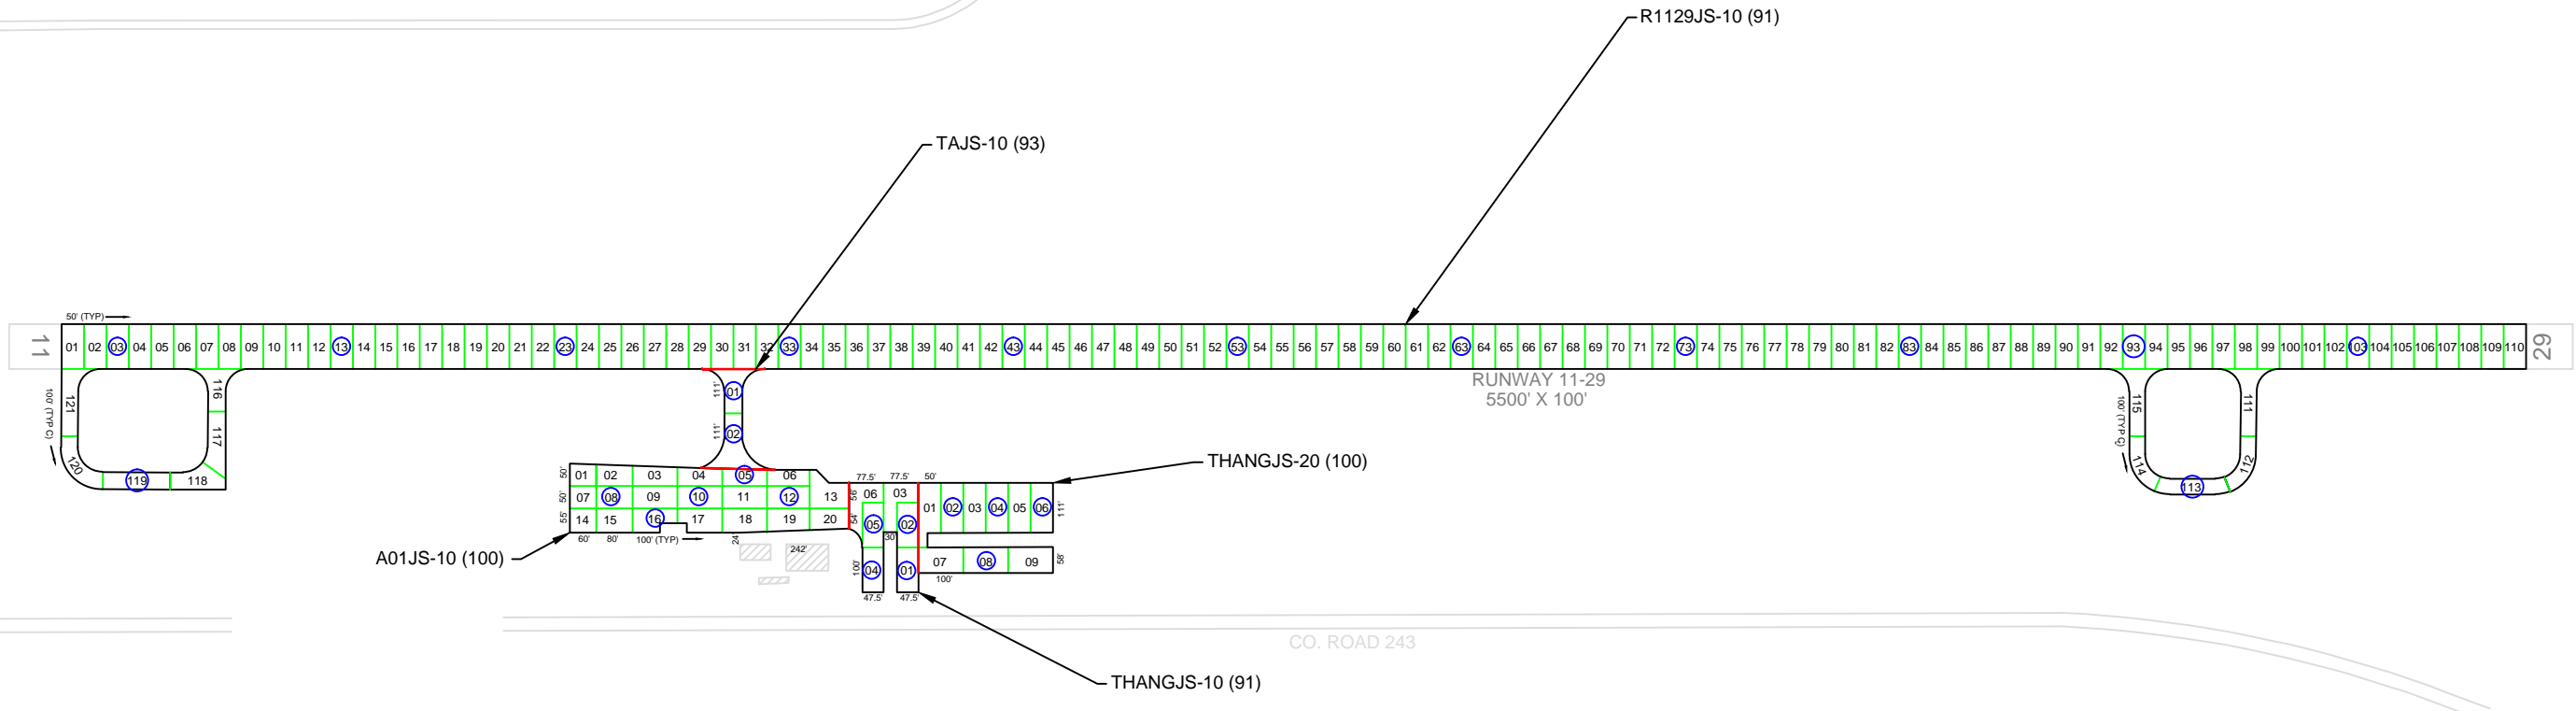
Jesup-Wayne County Airport has over 789,340 square feet of pavement, as shown in Figure 4. Figure 5 is a network definition map of the airport showing the pavement system broken down into management units, as described on page 3 of this report. It also shows the nomenclature used in the MicroPAVER™ pavement management database to identify the different pavement areas. Additionally, the map summarizes the construction history information compiled during the records review and identifies the areas inspected during the visual survey.

The inspection of Jesup-Wayne County Airport was completed on February 11, 2012 using the PCI procedure described previously. The map presented in Figure 5 identifies the sample units inspected during the pavement evaluation.

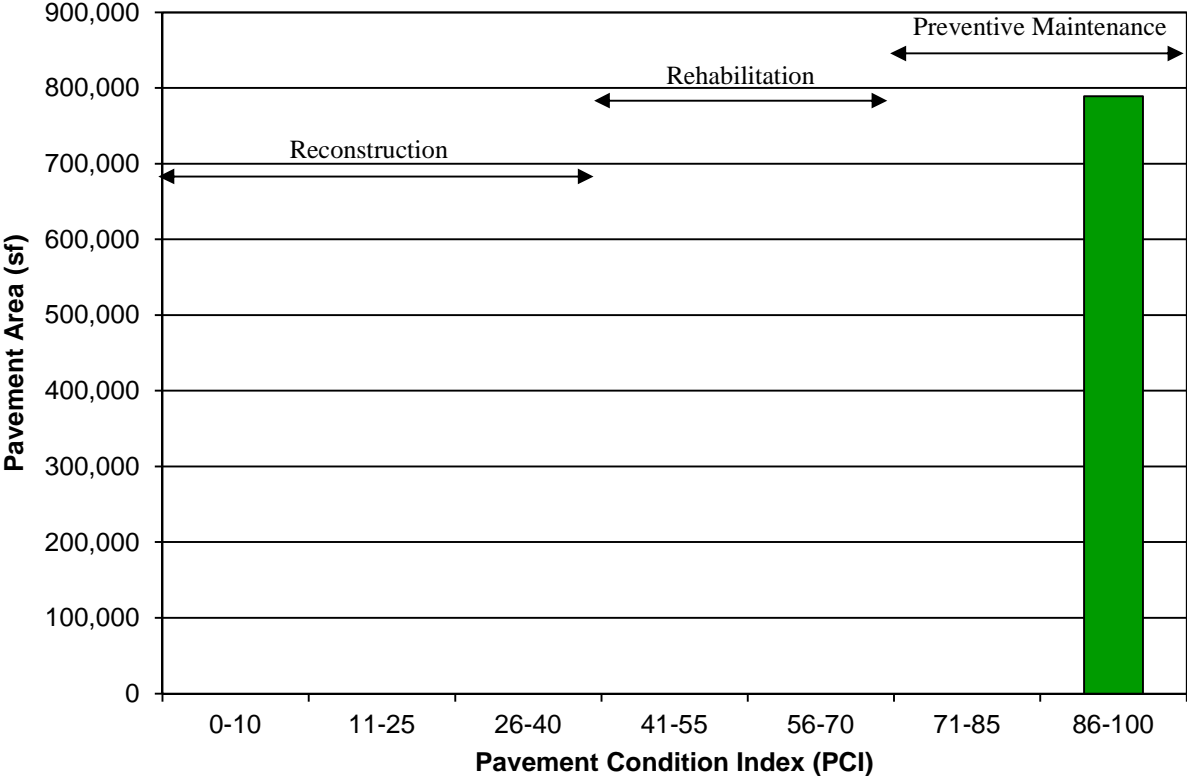
Figure 6. Condition Distribution.

Figures 6 and 7 provide graphs summarizing the overall condition of the pavements at Jesup-Wayne County Airport. Figure 8 is a map that displays the condition of the pavements evaluated. Table 2 summarizes the results of the pavement evaluation and paint assessment and also presents both the 2007 and 2012 PCI values. Please note that modifications have been made to the PCI methodology since the time of the last pavement inspection in 2007, as detailed in ASTM 5340-11. These changes include the separation of the raveling and weathering distress type on asphalt-surfaced pavements into two distress types along with the addition of the alkali silica reaction (ASR) distress type on PCC pavements.
