2012 Brantley County Airport Pavement Management Plan

BRANTLEY COUNTY AIRPORT

PAVEMENT MANAGEMENT REPORT

DECEMBER 2012

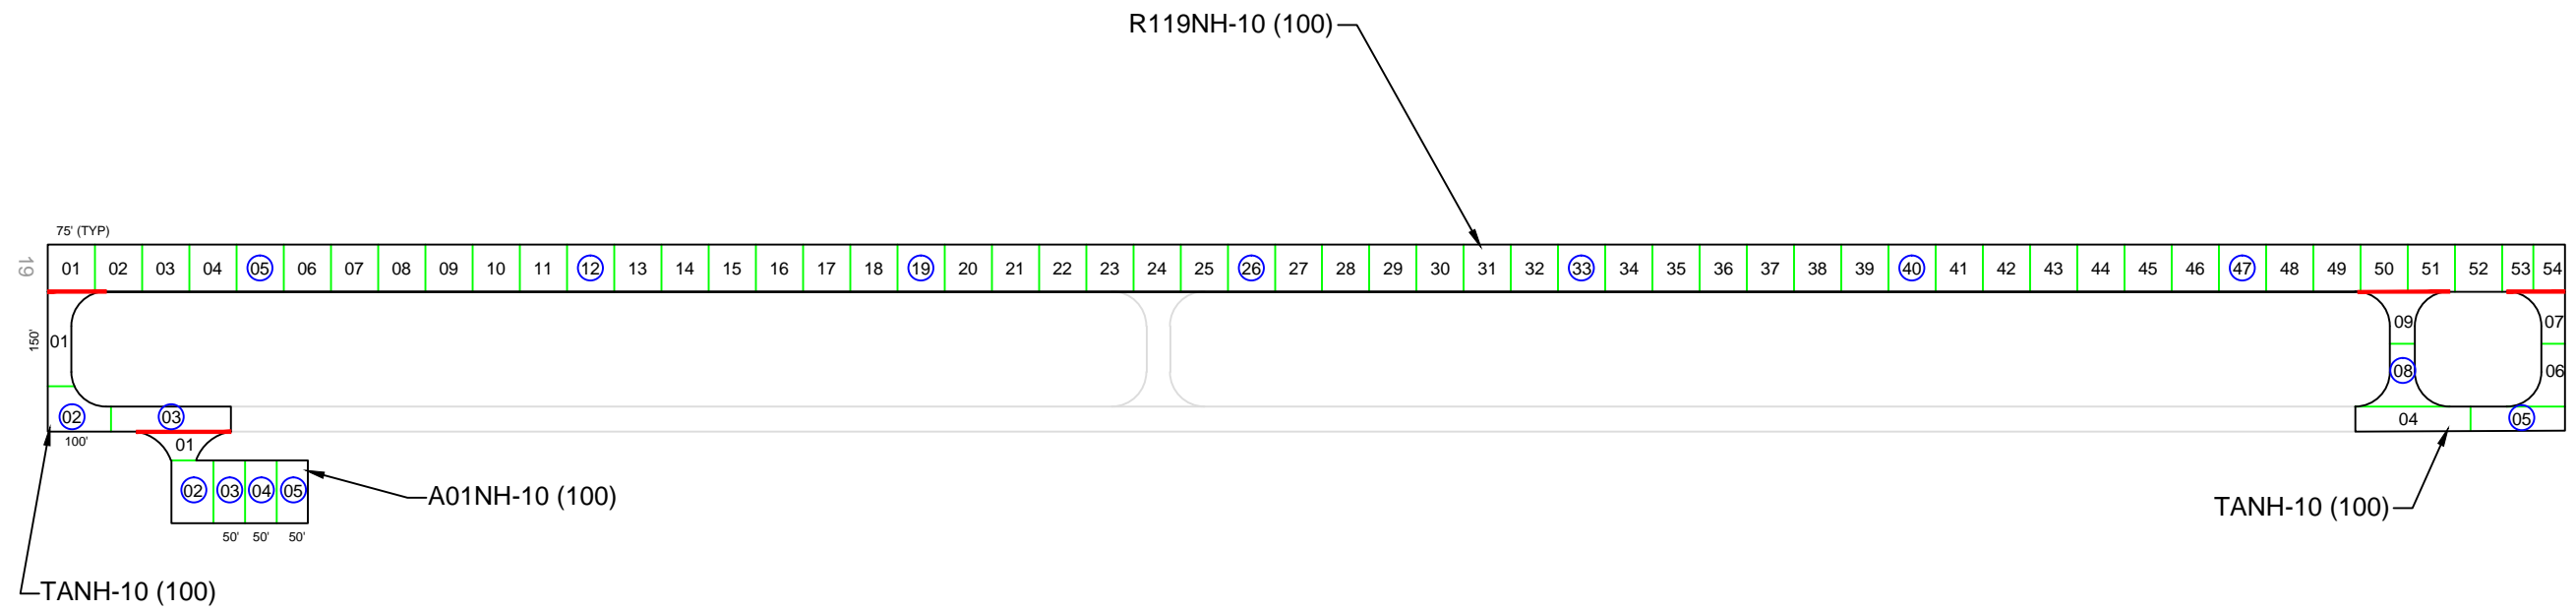
The inspection of Brantley County Airport was completed on February 10, 2012 using the PCI procedure described previously. The map presented in Figure 5 identifies the sample units inspected during the pavement evaluation.
