**Report:**

# Butler Municipal Airport Pavement Management Plan

PRESERVING  
GEORGIA'S  
CRITICAL  
PAVEMENT  
INFRASTRUCTURE

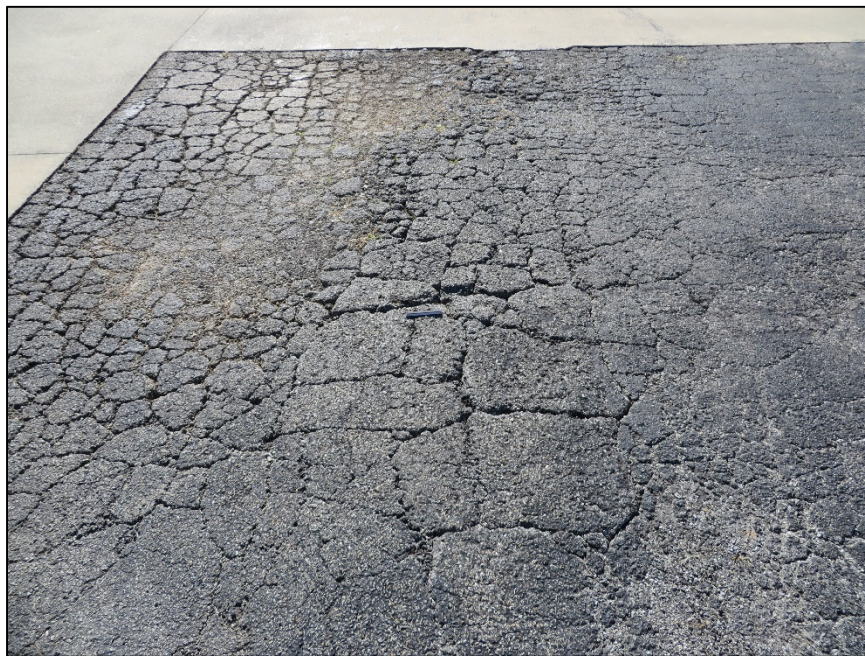
FIGURE H-1 HIGH-SEVERITY ALLIGATOR CRACKING

*Alligator cracking appears as a series of interconnecting cracks caused by fatigue failure of the AC surface. The fatigue failure is most often the result of repeated traffic loading. After repeated traffic loading, the cracks connect, forming many-sided, sharp-angled pieces that develop a pattern resembling chicken wire or the skin of an alligator.*

At the high-severity level, *the pieces are well defined and spalled at the edges*; there is definite FOD potential. If extensive, the only recourse is to overlay or reconstruct the pavement. If localized, full-depth patching is an appropriate repair. FIGURE H-1 illustrates what alligator cracking looks like at the high-severity level.

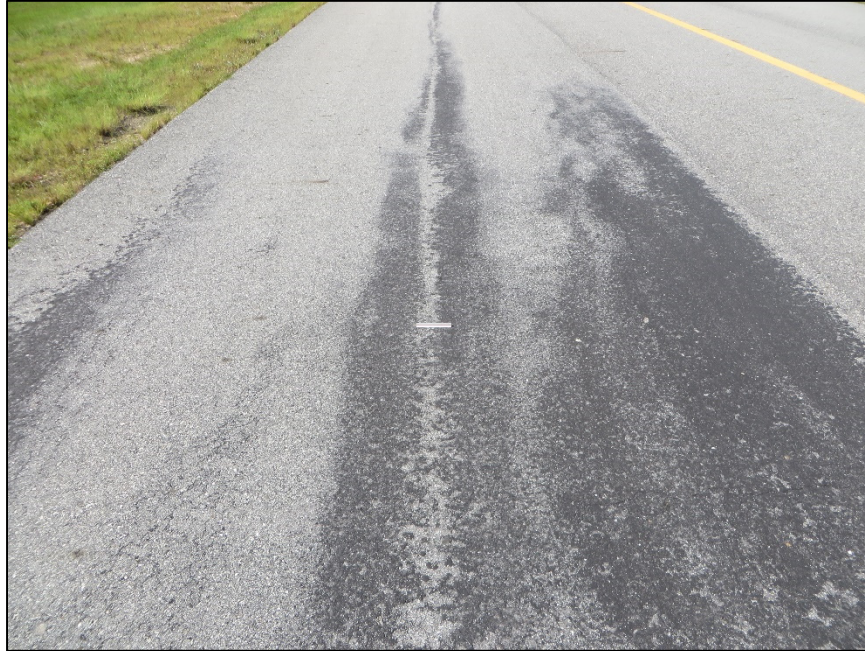
FIGURE H-2 EXTENSIVE BLEEDING

*Bleeding is a film of bituminous material on the pavement surface that creates a shiny, glass-like, reflecting surface that usually becomes quite sticky. Bleeding is caused by excessive amounts of asphaltic cement or tars in the mix or low-air void content, or both. It occurs when asphalt fills the voids of the mix during hot weather and then expands out onto the surface of the pavement. Since the bleeding process is not reversible during cold weather, asphalt or tar will accumulate on the surface.*

At its most severe, bleeding can result in a severe reduction in skid resistance. If bleeding is extensive and severe, as shown in FIGURE H-2, the AC layer should be removed and replaced.

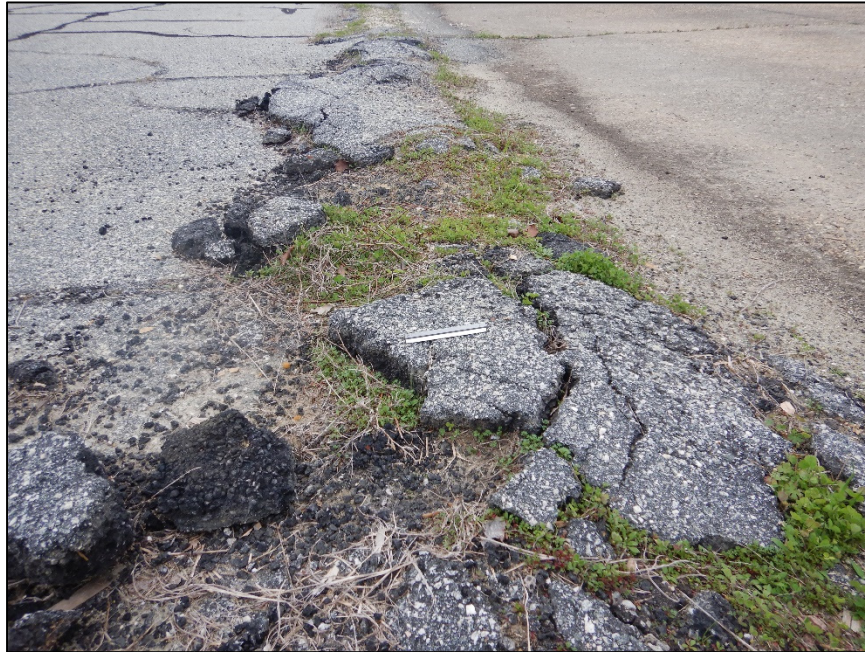
FIGURE H-8 HIGH-SEVERITY SHOVING AT AC/PCC INTERFACE

Pavement expands as its temperature increases. Due to its greater strength, when PCC pavement expands adjacent to AC pavement, it can cause a permanent vertical deformation in the AC pavement. Additionally, PCC pavement has a tendency to grow as gradual openings at the joint widen and are filled with incompressible material or distresses such as alkali-silica reaction (ASR) cause the pavement to expand. This is referred to as pavement growth and can also produce vertical deformation in adjacent AC pavements. This deformation is called shoving.

At high-severity, *a large amount of shoving has occurred, causing severe roughness or break-up of the asphalt pavement.* This situation can be corrected by milling the AC surface to restore smoothness and patching as needed. Installing an expansion joint may minimize the potential for recurrence of the distress. FIGURE H-8 depicts high-severity shoving.

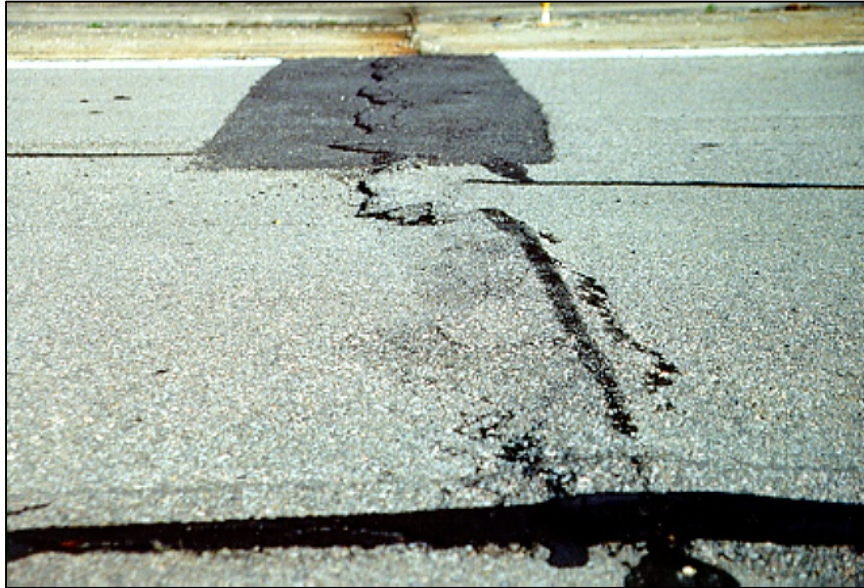
FIGURE H-9 HIGH-SEVERITY SWELLING

*Swell is characterized by an upward bulge in the pavement's surface. A swell may occur sharply over a small area or as a longer, gradual wave. Either type of swell can be accompanied by surface cracking. A swell is usually caused by frost action in the subgrade or by swelling soil, but a small swell can also occur on the surface of an asphalt overlay (over PCC) as a result of a blowup in the PCC slab.*

At the high-severity level, the height differential is greater than 1.5 inches. This distress can be corrected with a patch, or if it is an extensive problem, the pavement can be reconstructed. Consideration should be made to stabilizing and draining the subgrade and adding a frost protection layer if that is a factor. High-severity swelling is shown in FIGURE H-9.

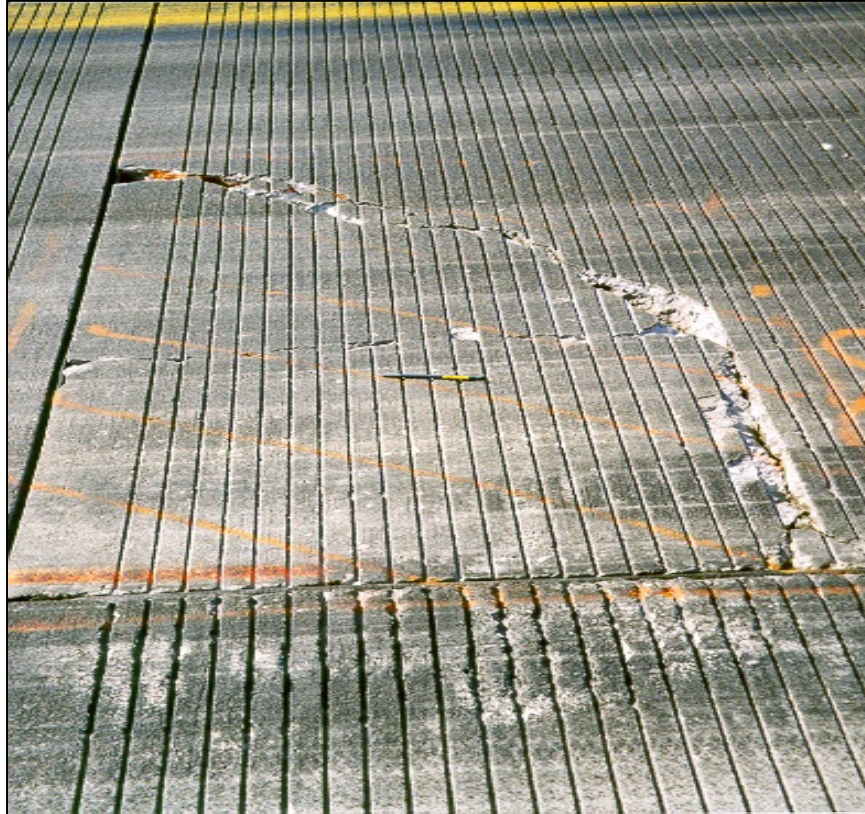
FIGURE H-11 HIGH-SEVERITY CORNER BREAKING

*A corner break is a crack that intersects the joints at a distance less than or equal to one half of the slab length on both sides, measured from the corner of the slab. Load repetition combined with loss of support and curling stresses usually cause corner breaks.*

At high-severity, the crack is severely spalled, causing definite FOD potential; a nonfilled crack has a mean width greater than approximately 1 inch, creating tire damage potential; or the area between the corner break and the joints is severely cracked. This distress needs to be repaired with a full-depth patch or in some cases with a slab replacement. This distress type is shown below in FIGURE H-11.

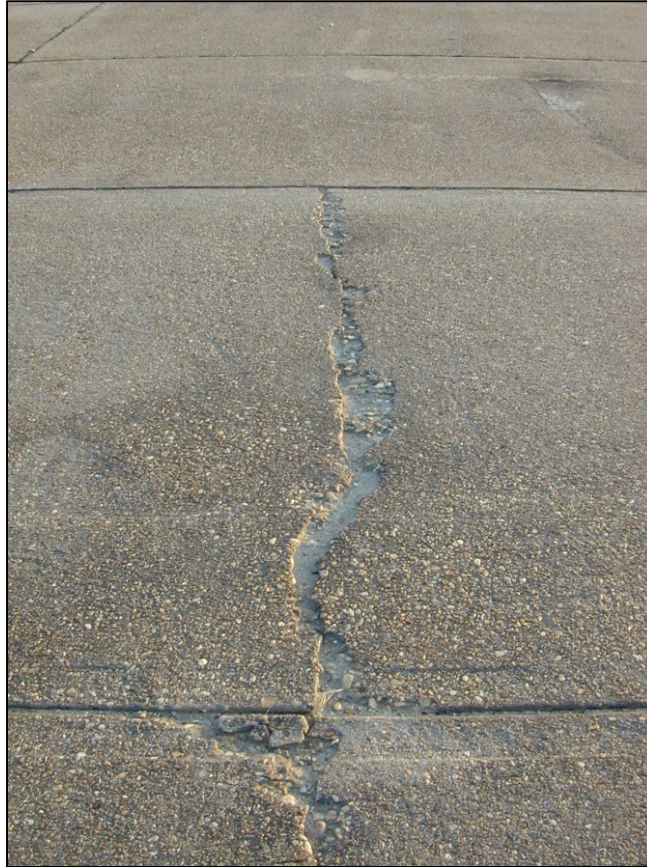
FIGURE H-12 HIGH-SEVERITY LTD CRACKING

LTD cracks divide a slab into two or more pieces. These types of cracks are usually caused by a combination of repeated loading, curling stresses, and/or shrinkage stresses. Low-severity cracks are usually caused by curling or warping stresses (or both) and are not considered serious structural problems. Medium- and high-severity cracks are usually working cracks and typically constitute structural problems. At the high-severity level, the slab will often require replacement or large, full-depth patches. FIGURE H-12 depicts a high-severity LTD crack.

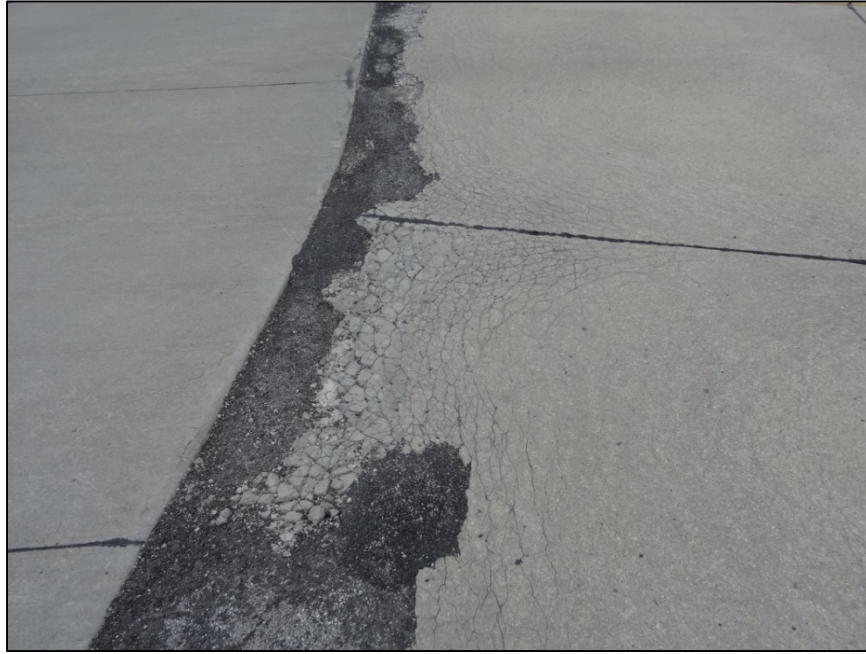
FIGURE H-13 HIGH-SEVERITY DURABILITY CRACKING

Durability cracking is usually caused by a pavement's inability to withstand the forces created by freeze-thaw cycles in PCC pavements that are susceptible to moisture penetration, and it can lead to the disintegration of a pavement along joints and cracks. At high-severity levels, significant FOD potential can exist, and the slab should be replaced. High-severity durability cracking is shown below in FIGURE H-13.

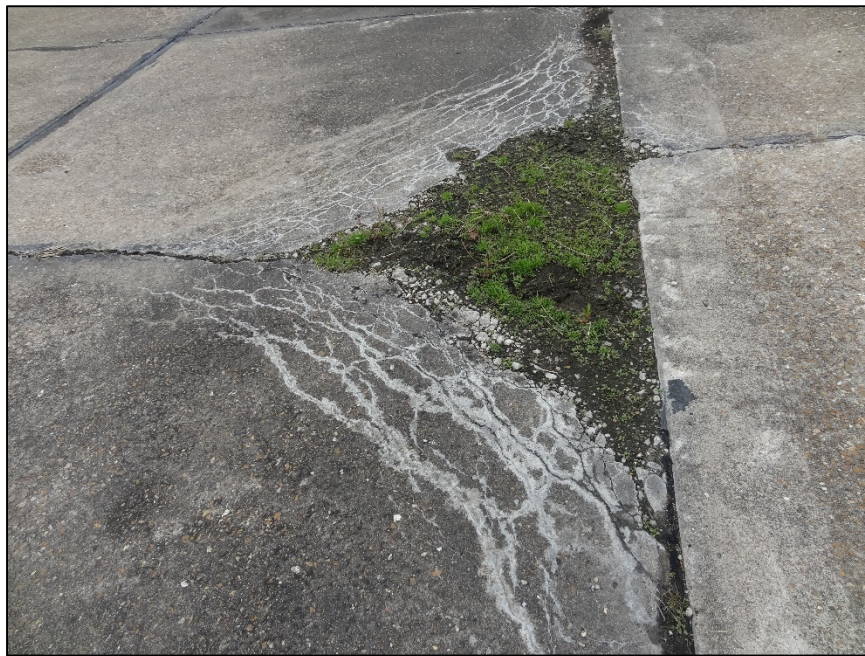
**FIGURE H-20 HIGH-SEVERITY ASR**

*ASR is caused by chemical reaction between alkalis and certain reactive silica minerals which form a gel. This gel expands in the presence of water, causing the fracturing of the aggregates and paste. Visual indicators that ASR may be present include: (1) cracking of the concrete pavement (often in a map pattern); (2) white, brown, gray or other colored gel or staining may be present at the crack surface; (3) aggregate popouts; or (4) increase in concrete volume (expansion) that may result in distortion of adjacent or integral structures or physical elements.*

For ASR to be recorded at high-severity, *one or both of the following exist: (1) loose or missing concrete fragments and poses high FOD potential, (2) slab surface integrity and function significantly degraded and pavement requires immediate repairs; may also require repairs to adjacent structures or elements.* This distress should be repaired with a slab replacement. If extensive, reconstruction may be the only viable option. FIGURE H-20 depicts this distress type.
