Report:

Brantley County Airport Pavement Management Plan

PRESERVING
GEORGIA'S
CRITICAL
PAVEMENT
INFRASTRUCTURE

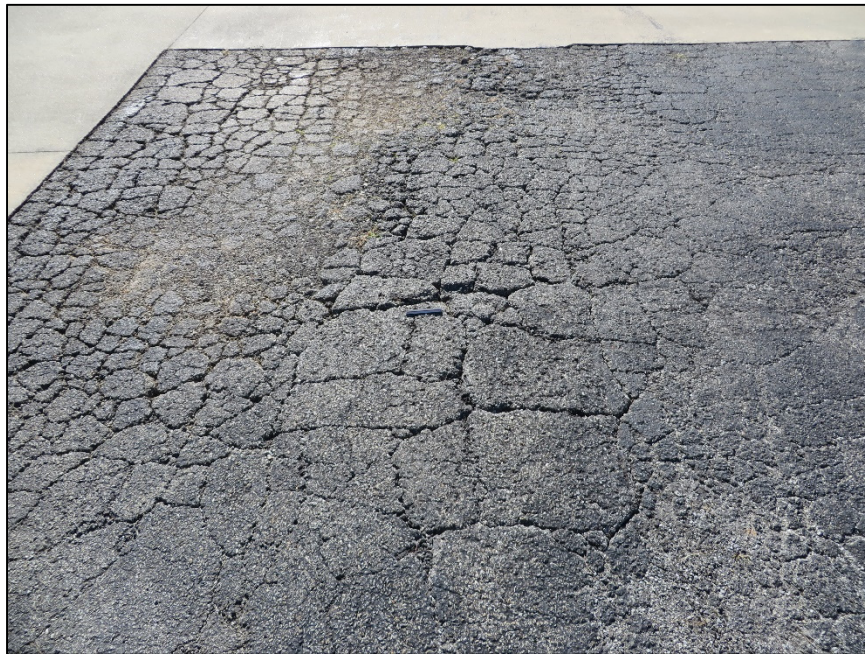
FIGURE H-1 HIGH-SEVERITY ALLIGATOR CRACKING

Alligator cracking appears *as a series of interconnecting cracks caused by fatigue failure of the AC surface*. The fatigue failure is most often the result of repeated traffic loading. *After repeated traffic loading, the cracks connect, forming many-sided, sharp-angled pieces that develop a pattern resembling chicken wire or the skin of an alligator.*

At the high-severity level, *the pieces are well defined and spalled at the edges*; there is definite FOD potential. If extensive, the only recourse is to overlay or reconstruct the pavement. If localized, full-depth patching is an appropriate repair. FIGURE H-1 illustrates what alligator cracking looks like at the high-severity level.

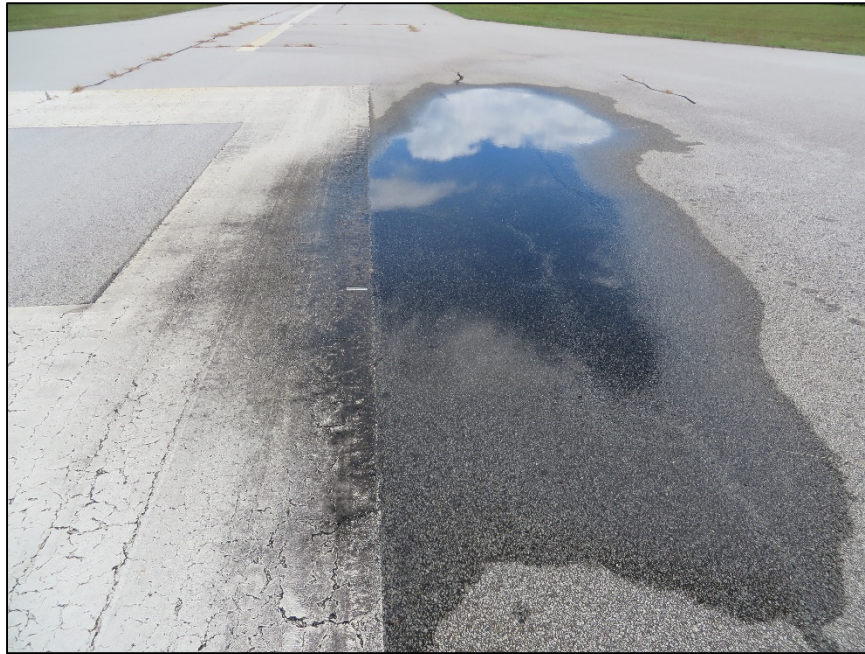
FIGURE H-3 HIGH-SEVERITY DEPRESSION

Depressions are localized pavement surface areas having elevations slightly lower than those of the surrounding pavement. Depressions can be caused by settlement of the foundation soil or can be built during construction. Depressions cause roughness and, when filled with water of sufficient depth, could cause hydroplaning of aircraft.

High-severity depressions in areas where aircraft maneuver at high speeds should be patched. An example of a high-severity depression is shown in FIGURE H-3.

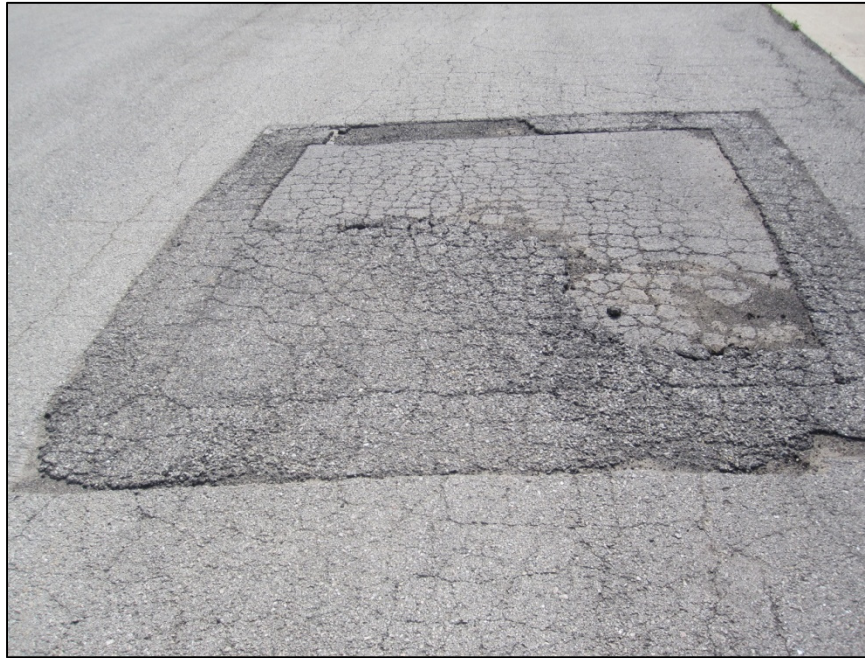
FIGURE H-5 HIGH-SEVERITY PATCHING

At high-severity, a *patch is badly deteriorated and affects ride quality significantly or has high FOD potential*. High-severity patches need to be replaced to avoid FOD and tire damage potential. FIGURE H-5 shows a high-severity patch.

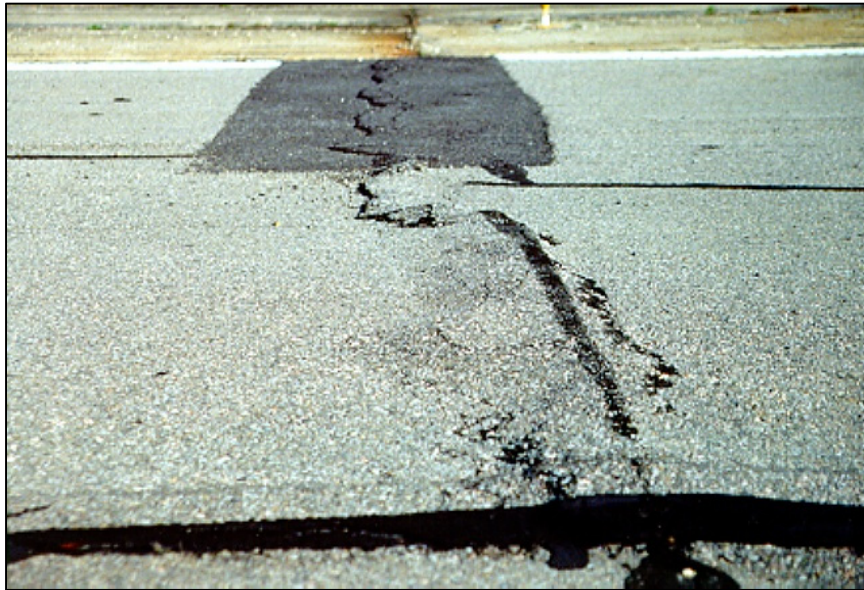
FIGURE H-9 HIGH-SEVERITY SWELLING

Swell is characterized by an upward bulge in the pavement's surface. A swell may occur sharply over a small area or as a longer, gradual wave. Either type of swell can be accompanied by surface cracking. A swell is usually caused by frost action in the subgrade or by swelling soil, but a small swell can also occur on the surface of an asphalt overlay (over PCC) as a result of a blowup in the PCC slab.

At the high-severity level, the height differential is greater than 1.5 inches. This distress can be corrected with a patch, or if it is an extensive problem, the pavement can be reconstructed. Consideration should be made to stabilizing and draining the subgrade and adding a frost protection layer if that is a factor. High-severity swelling is shown in FIGURE H-9.

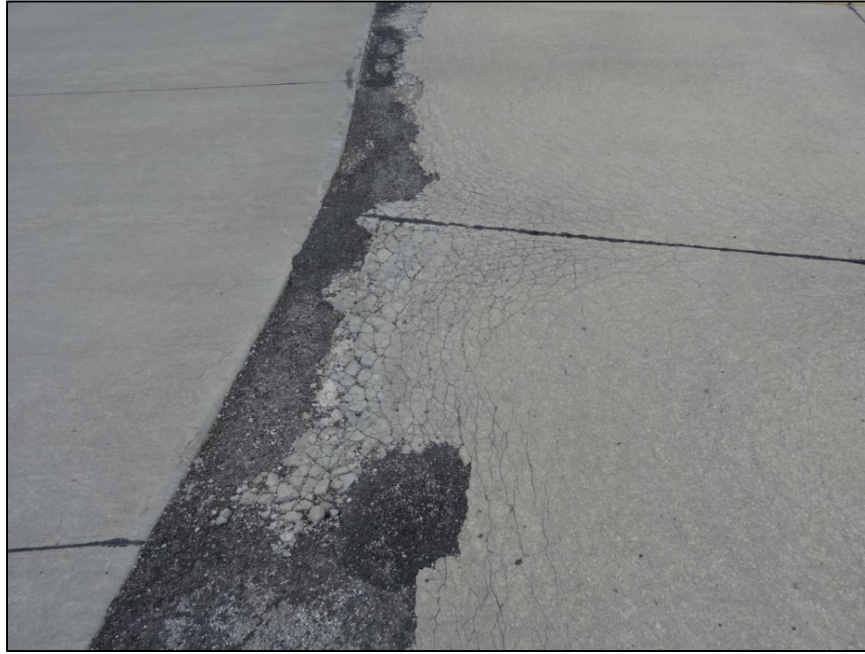
FIGURE H-13 HIGH-SEVERITY DURABILITY CRACKING

Durability cracking is usually caused by a pavement's inability to withstand the forces created by freeze-thaw cycles in PCC pavements that are susceptible to moisture penetration, and it can lead to the disintegration of a pavement along joints and cracks. At high-severity levels, significant FOD potential can exist, and the slab should be replaced. High-severity durability cracking is shown below in FIGURE H-13.

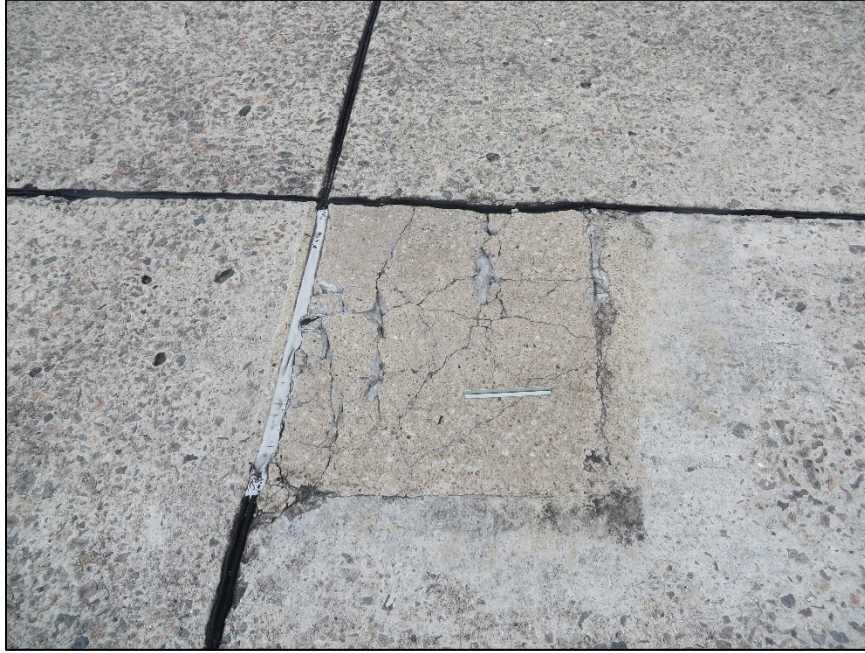
FIGURE H-14 HIGH-SEVERITY PATCHING

A patch is an area where the original pavement has been removed and replaced by a filler material. High-severity patches must be replaced. An example of a high-severity patch is shown in FIGURE H-14.

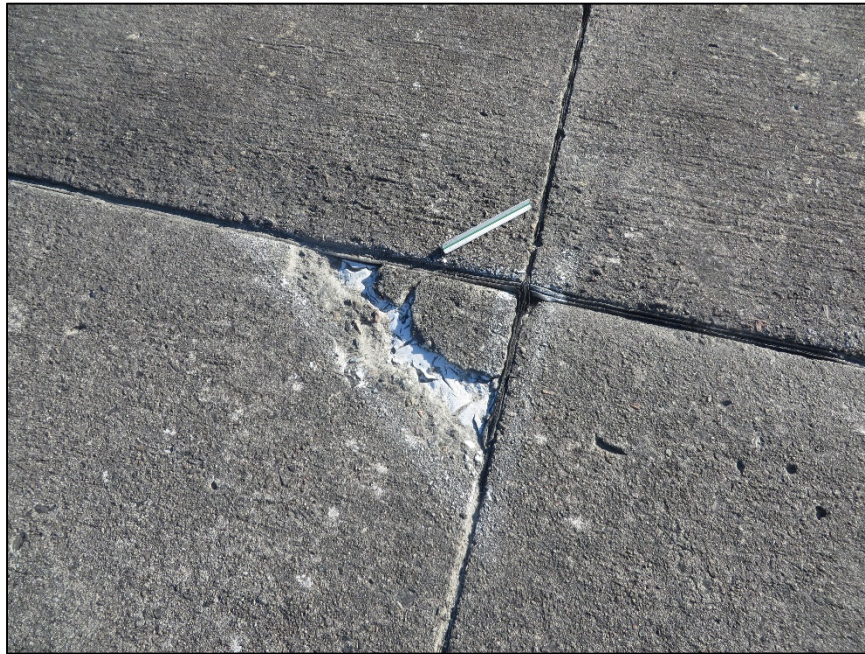
FIGURE H-19 HIGH-SEVERITY CORNER SPALLING

Corner spalling is defined as *the raveling or breakdown of the slab within approximately 2 feet of the corner*. Corner spalling has the same causes as joint spalling and must be greater than 3 inches wide to be considered a spall.

For a corner spall to be recorded at high-severity, *one of the following conditions exists: (1) spall is broken into two or more pieces defined by high-severity fragmented crack(s) with loose or absent fragments; (2) pieces of the spall have been displaced to the extent that a tire damage hazard exists; or (3) spall has deteriorated to the point where loose material is causing high FOD potential*. Due to the high FOD potential, this distress should be repaired with a partial-depth patch. FIGURE H-19 shows this distress type.
